Pit, Below-Grade Tank, or  
Proposed Alternative Method Permit or Closure Plan Application

1.  
Operator: BP America Production Company OGRID #: 778  
Address: 380 North Airport Road, Durango, CO 81303  
Facility or well name: HOLMBERG GC A # 1 (A)  
API Number: 3004521016 OCD Permit Number: \_\_\_\_\_  
U/L or Qtr/Qtr B Section 28 Township 32N Range 10W County: San Juan  
Center of Proposed Design: Latitude 36.960365 Longitude -107.883420 NAD83  
Surface Owner:  Federal  State  Private  Tribal Trust or Indian Allotment

BELOW-GRADE TANK CLOSURE PLAN

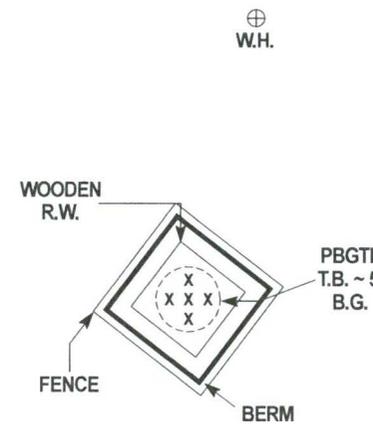
**X - S.P.D.**

SITE SKETCH	BGT Located: off <input checked="" type="checkbox"/> on <input type="checkbox"/> site	PLOT PLAN circle: <b>attached</b>	OVM CALIB. READ. = <b>NA</b> ppm RF = 1.00 OVM CALIB. GAS = <b>NA</b> ppm TIME: <b>NA</b> am/pm DATE: <b>NA</b>
-------------	---	-----------------------------------	---

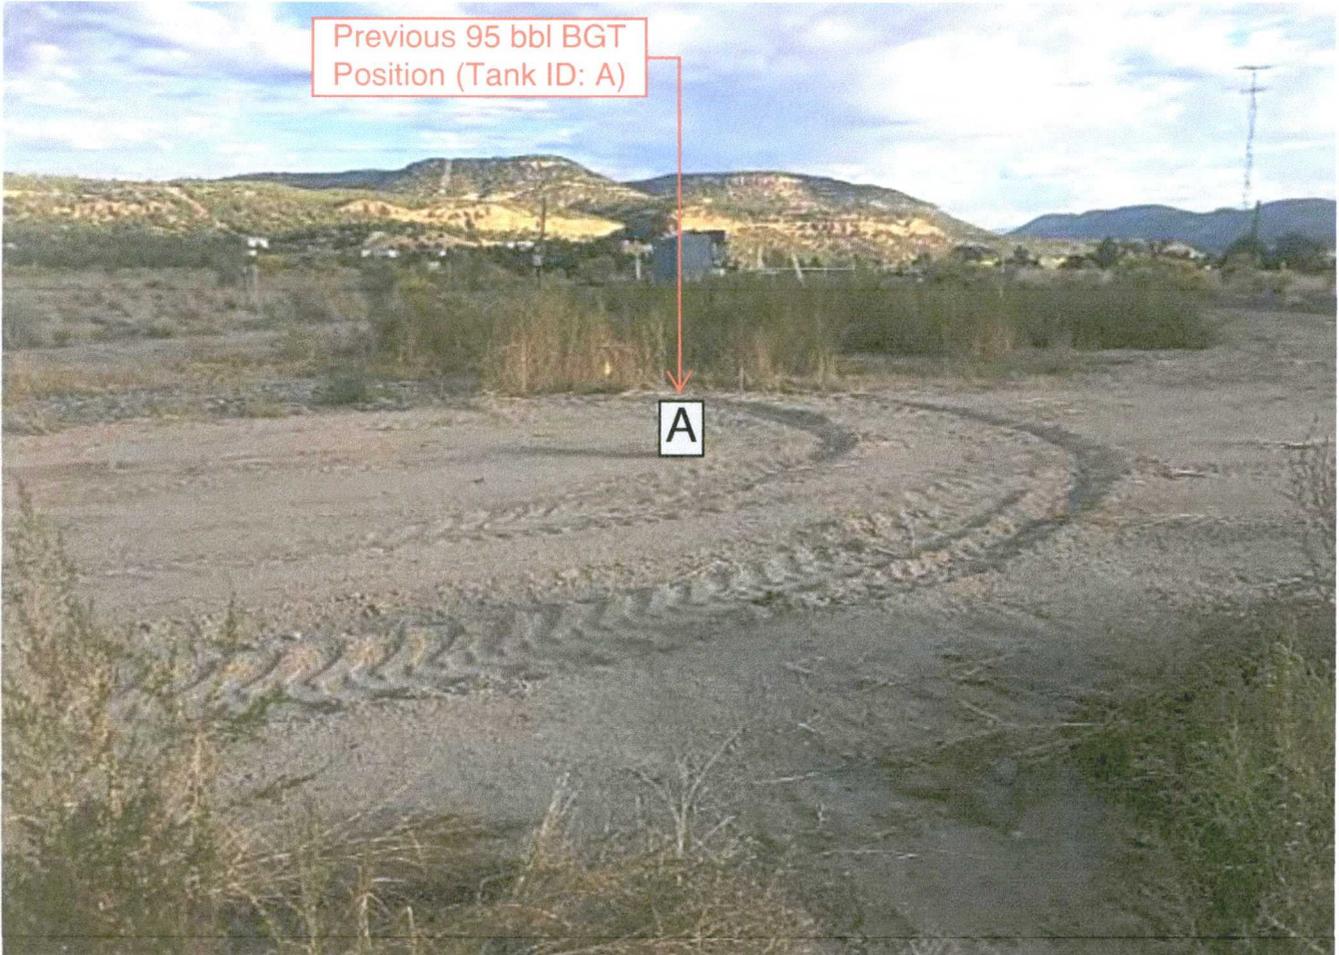
A

Previous 95 bbl BGT  
Position (Tank ID: A)

**The area has been backfilled and BGT location's surface condition is clear. The location will be reclaimed after the production well has been plugged and abandoned.**
