Pit, Closed-Loop System, Below-Grade Tank, or Proposed Alternative Method Permit or Closure Plan Application

BELOW-GRADE TANK CLOSURE PLAN

EE Elliott B # 4 – Tank ID: A
API #: 3004509107
Unit Letter P, Section 27, T30N, R9W

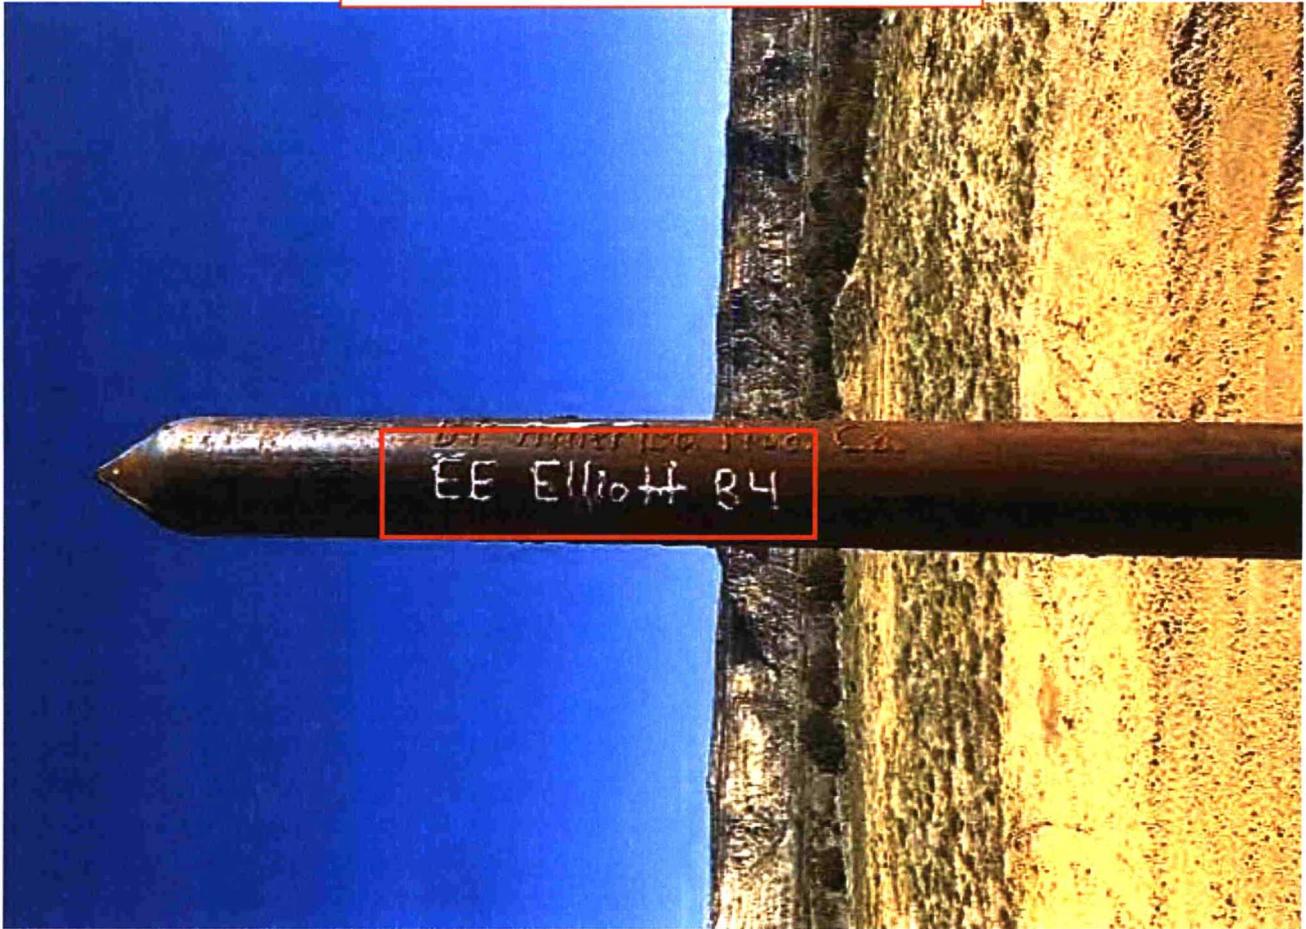
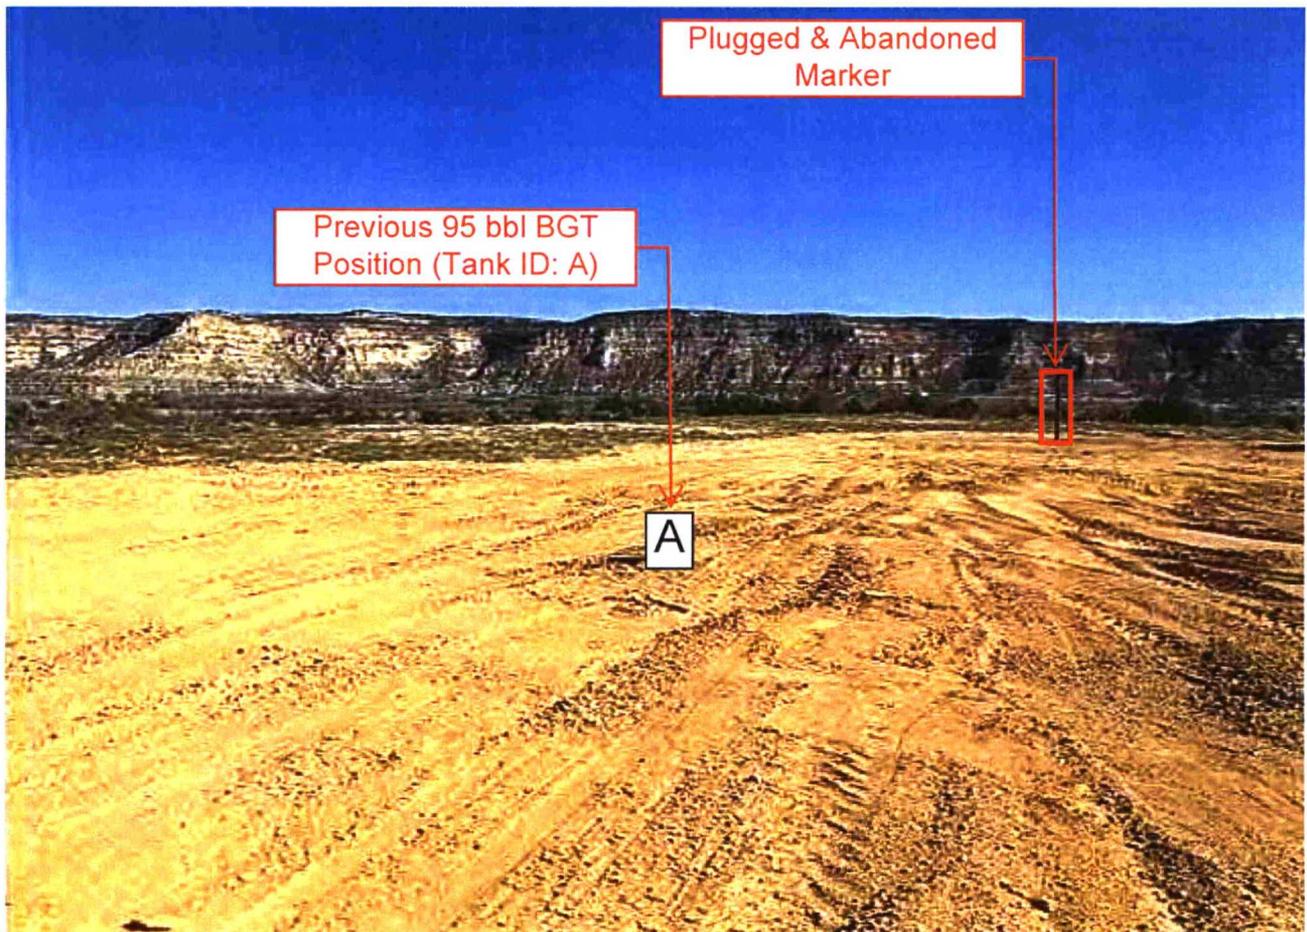
E E ELLIOTT B 004

The BGT area has been backfilled with clean, earthen material and is within the active well pad. Reclamation will be completed within the allowable timeframe after the well has been plugged & abandoned.

- e. site reclamation, photo documentation.**Closure report on C-144 form is included & contains a photo of the current reclamation requirements completed.**

Sampling results reveal no evidence of a release has occurred. Area was backfilled with clean, earthen material and is within the active well pad.
