| Deviation Report | | |
| <u>Lease Name and Number</u><br>Ripley <del>#26</del> <sup>*6</sup> | | <u>API Number</u><br>30-045-33425 |

**Ripley #26-6**  
**San Juan County, New Mexico**  
**Current Well Schematic**

API: 30-045-33425  
Legals: 26-32N-13W  
Field: Basin

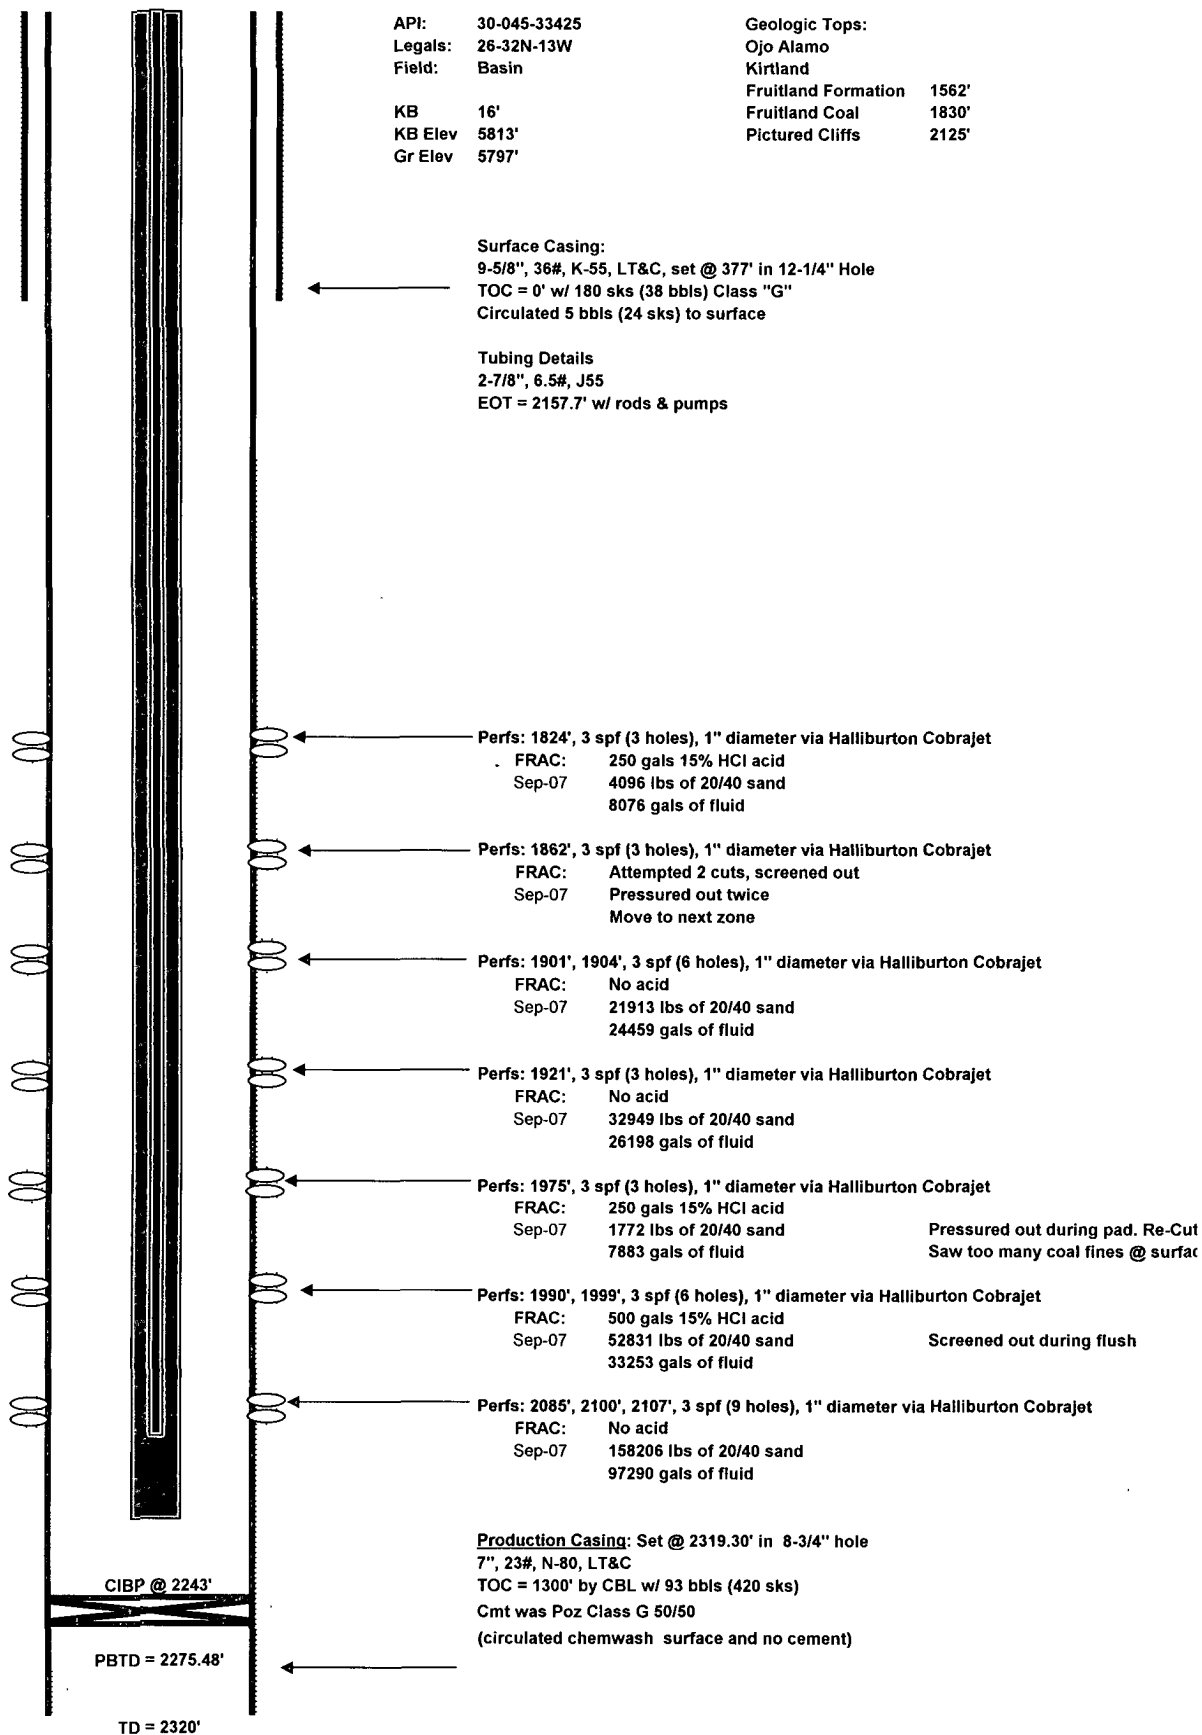
KB 16'  
KB Elev 5813'  
Gr Elev 5797'

Geologic Tops:  
Ojo Alamo  
Kirtland  
Fruitland Formation 1562'  
Fruitland Coal 1830'  
Pictured Cliffs 2125'

Surface Casing:  
9-5/8", 36#, K-55, LT&C, set @ 377' in 12-1/4" Hole  
TOC = 0' w/ 180 sks (38 bbls) Class "G"  
Circulated 5 bbls (24 sks) to surface

Tubing Details  
2-7/8", 6.5#, J55  
EOT = 2157.7' w/ rods & pumps
