# NORTHEAST BLANCO UNIT #319

30-045-31089  
Current

Blanco Mesaverde

(N), Section 7, T-31-N, R-6-W, San Juan County, NM

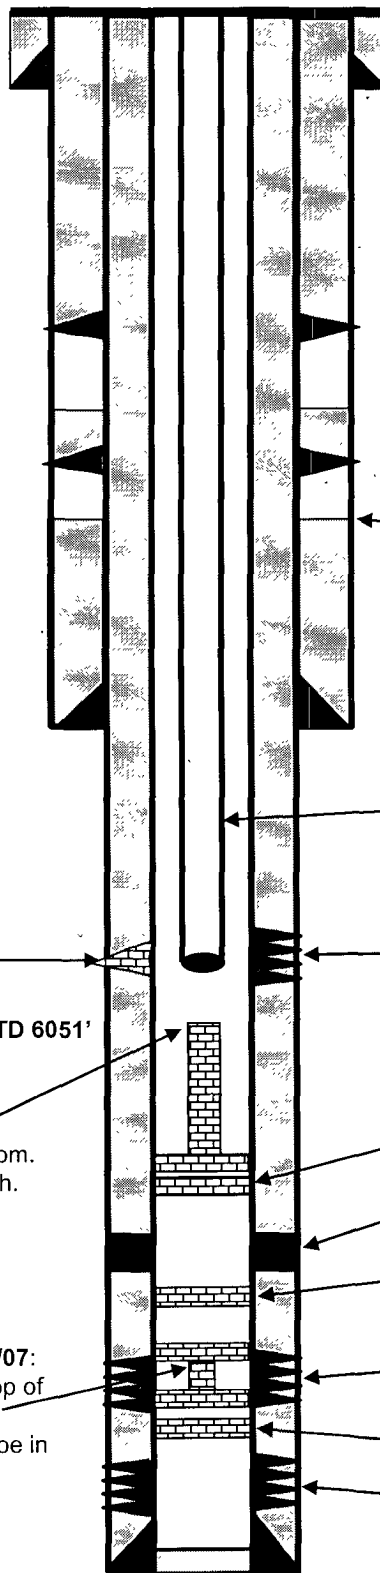
Ojo Alamo @ 2409'

Kirtland @ 2534'

Fruitland @ 2950'

Pictured Cliffs @ 3335'

Lewis @ 3555'

12-1/4" Hole

9-5.8" 32.3# H-40 @ 270'  
200 sx cement  
(Circ.cmt to Surf.)

Perf 3 holes @ 2403' & SQ  
w/641 cf

Perf 3 holes @ 3000' & SQ  
w/118 cf

TOC @ 3080'-Temp Survey

8-3/4" Hole to 3753'

7" 23# @ 3753'  
Cmted with 532 cf  
foamed cmt+67 cf cmt

2-3/8" tbg @ 5836'

Massive Cliffhouse @ 5130'

Menefee @ 5520'  
Point Lookout @ 5790'

Csg Leaks  
5550'-5840' SQ  
w/86 cf cmt

10/08: MV Perfs @ 5465'-6027'  
Fraced w/196,358# sand

PBTD 6051'

Mancos @ 6130' **FISH IN HOLE': 10/08:**  
Stuck pkr & pushed to bottom.  
Dumped 10 gal sand on fish.  
Top of fish @ 6051'.

9/08: 4-1/2" RBP @ 6068'

DV Tool @ 6788'  
Cmted w/661 cf  
Circ. 25 bbls Cmt

9/08: 4-1/2" RBP @ 6990'

Mancos-Perfs @ 7190'-7260'  
8/07: Perfed additional  
Mancos @ 7806'-7833' &  
fraced w/85,759# sand

Dakota @ 8010' **FISH IN HOLE - 125': 8/07:**  
Aeroset pkr @ 7688'. Top of  
fish (2-7/8" tbg) @ 7599'.  
9/08: Lost wash over shoe in  
hole on top of old fish.

4-1/2" RBP @ 7940'

Dakota Perfs @ 7977'-8083'  
Fraced w/50,000# sand

7-7/8" Hole to TD

4-1/2" 11.6# @ 8150'  
Cmted with 218 bbls &  
circ 8 bbls cmt

TD 8150'
