PIT REMEDIATION AND CLOSURE REPORT

Facility Or: SJ 30-5 #9A API #: 30-039-22710

Location: SJ 30-5 #9A
Footages: 1540' FNL & 1050' FWL
Unit Letter: E Sec. 32 Twn. 30N Rng 5W
Latitude: 36.77208° N **Longitude:** 107.38544° W
Lease Num. E - 347 - 23 **Land Type:** State

Pit Type: Abandoned Drip Pit

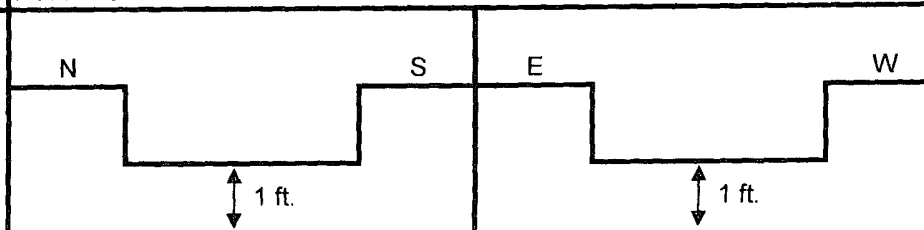
Site Diagram:

Pit built into a sandstone shelf.

Bedrock at 1 foot.

No odor or discoloration.

SJ 30-5 #9A
Not to Scale

Wellhead

Abandoned Dip Pit

Meter Run
(disconnected)
