**PIT REMEDIATION AND CLOSURE REPORT**

Facility Or: State Com AI # 33 API #: 30-045-06118  
Well Name

Client: ConocoPhillips Company

Location: State Com AI #33  
Footages: 1190' FSL & 1650' FWL  
Unit Letter: N Sec. 32 Twn. 27N Rng 9W  
Latitude: 36.52774° N Longitude: 107.81444° W  
Lease Num. STE 92252 Land Type: State

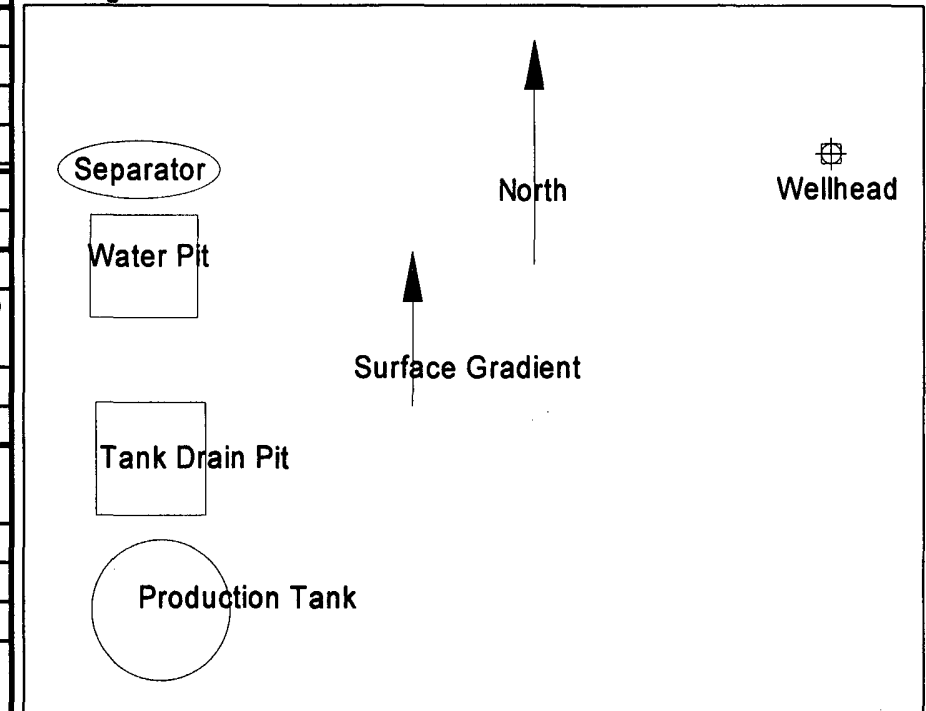
## Site Diagram:

Sample location Center of pit, 6-ft below surface level (3-ft. below pit bottom)

Reference: Wellhead Footage: 85'  
Direction: N or (S) 72 Degrees E or (W)  
Initial size: 12' X 15' X 3' deep  
Final Size: 12' X 15' X 3' deep
