PIT REMEDIATION AND CLOSURE REPORT

Operator: ConocoPhillips Company Telephone: (505) 599-3400

Facility Or: Schlosser Wn Fed. #2R API #: 30-045-26145

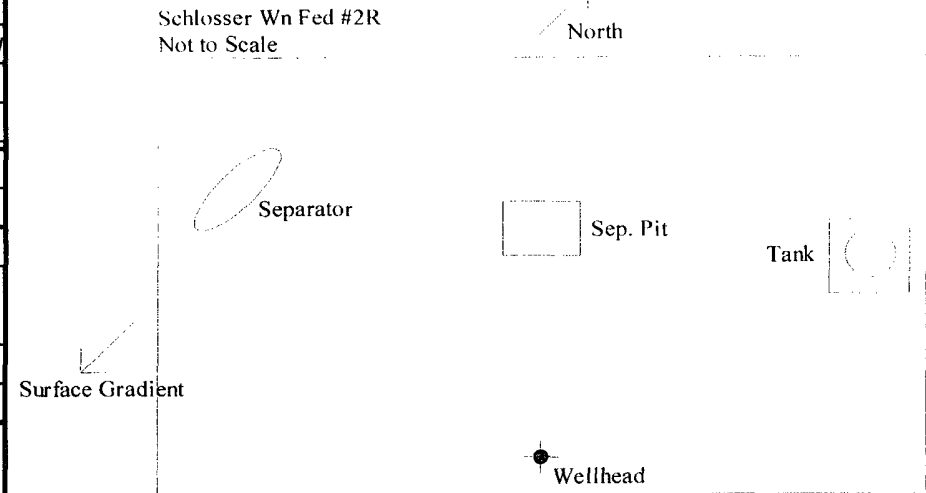
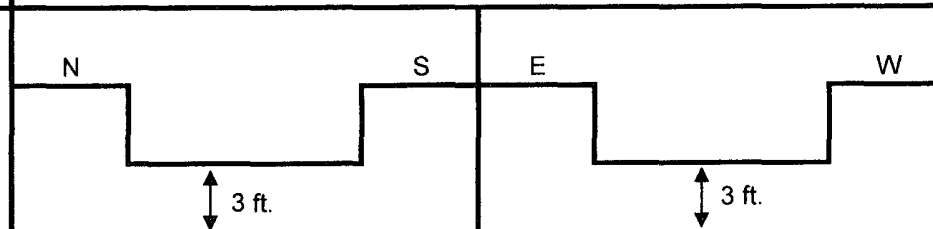
Tests:**Site Diagram:**

Sample location Center of pit, 6-ft below surface level (3-ft. below pit bottom)

Reference: wellhead **Footage:** 85'
Direction: (N) or S 15 Degrees E or (W)
Initial size: 25' x 25' x 3' = 1875 ft³
Final Size: 25' x 25' x 3' = 1875 ft³
Total Cubic Yards: 0 yd³

Gray layer of soil at 30" below surface level.
