# FIELD PIT SITE ASSESSMENT FORM

# FIELD PIT REMEDIATION/CLOSURE FORM

**FIELD SERVICES LABORATORY**  
**ANALYTICAL REPORT**  
**PIT CLOSURE PROJECT - Soil**

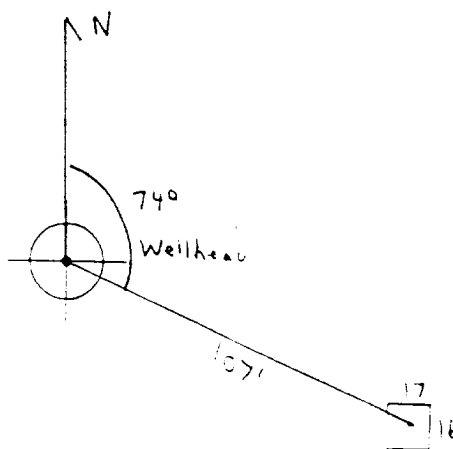
Original Pit : a) Degrees from North 74° Footage from Wellhead 107'  
b) Length : 17' Width : 16' Depth : 3'

Pictures @ 1236 (23-26)  
Dump Truck
