## PIT REMEDIATION AND CLOSURE REPORT

Lease Name: San Juan 28-7 # 208

Operator: Conoco

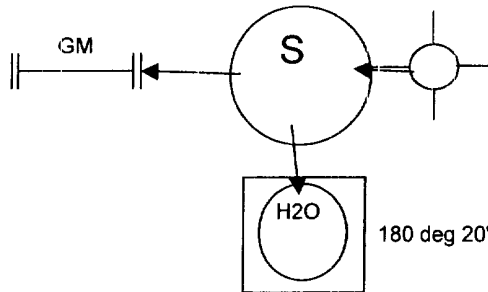
Site Security  
(Indicate North)

Load line valves :  
Sealed during Production

Drain line valves :  
Sealed during Production

Production Line valve:  
Sealed during sales
