**PIT REMEDIATION AND CLOSURE REPORT**

Operator: Phillips Petroleum Company Telephone: (505) 599-3460  
Address: 5525 Hwy. 64, NBU 3004, Farmington, NM 87401  
Facility Or: San Juan 29-6 Unit #33 (DK)  
Well Name \_\_\_\_\_  
Location: Unit or Qtr/Qtr Sec B NWNE Sec 13 T 29N R 6W County Rio Arriba  
Pit Type: Separator X Dehydrator \_\_\_\_\_ Other \_\_\_\_\_  
Land Type: BLM X, State \_\_\_\_\_, Fee \_\_\_\_\_, Other \_\_\_\_\_

PHILLIPS PETROLEUM PIT ASSESSMENT SUMMARY  
REVISED DATE: JANUARY 7, 1994

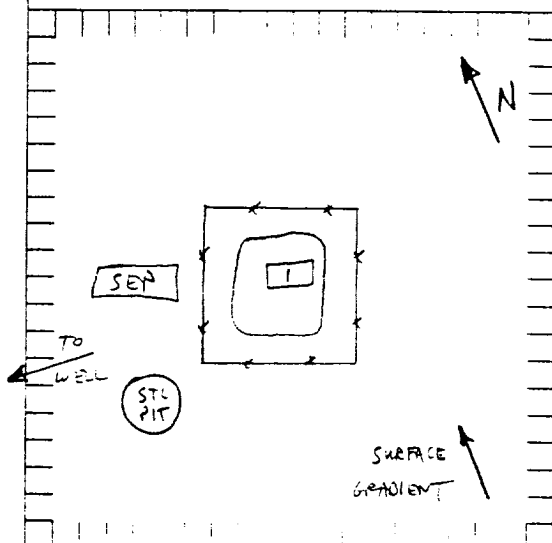
## SITE DIAGRAM

LAND USE: RANGE - LEASE # SF 078278  
SURFACE CONDITIONS: EARTHEN PIT - FENCED 25' x 25' - DEAD WEEDS IN PIT - NO STAIN

FIELD NOTES & REMARKS: PIT IS LOCATED APPROXIMATELY 20 FEET EAST OF WELLHEAD.  
CLOSURE STD: 1000 PPM TNH DUAL COMPLETION WELL  
RANKING SCORE: 10 T1; MOIST, BROWN, ORGANIC SILTY SAND/CLAY - NO OIL.
