Meter Number:LD013
Location Name:A-5 LINE DRIP
Location:TN-29 RG-08
SC-31 UL-A
2 - Federal
NMOCD Zone:OUTSIDE
Hazard Ranking Score:00

**RATIONALE FOR RISK-BASED CLOSURE OF PRODUCTION PITS
LOCATED OUTSIDE OF THE VULNERABLE ZONE
IN THE SAN JUAN BASIN**

FIELD PIT SITE ASSESSMENT FORM

FIELD PIT REMEDIATION/CLOSURE FORM

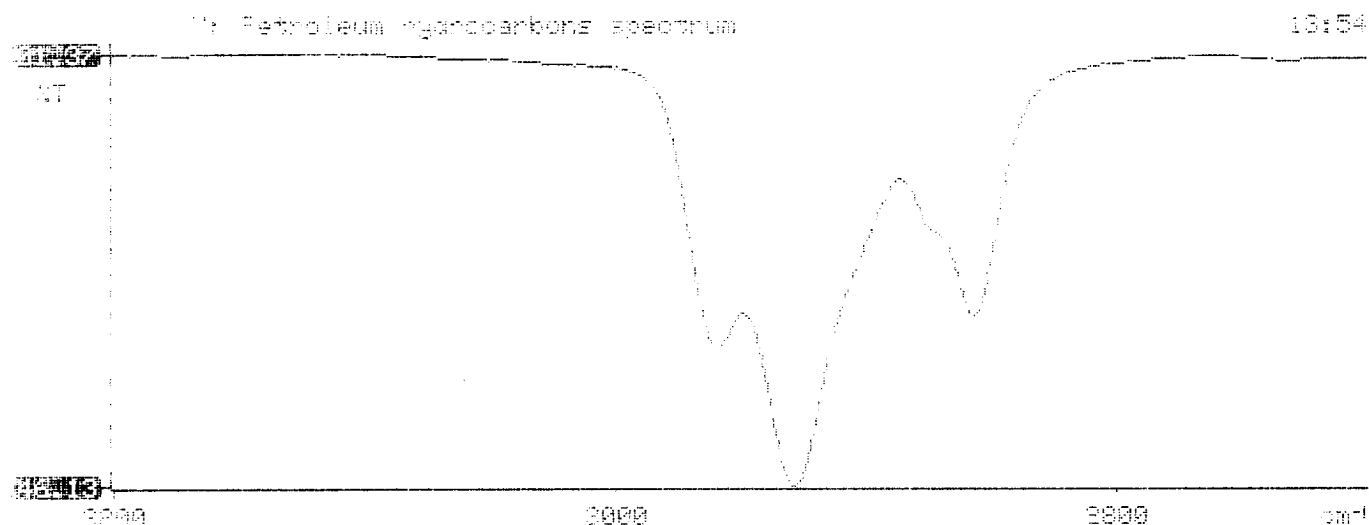
Test Method for
 Oil and Grease and Petroleum Hydrocarbons
 in Water and Soil
 Perkin-Elmer Model 1600 FT-IR
 Analysis Report

Petroleum hydrocarbons, ppm
 1436.044

Net absorbance of hydrocarbons (2930 cm⁻¹)
 0.1740
