From: joetippy@valornet.com
To: [Yu, Olivia, EMNRD](#)
Subject: RE: JR Oil Co. Eaton BAC Remediation
Date: Friday, June 29, 2018 5:49:40 PM

A pleasure to see you this morning at 10:30 am MST regarding 1RP-4591. Please inform if the below information was miscommunicated or if there are missing information.

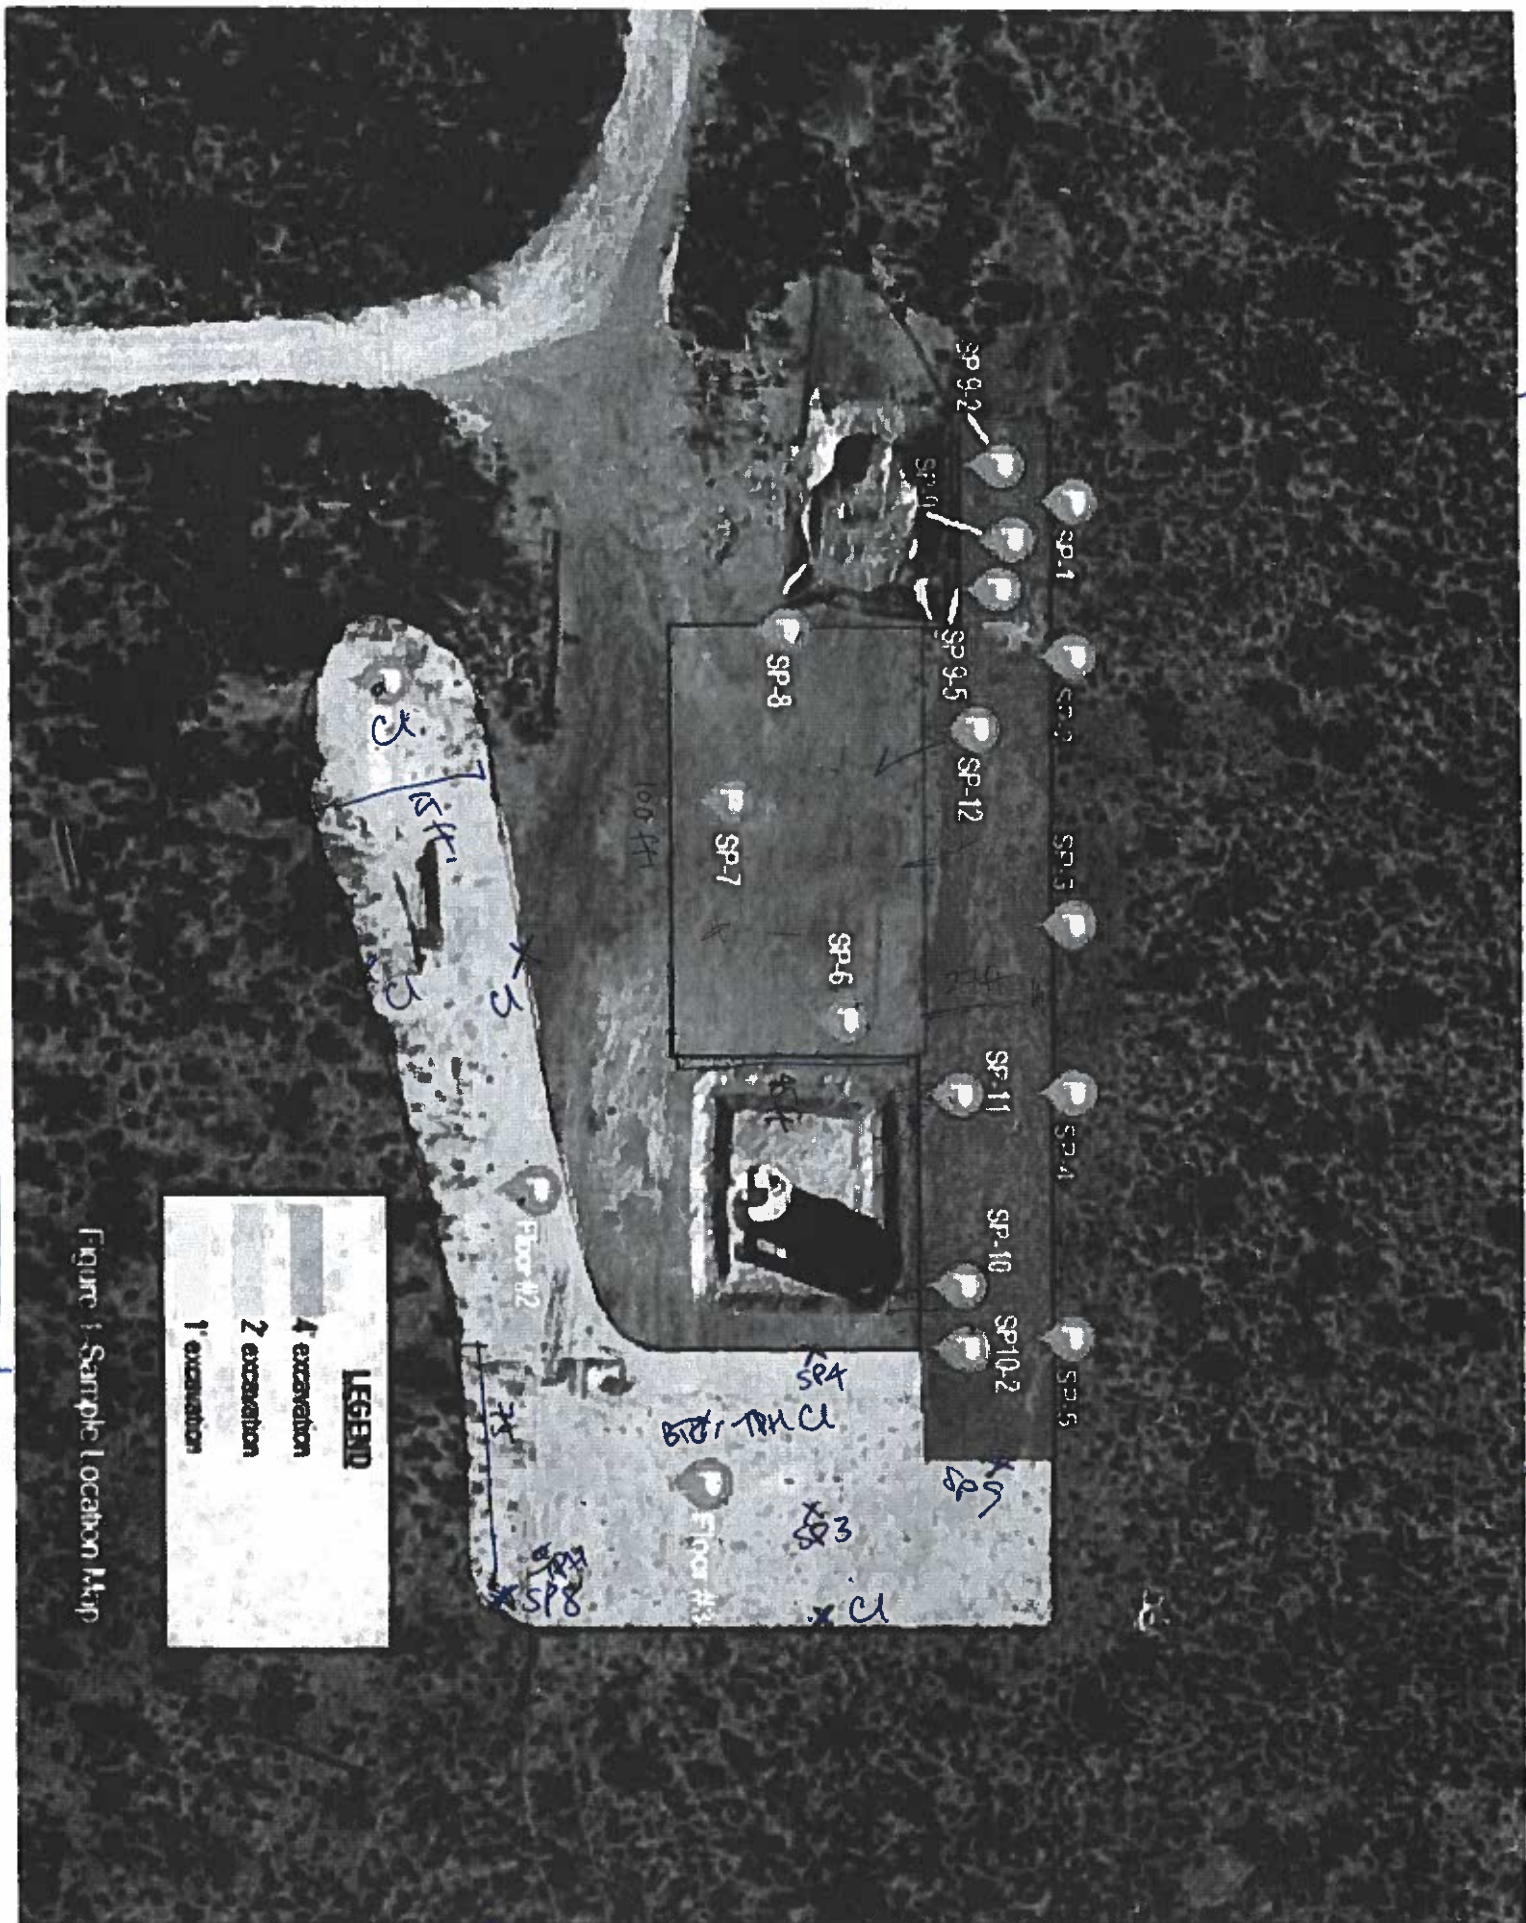
Figure 1: Sample Location Map

These additional confirmation samples will be taken in the 1 ft. excavation area. See attachment. Please review. Several sampling locations may be missing from the annotated map.

1. There may have been some miscommunication during the meeting on February 27, 2018. Please be advised that generally, confirmation sidewall samples are required for each area with a different excavation depth. For example, sidewall/edge samples were expected at the border between the 4 ft. (red) and 2 ft. (blue) areas and the border between the 4 ft. and 1 ft. (green) area. Do you have field tests to represent the change in excavation depth with permissible levels of BTEX, chlorides, and TPH extended demonstrated?

2. Were confirmation samples taken from the edge of the 1 ft. excavation (green)?
3. Does delineation sample location SP-9 fall within the 4 ft. or 2 ft. excavation area?

1. Confirmation sidewall sample to represent SP-4 delineation sample location will be analyzed for BTEX, TPH, and chlorides.
2. Confirmation sidewall samples will be taken for chloride analyses at the East border and North and South of the pasture area.
3. A bottom confirmation sample will be taken for chloride analyses in the vicinity of the Floor 1 area.
3. Confirmation sidewall sample for TPH extended analyses will be taken in the area represented by the SP-8 delineation sample location.
