Release Notification

Responsible Party: ETC Texas Pipeline, Ltd.	OGRID: 371183
Contact Name: Carolyn J. Blackaller	Contact Telephone: (817) 302-9766
Contact email: carolyn.blackaller@energytransfer.com	Incident # NCH1831954977 ETC 2B PIPELINE @ FCH1831949029
Contact mailing address: 600 N. Marienfeld Street, Suite 700, Midland, TX 79701

Site Name: 2B	Site Type: Pipeline
Date Release Discovered: 10/26/2018	API# (if applicable): N/A

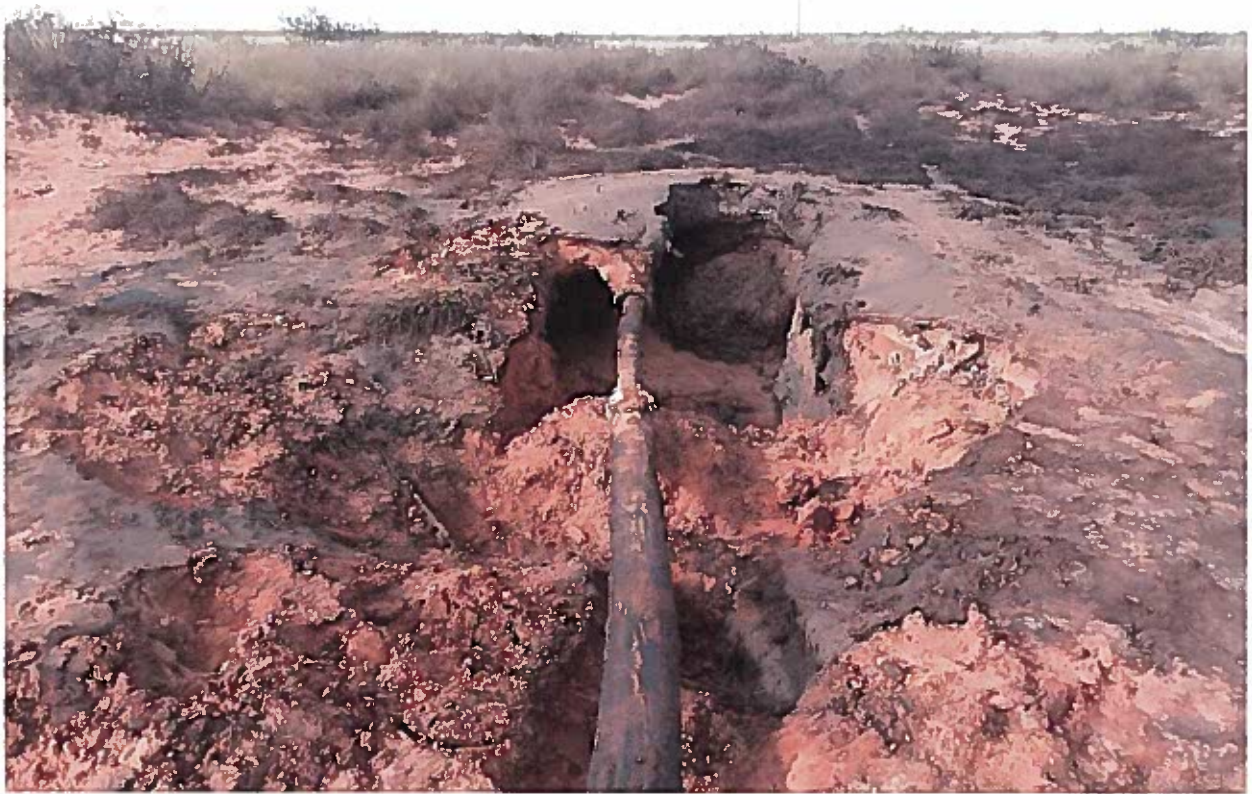
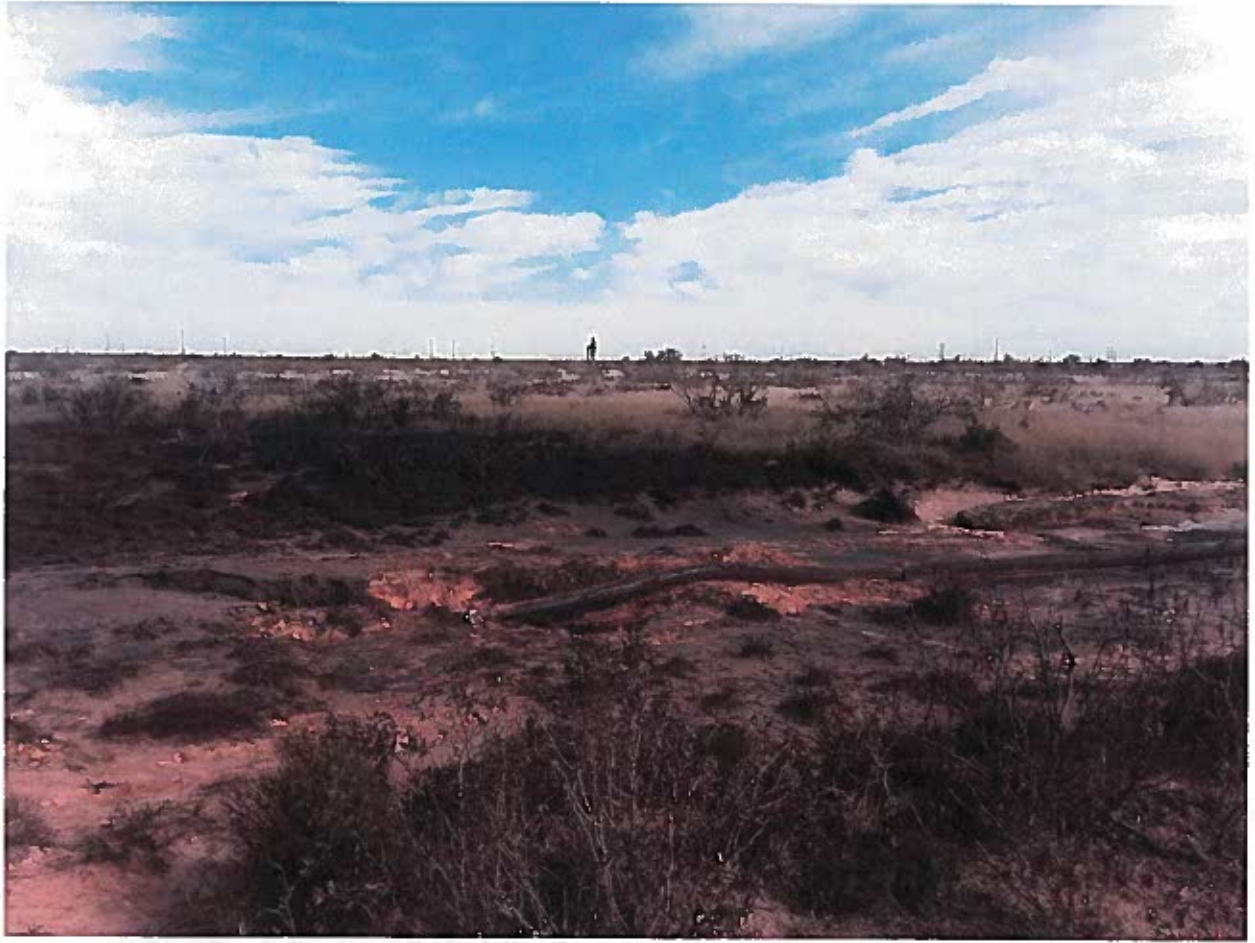
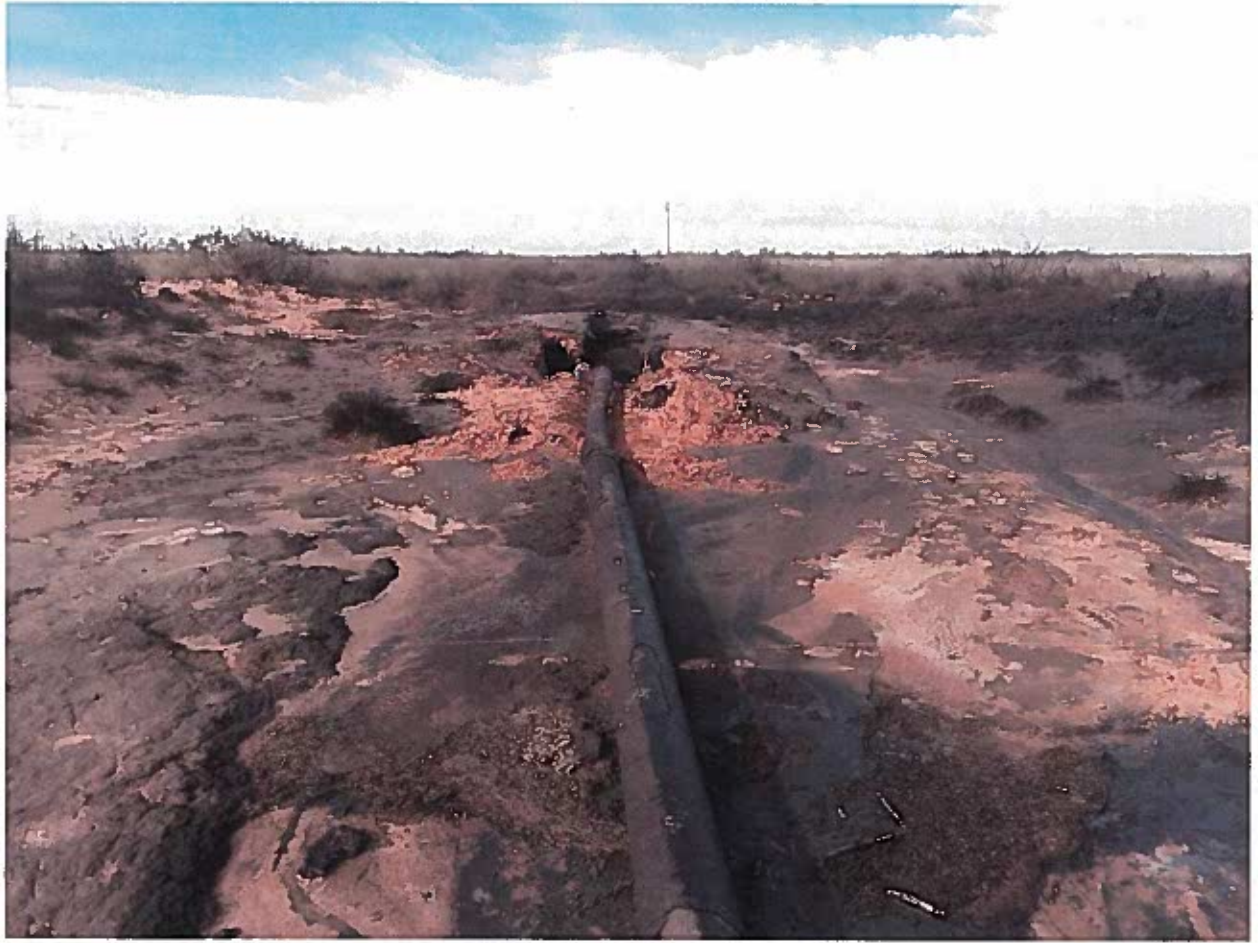
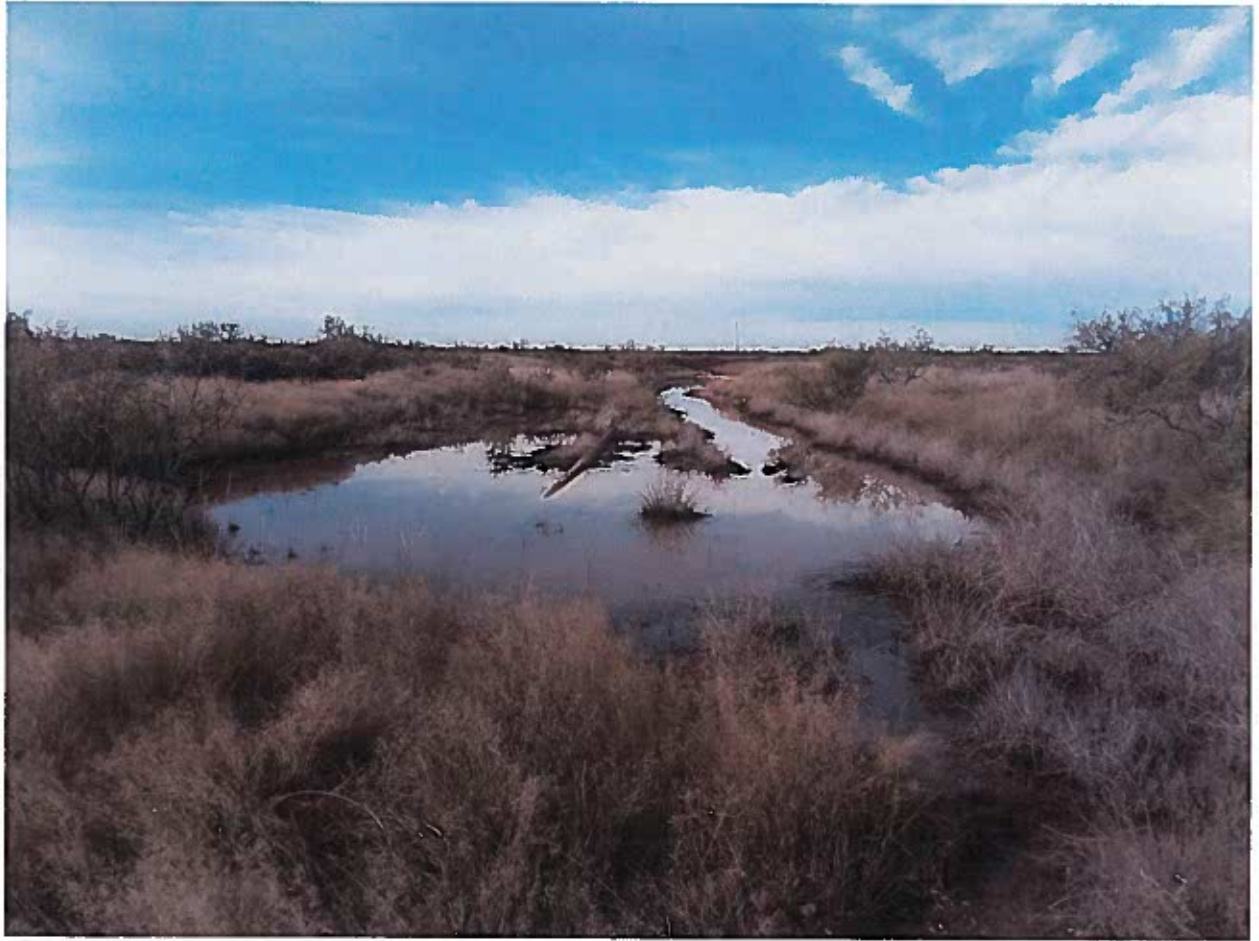
Cause of Release: On October 26, 2018, it was discovered that a crack in the poly line on a segment of the 2B 4-inch Pipeline in Lea County, NM was causing a leak of field gas, water, and condensate. A crew was dispatched to begin repairs to this segment. The poly was flanged back together and the leak of fluids and gas stopped. Given the amount of time it took to repair the leak, the leak hole size, and pipe pressure, it was calculated that approximately 187.597 Mcf of gas was released. Please find these calculations appended to this form. A survey of the water and condensate release showed that approximately 3.06 barrels of condensate and 27.54 barrels of water were released. Please find appended to this form photos from the release site.
