Case No.  
4565

Large Exhibits

NORTHWEST - SOUTHEAST CROSS SECTION  
SHOWING OCCURRENCE OF POROSITY AND  
PERMEABILITY ON SHELF SIDE OF THE  
ABO REEF CREST, NORTHWEST OF THE  
SUN NO. 1 STATE "D" DRY HOLE

BEFORE EXAMINER NUTTER  
OIL CONSERVATION COMMISSION  
EXHIBIT NO. 3  
CASE NO. 4565

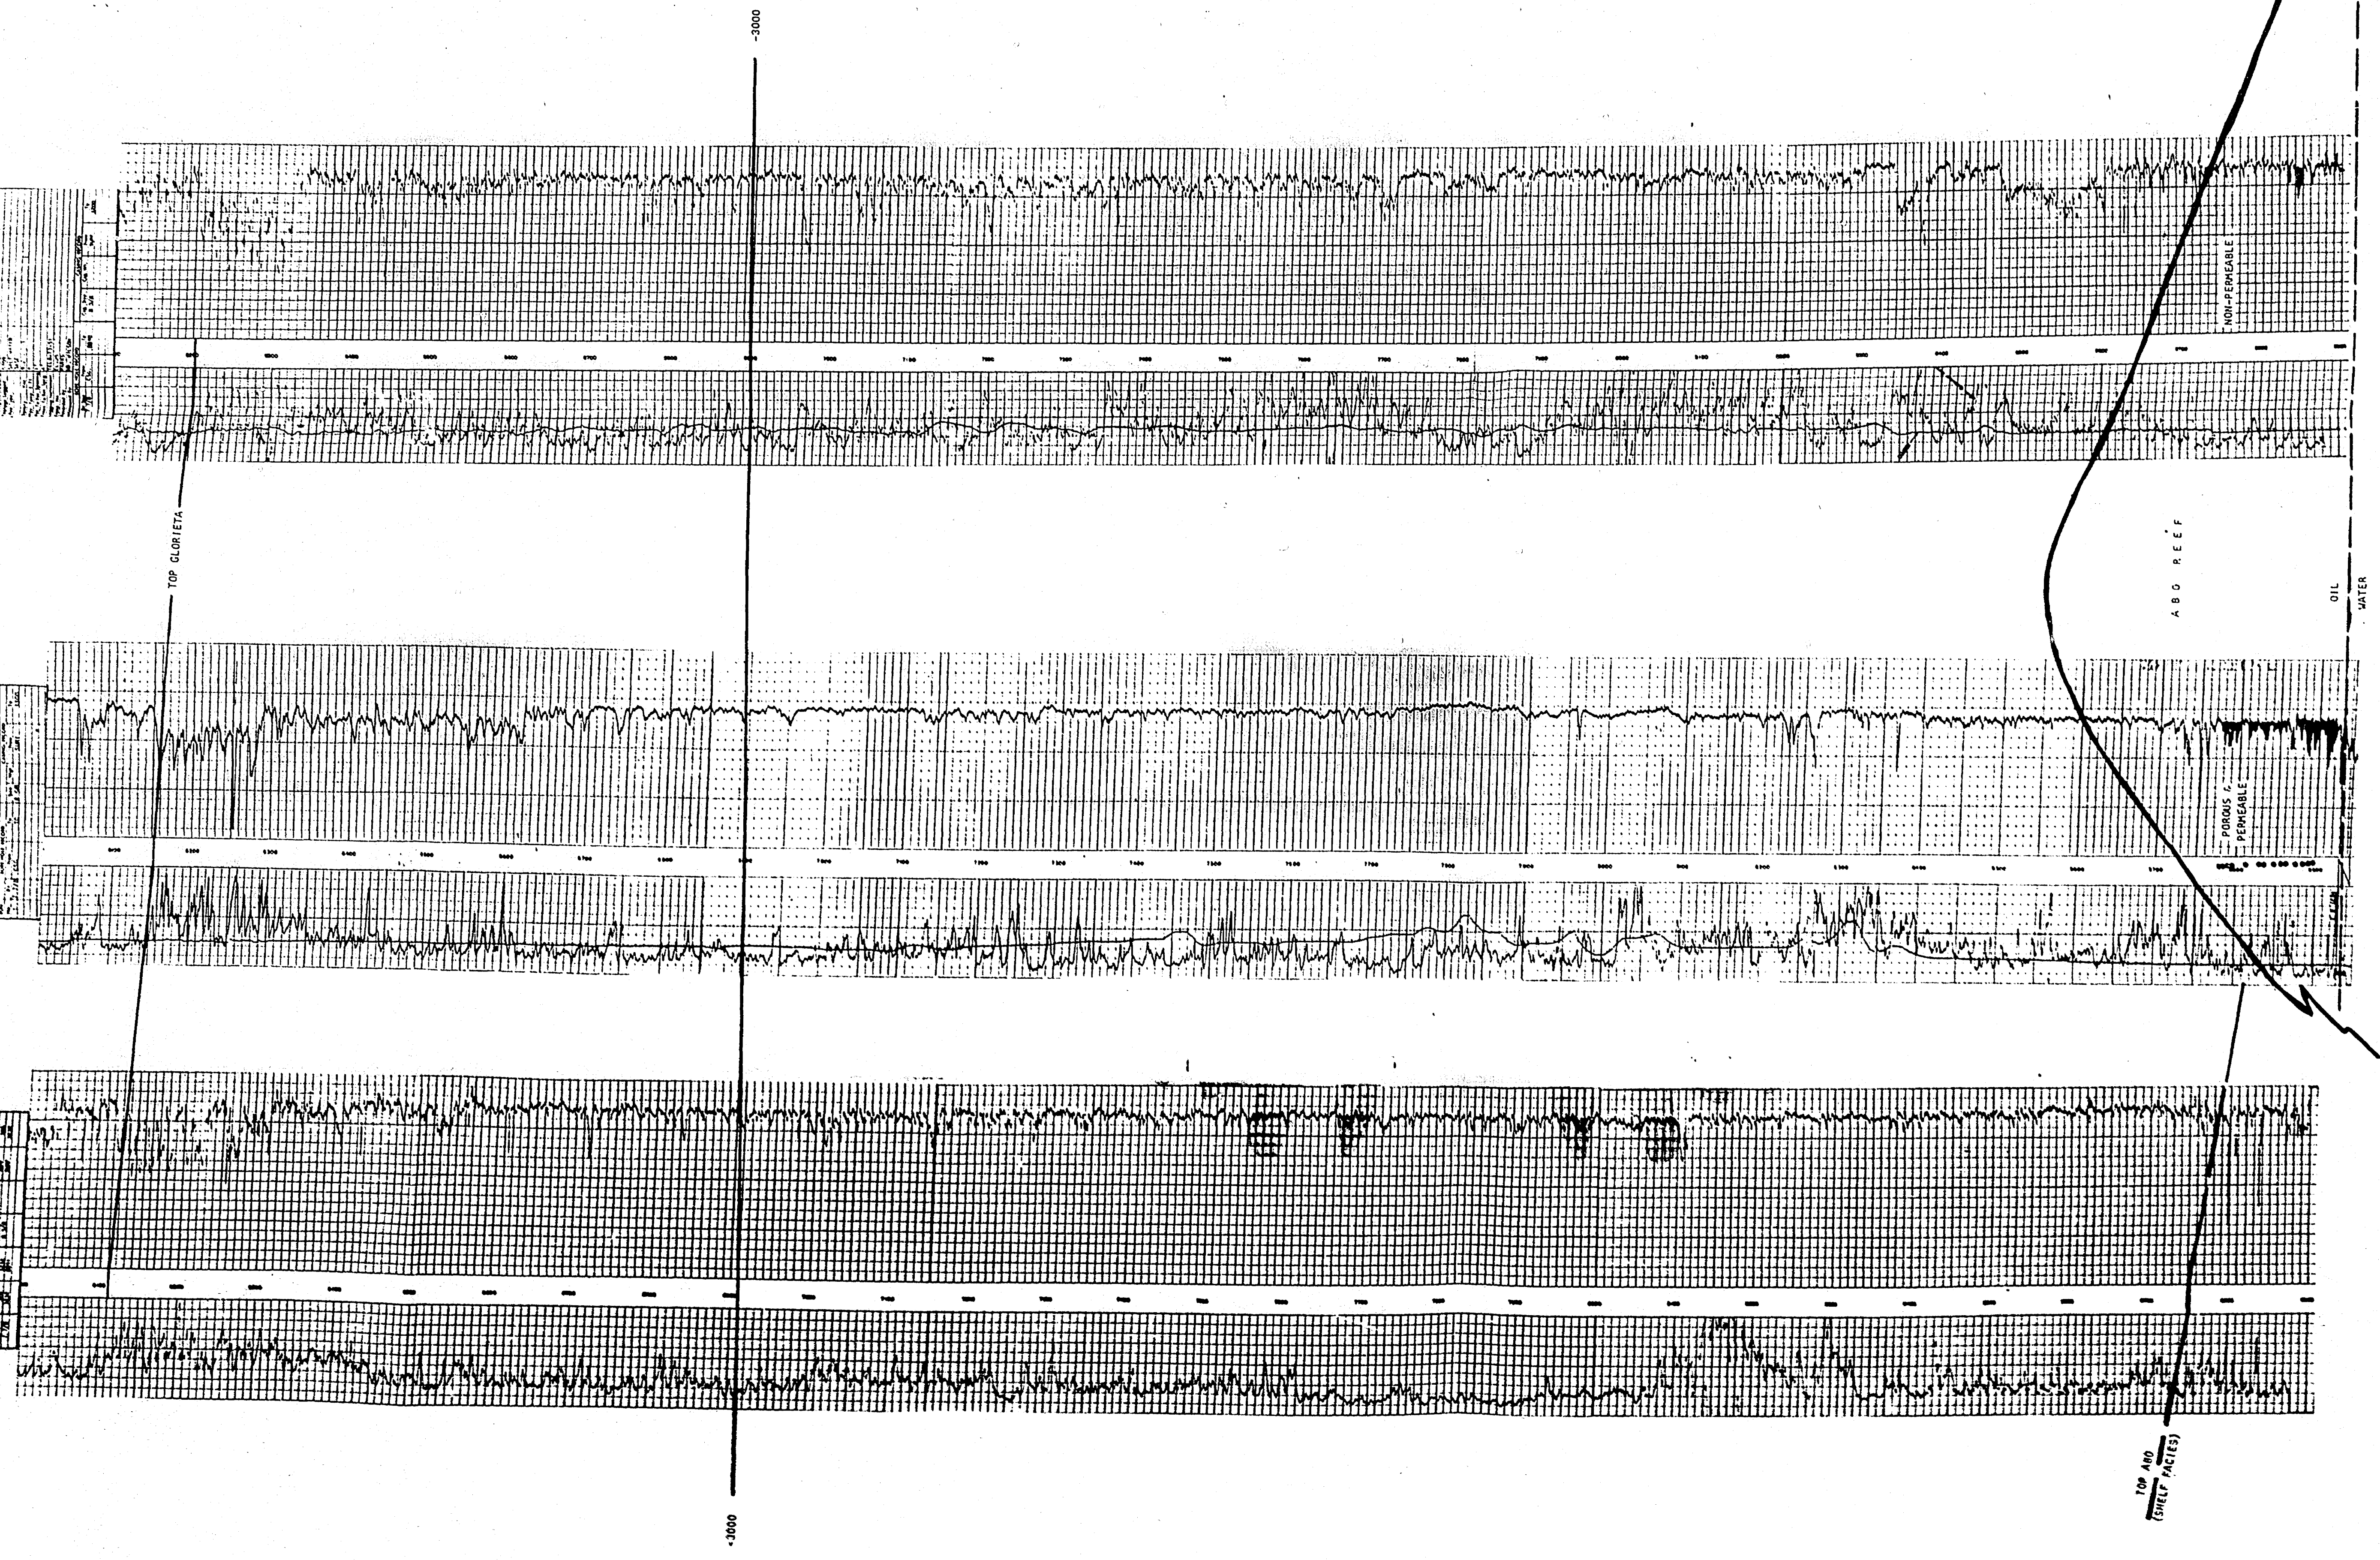
**ANALYSIS OF CORE LOG**

Core No. 1  
 Date: 1-5-58  
 Location: 346-347  
 Depth: 1-5-58  
 Scale: 1" = 100'

Core No. 2  
 Date: 1-5-58  
 Location: 346-347  
 Depth: 1-5-58  
 Scale: 1" = 100'

Core No. 3  
 Date: 1-5-58  
 Location: 346-347  
 Depth: 1-5-58  
 Scale: 1" = 100'

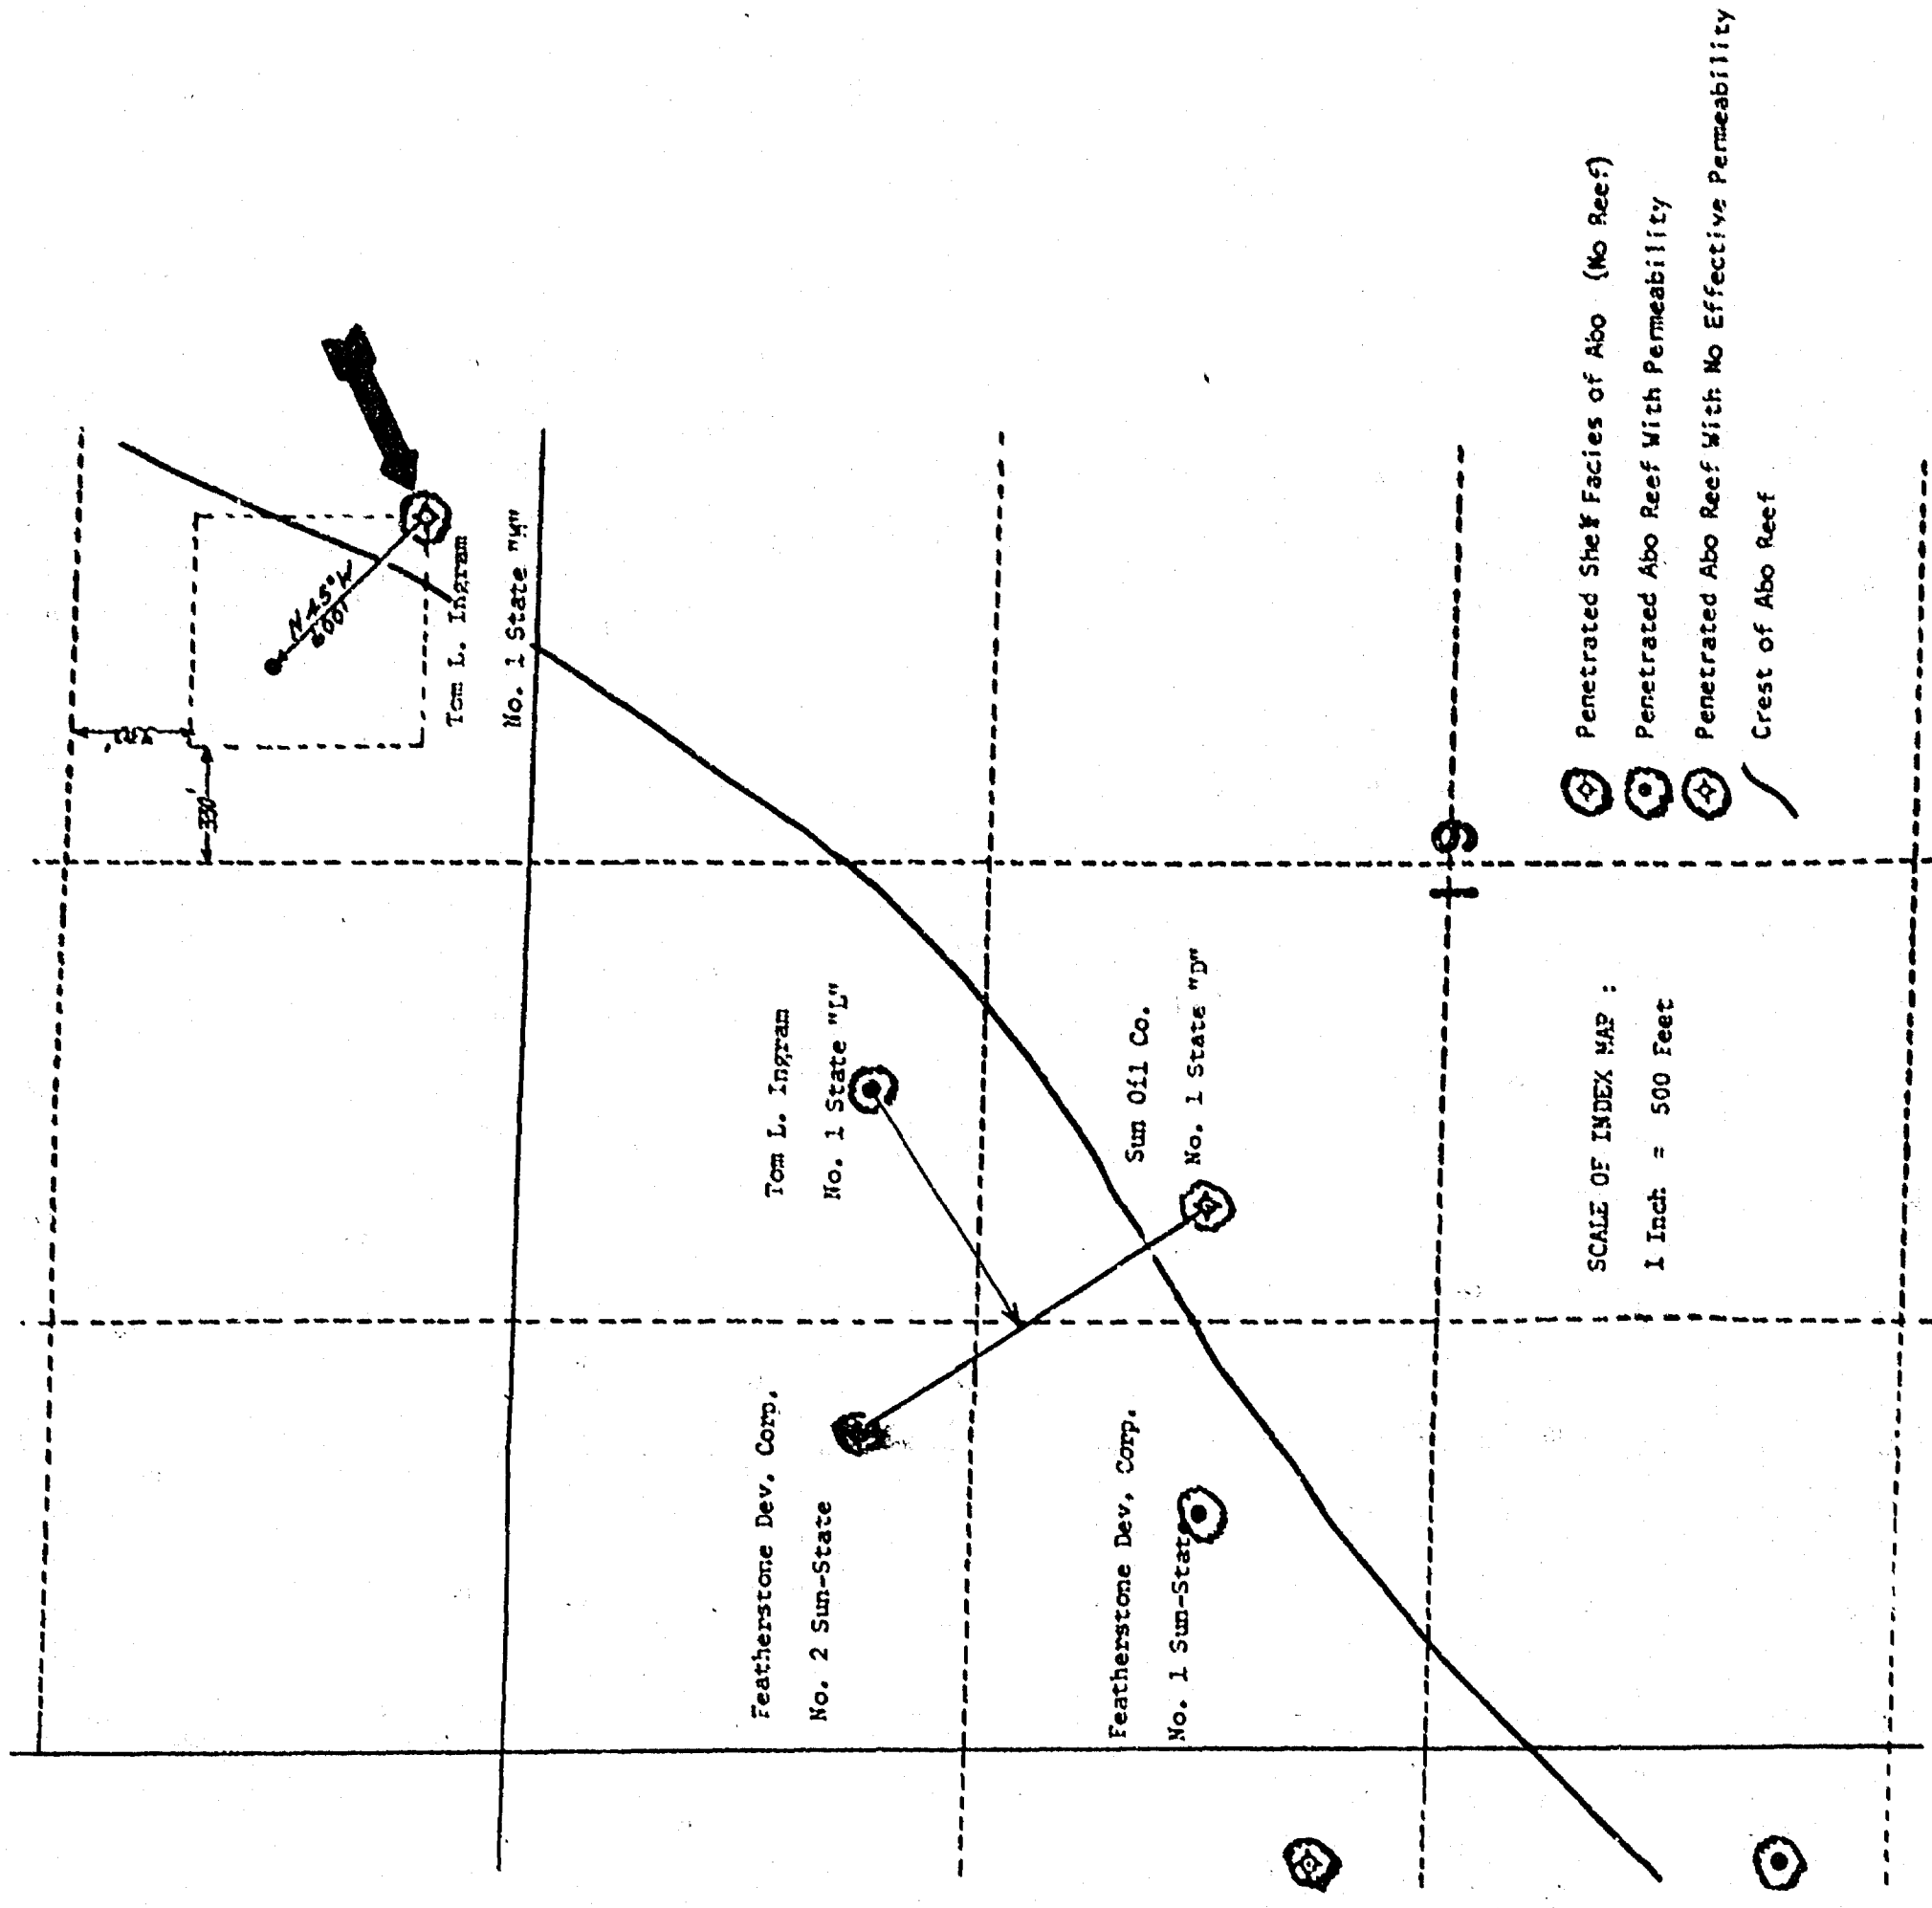
CASE 066  
 TOP L. 1000  
 EXHIBIT 3

NORTHWEST - SOUTHEAST CROSS SECTION  
 SHOWING OCCURRENCE OF POROSITY AND  
 PERMEABILITY ON SHELF SIDE OF THE  
 ABO REEF CREST, NORTHWEST OF THE  
 SUN NO. 1 STATE "O" DRY HOLE

Horizontal & Vertical Scale: 1" = 100'  
 Datum: -3000 Feet

Perforations  
 Porosity
