Remediation Plan

Re: CLFCA Water Transfer Line Case nAPP2114756542

Background:

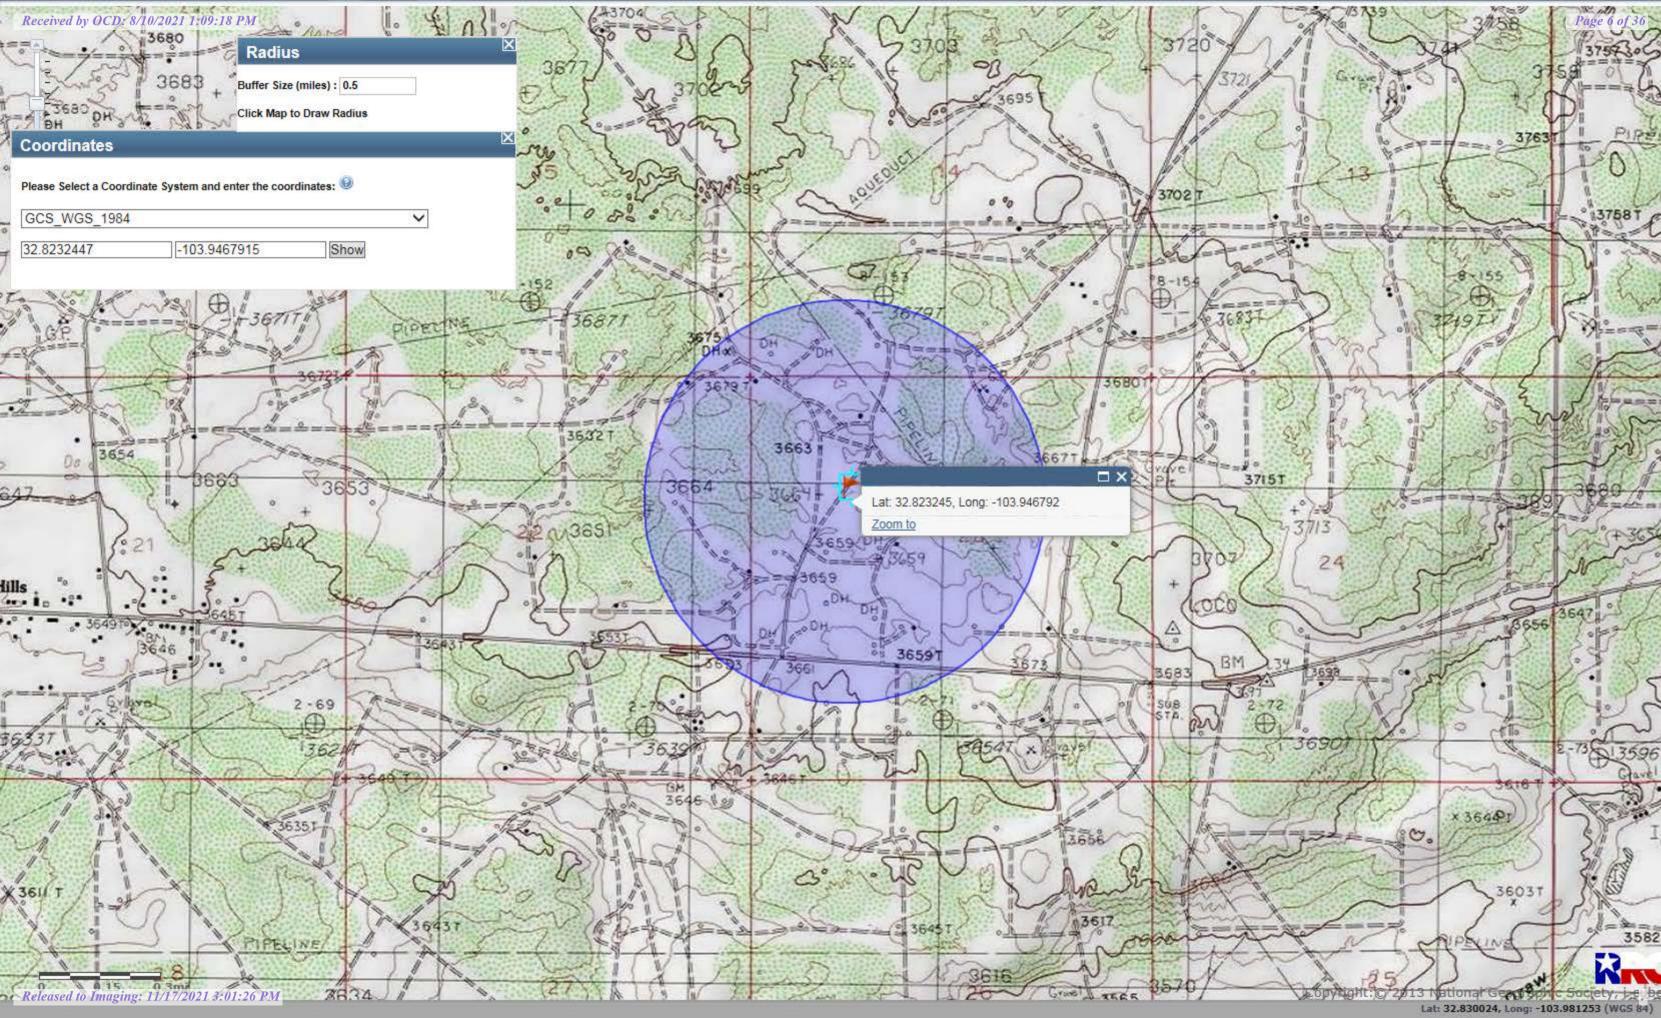
Soil Bore Report

Info	Customer:				Phone:	Date:
General / Well I	-	oack Dispos	al/Apach	e Corp.	575-631-9586	8/2/21
ral/	Well Name				Location:	i
Gene	CLFCA	WATER TI	RANSFEI	R LINE	32.823401, -103.946934	
	DI	EPTH				
	FROM	ТО	THICKNESS (feet)	COLOR	AND TYPE OF MATERIAL ENCOUNTERED - I BEARING CAVITIES OR FRACTURES	ICLUDE WATER
	0	7	7		TOP SOIL	
	7	20	13	*****	CALECHE	
	20	55	25		RED SAND / ROCK	
	55	60	5		RED CLAY	
	60	80	20		RED SAND WITH RED CALY STRINGE	RS
	80	117	37		RED CLAY / GRAVEL	
		A state of the sta				
		and a second sec				
	and and a second s	sizer de				
	Sec.	- See				
WELL		and the second second

-	DODE		
OF					OLE WAS LEFT OPEN 72 HOURS THEN C	
LOG OF	the first start			WATER, TH	HE BORE HOLE WAS DRY AFTER 72 HOURS.	BORE HOLE WAS
2					FROM THE BOTTOM OF THE HOLE TO	THE TOP WITH
				Planta de la comp	AN NATURAL FILL AND 3/8 HOLE PLUG	ON 8/6/21.

On 5/13/2021 a release occurred due to a 4 inch metal grooved transition failed due to external corrosion. The release (GPS: 32.823203, -103.946841) is located east of Loco Hills, New Mexico in unit letter F section 23 township 17S range 30E. On 8/2/2021 a soil bore was conducted 52 feet north of the release. The soil bore was advanced to a depth of 117 feet below ground surface. The bore hole was left open for 72 hours and gauged for the presence of water. The bore hole was dry to a depth of 117 feet.

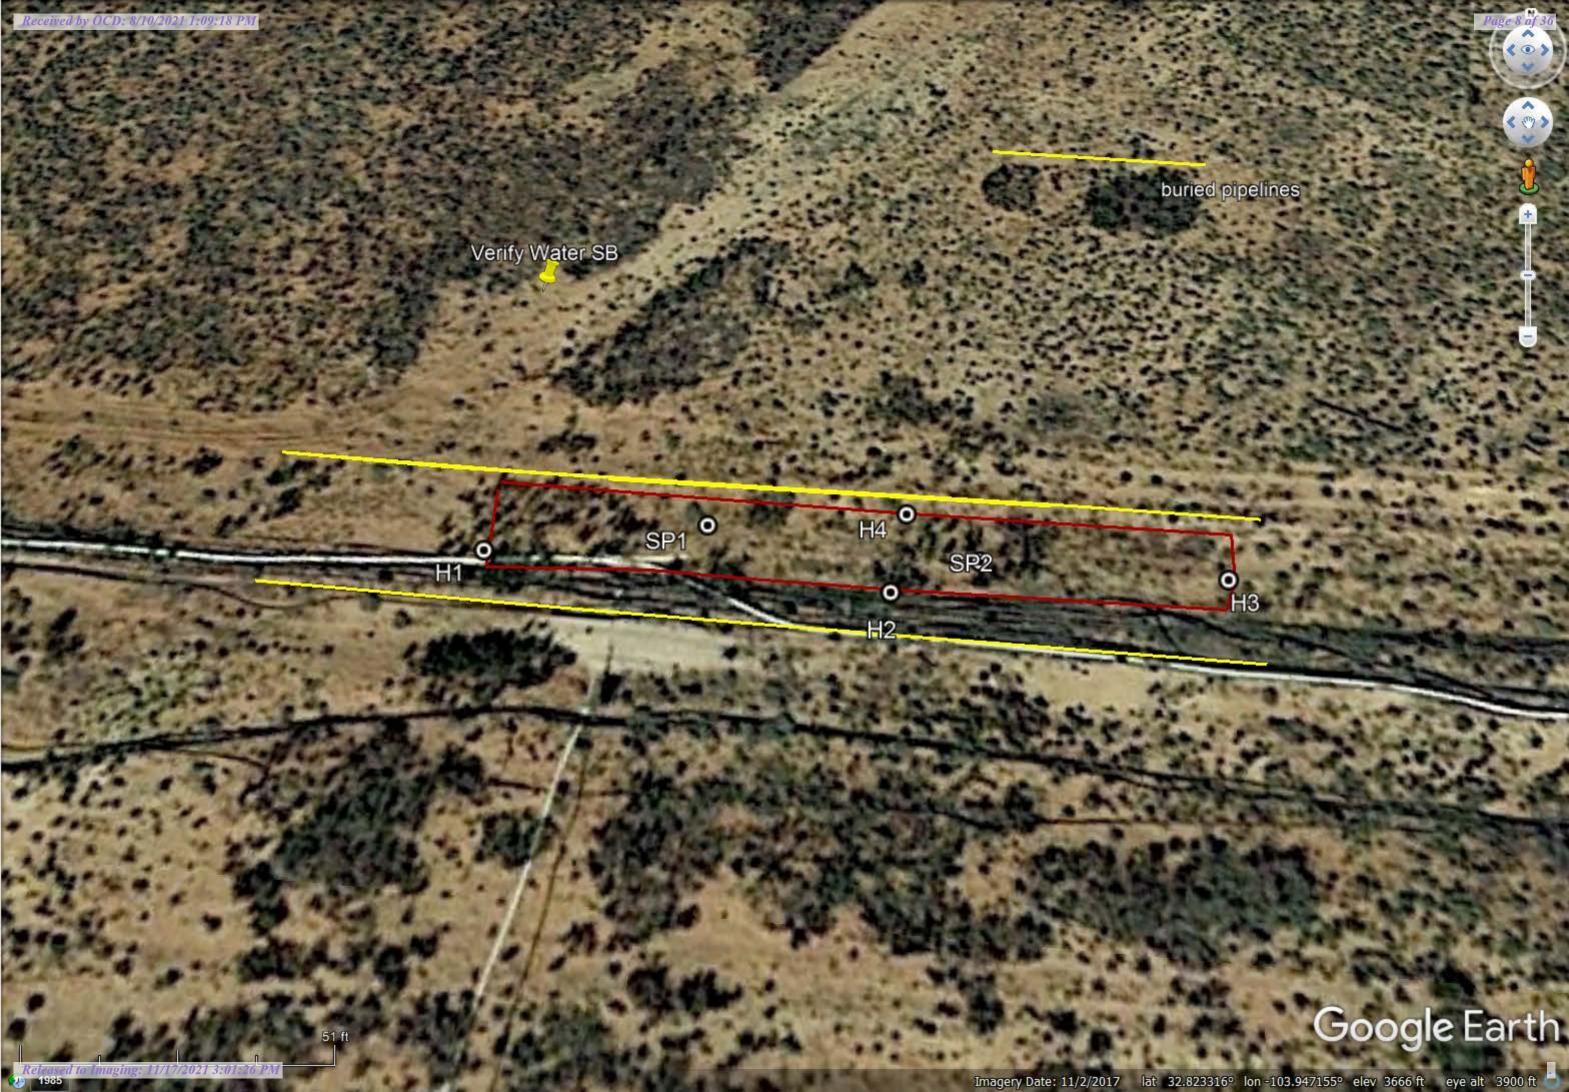
Sample Date	Sample ID	Depth	Chloride	Benzene	Toulene	Ethybenzene	Total Xylenes	Total BTEX	GRO	DRO	EXT DRO	GPS Coordinates
Delineation Sa	amples						Ayreneo	012/		1

32.8232447,
6/30/2021	SP 1	S	464	<0.050	<0.050	<0.050	<0.150	<0.300	<10.0	174	52.5	-103.9467915
		2'	5,200	<0.050	<0.050	<0.050	<0.150	<0.300	<10.0	<10.0	<10.0	
		4'	1,900	<0.050	<0.050	<0.050	<0.150	<0.300	<10.0	15.4	<10.0	
		6'	7,440	<0.050	<0.050	<0.050	<0.150	<0.300	<10.0	<10.0	<10.0	
		8'	5,280	<0.050	<0.050	<0.050	<0.150	<0.300	<10.0	<10.0	<10.0

32.8232351,
6/30/2021	SP 2	S	6,640	<0.050	<0.050	<0.050	<0.150	<0.300	<10.0	135	74.8	-103.9466125
		2'	5,360	<0.050	<0.050	<0.050	<0.150	<0.300	<10.0	188	94.6	
		4'	19,000	<0.050	<0.050	<0.050	<0.150	<0.300	<10.0	14.4	<10.0	
		6'	23,600	<0.050	<0.050	<0.050	<0.150	<0.300	<10.0	20.2	<10.0	
		8'	17,400	<0.050	<0.050	<0.050	<0.150	<0.300	<10.0	17.6	<10.0	
		10'	17,200	<0.050	<0.050	<0.050	<0.150	<0.300	<10.0	19.7	<10.0	
		12'	20,000	<0.050	<0.050	<0.050	<0.150	<0.300	<10.0	15	<10.0	
8/2/2021		15'	14,600									
		20'	19,000									
		25'	15,400									
		30'	9,000									
Horizontal Sar	nples_										•	•

32.8232188,
6/30/2021	H1	S	<16.0	<0.050	<0.050	<0.050	<0.150	<0.300	<10.0	<10.0	<10.0	-103.9469313
												32.8232129,
6/30/2021	H2	S	<16.0	<0.050	<0.050	<0.050	<0.150	<0.300	<10.0	<10.0	<10.0	-103.9466679

32.8232408,
6/30/2021	H3	S	<16.0	<0.050	<0.050	<0.050	<0.150	<0.300	<10.0	<10.0	<10.0	-103.9464526
												32.8232613,
6/30/2021	H4	S	48.0	< 0.050	<0.050	<0.050	<0.150	<0.300	<10.0	<10.0	<10.0	-103.9466621

On 6/30/2021 vertical delineation was conducted to depths of 8 and 12 feet. All samples collected were submitted to a commercial laboratory for analysis of chloride, TPH, and BTEX. Horizontal 5 point surface composite samples were collected not to exceed 200 square feet. All samples collected were submitted to a commercial laboratory for analysis of chloride, TPH, and BTEX. On 8/2/2021 further delineation was conducted at SP2 utilizing a soil bore rig. SP 2 was advanced to a depth of 30 feet. All samples collected were submitted to commercial laboratory for analysis of chloride. The release area has been delineated below table one standards for release greater than 100 feet to groundwater.
