## Release Notification

Site Name Bandit State 4-9 Tank Battery	Site Type Tank Battery
Date Release Discovered 07/24/2022	API# (if applicable)

**Remediation Progress to date: Attachment to C-141**

Read & Stevens Inc  
Bandit State 4-9 Tank Battery  
UL L-10-23S-26E

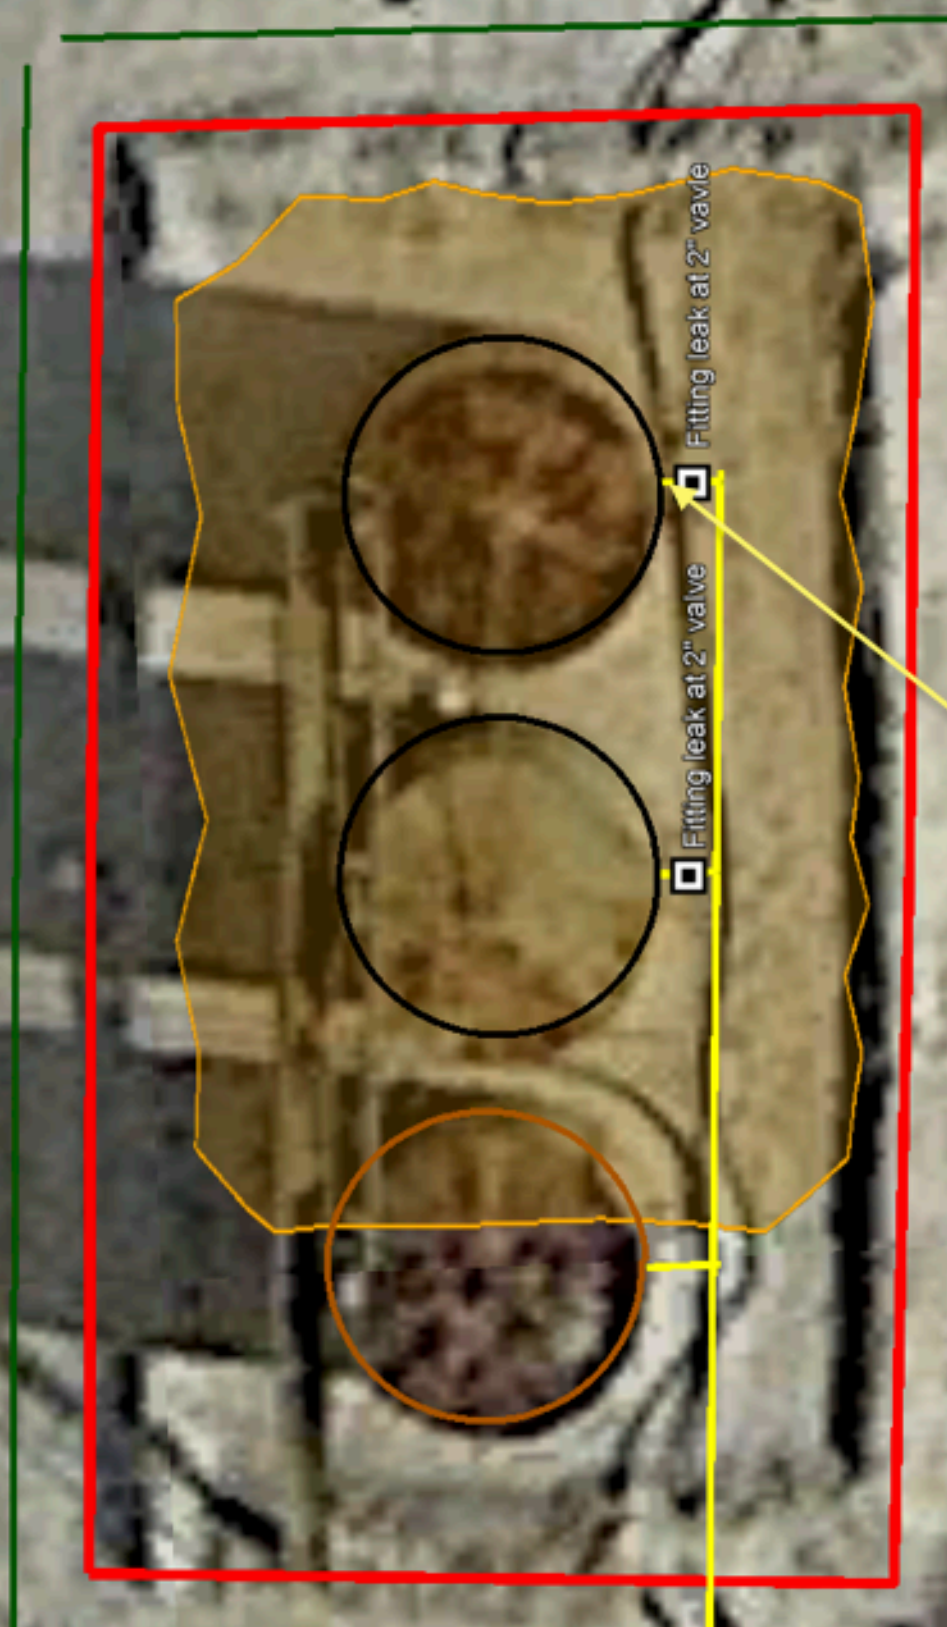
The leak occurred on a 4" x 2" swedge (fitting) that was in between a (500) bbl oil storage tank and a 2" valve. Corrosion ate a hole in the swedge. No way so shut the leak off since the valve was on the outside of the fitting. We have a 2' high earth berm around the (3) oil storage tanks, so it was contained inside the berm. The oil mainly ran in between and around the tanks. By the time the vacuum truck arrived most of the oil was saturated into the ground. We pulled what oil was left in the tank and transferred it over to the next tank. The way we calculated how much oil was lost is by the previous gauge and the gauge that was taken right before the oil was transferred over to the next tank.

1. Annotated aerial view of impact.
2. East Tank where leak occurred. Contained inside of berm.

- 500 bbl Oil Tanks (2)
- Berm (exterior: 80' X 45')
- Berms (Interior: 75' X 41')
- Out of Service Tank (West Tank)
- Spill Area

Once tank was emptied and isolated, began excavating inside of berm of visually impacted soils and approximately 200 yards have been disposed of at the R-360 OCD permitted facility.

R&S has decided to dismantle this battery and re-build a new battery with secondary containment. Once all tanks are removed, then removal of soils will continue until the site meets the OCD clean-up standards.

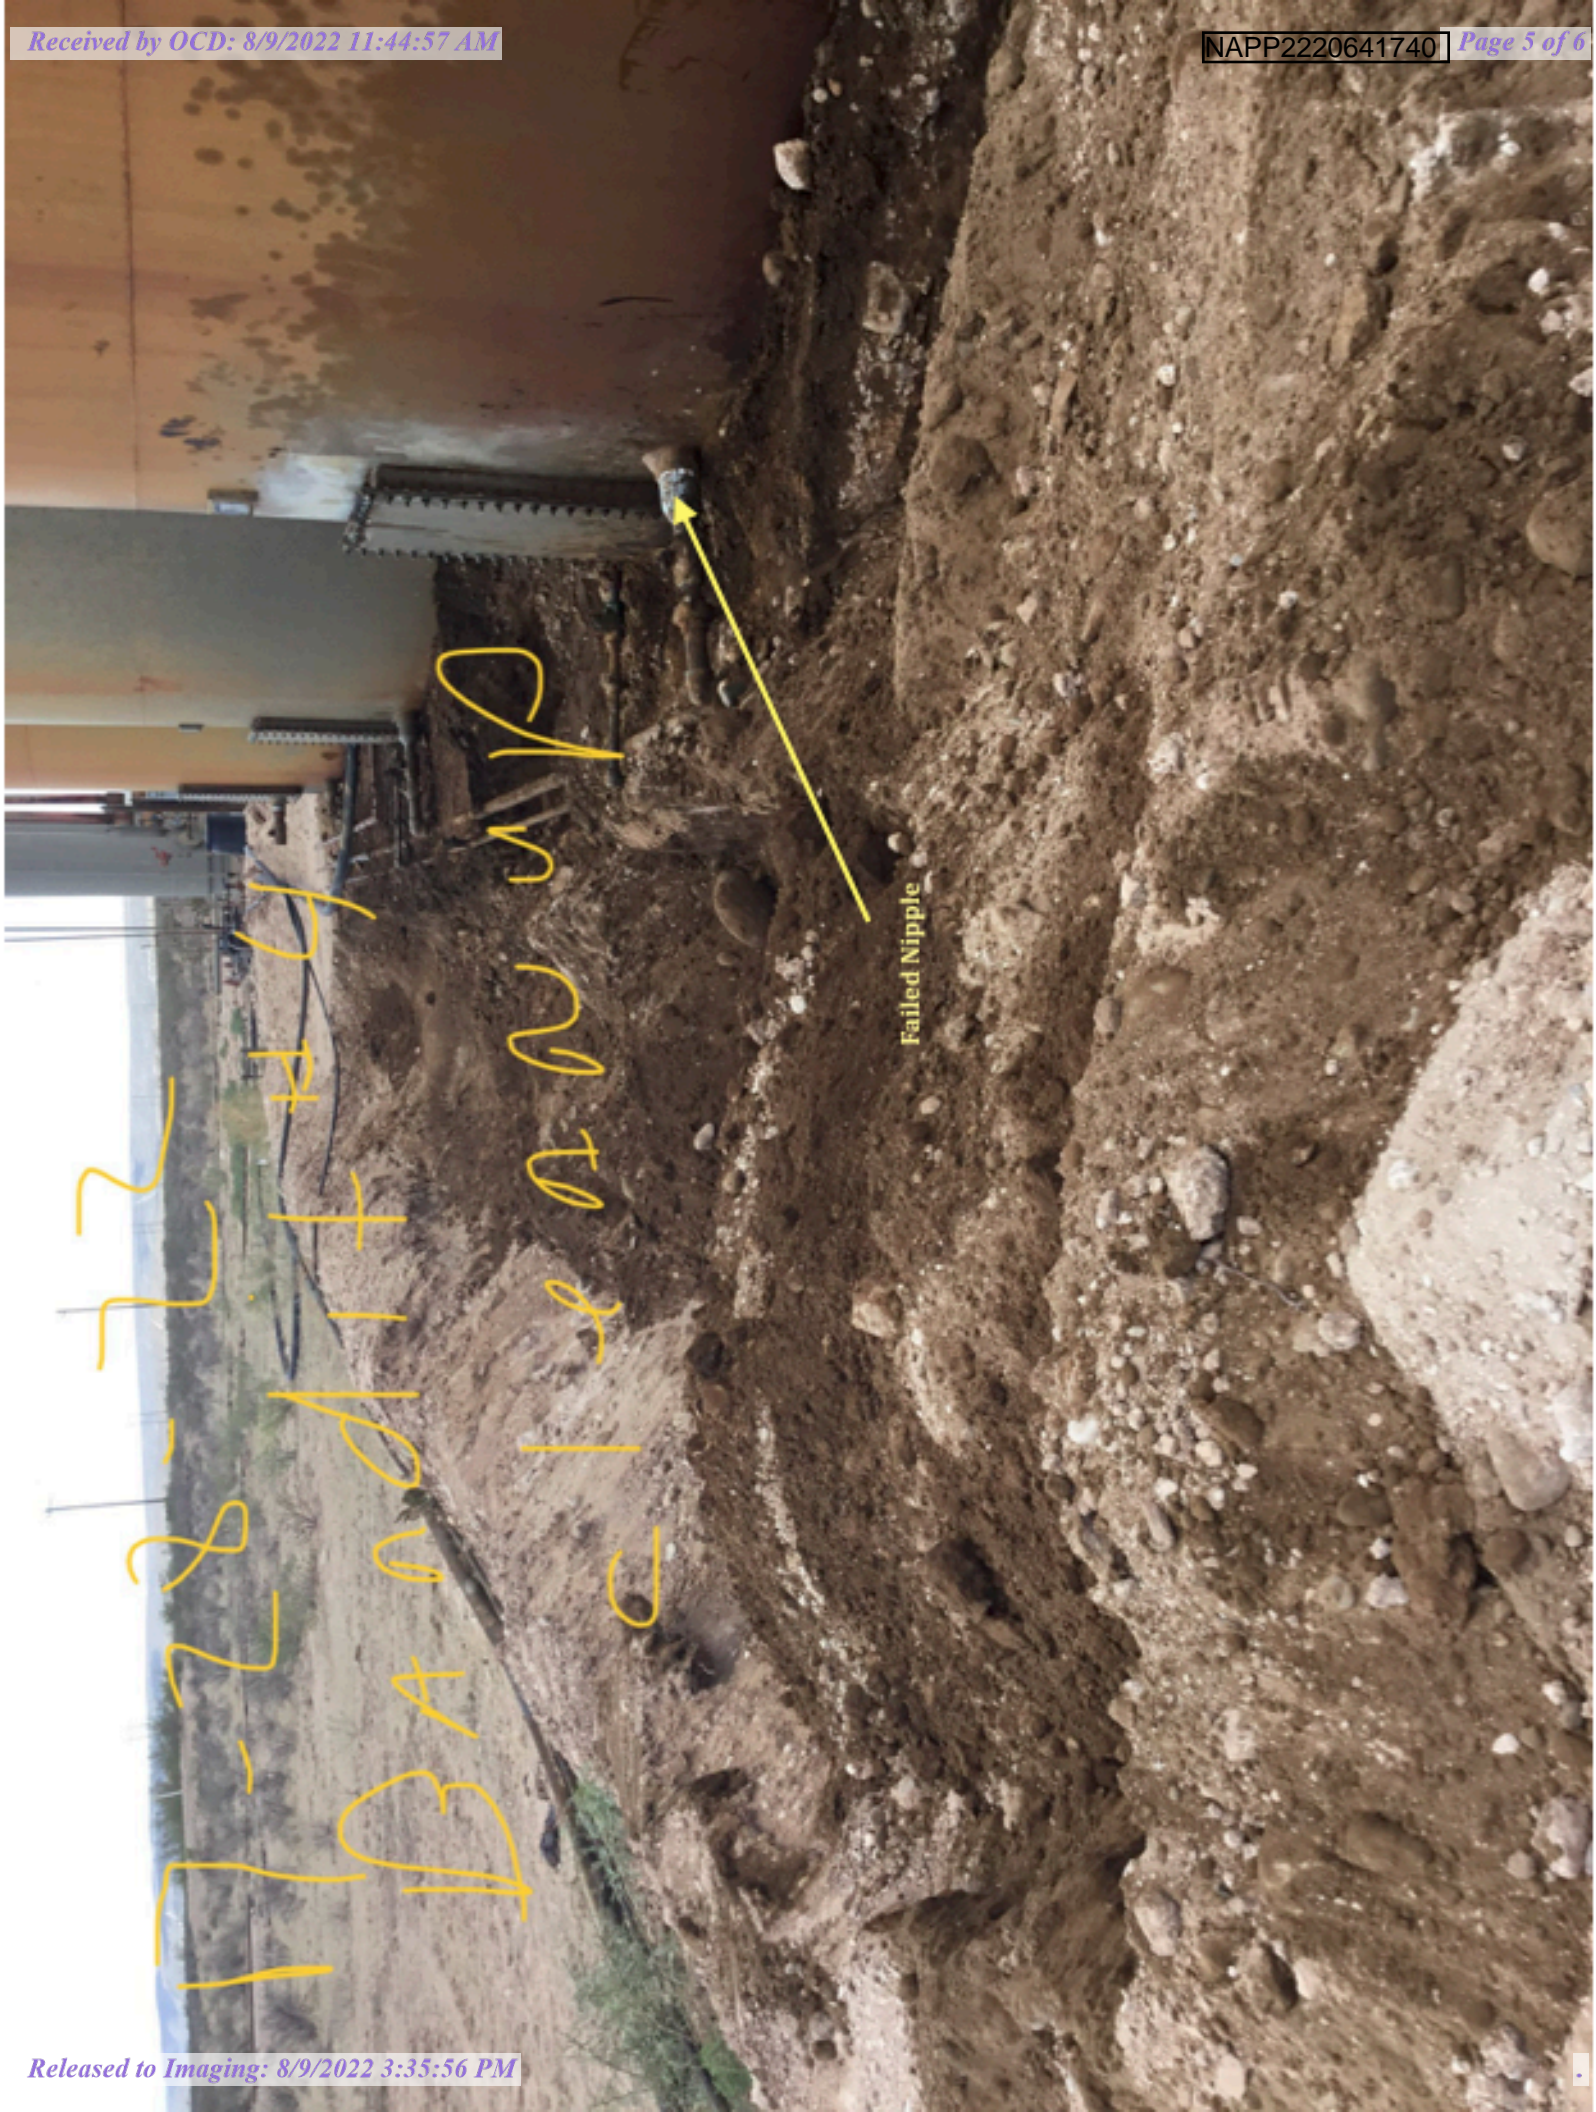
Cause of Release Corrosion in Tank Valve Nipple

Failed Nipple
