Closure Report NRM192733505

Site Name:	RED TANK 30 31 34H
Company:	OXY
Legal Description:	U/L: A, SECTION 30, T22S, R33E
County:	LEA COUNTY, NM
GPS Coordinates:	N32.36954 W103.60459

Date of Release:	8/22/2019
Type of Release:	PRODUCED WATER & CRUDE OIL
Source of Release:	CORROSION OF A 2 INCH STEEL PRODUCTION FLOW LINE
Volume of Release:	4 BBLS CRUDE OIL/ 3 BBLS PRODUCED WATER
Volume Recovered:	0 BBLS CRUDE OIL/ 0 BBLS PRODUCED WATER

OXY, RED TANK 30 31 34H

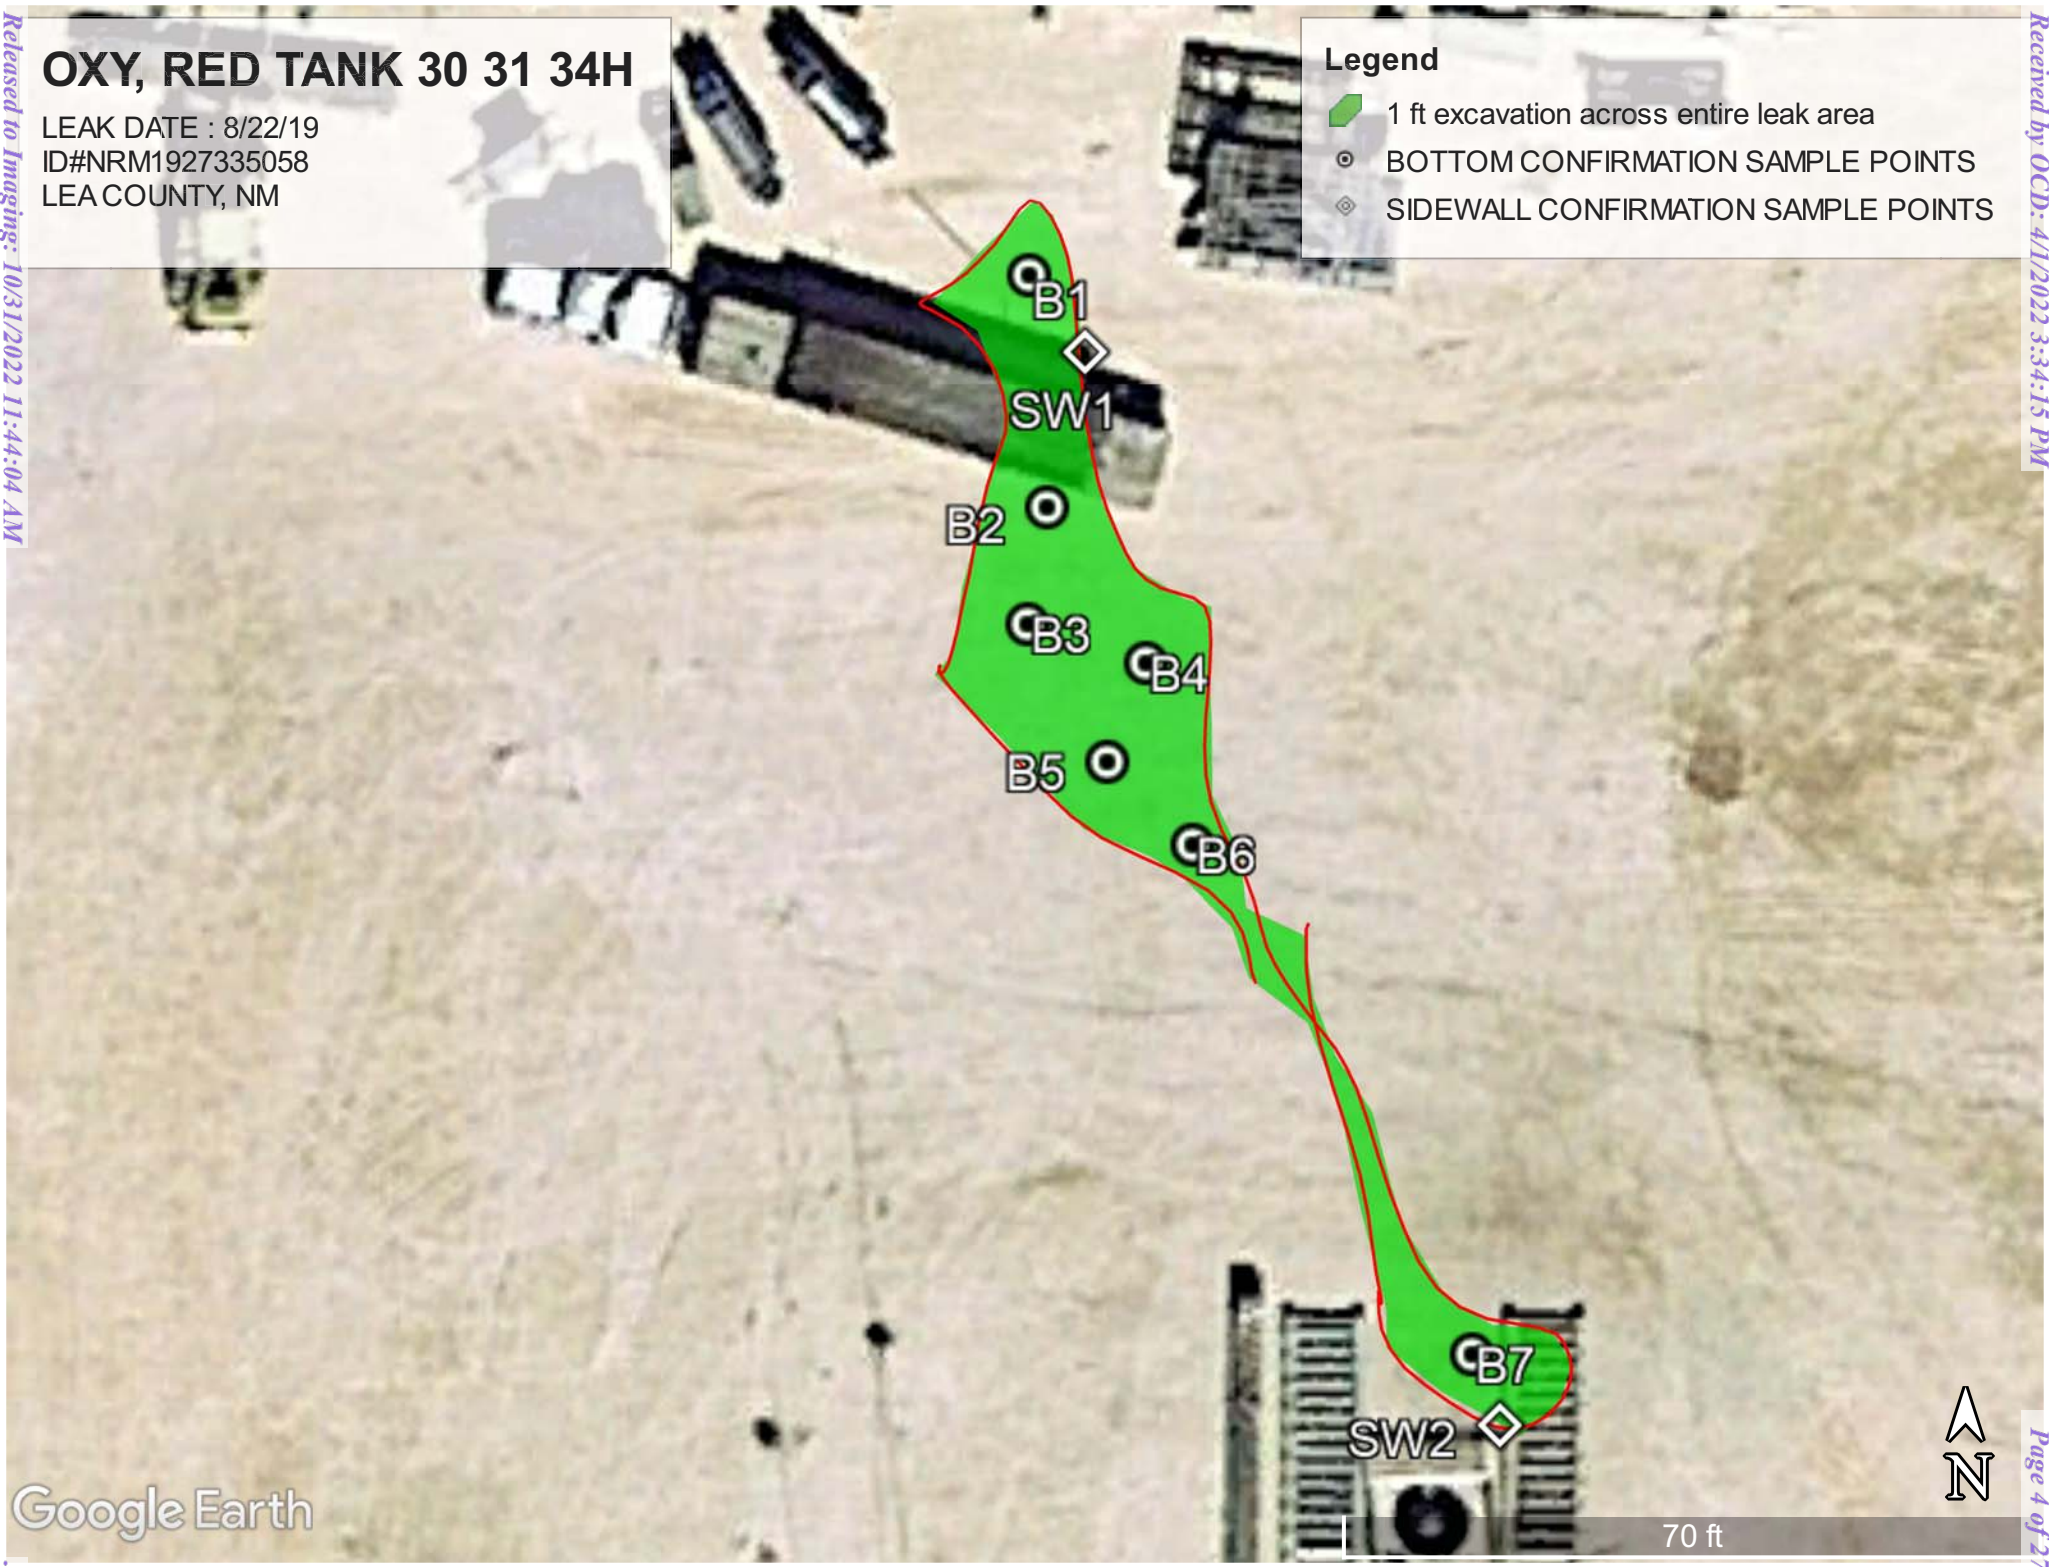
RED TANK 30-31 34H (8/22/19)

1 ft excavation across entire leak area

BOTTOM CONFIRMATION SAMPLE POINTS

SIDEWALL CONFIRMATION SAMPLE POINTS

SIDEWALL 1	N32.369851	W-103.604703
SIDEWALL 2	N32.369557	W-103.604569
BOTTOM SAMPLE 1	N32.369873	W-103.604721
BOTTOM SAMPLE 2	N32.369810	W-103.604715
BOTTOM SAMPLE 3	N32.369778	W-103.604721
BOTTOM SAMPLE 4	N32.369767	W-103.604683
BOTTOM SAMPLE 5	N32.369740	W-103.604695
BOTTOM SAMPLE 6	N32.369717	W-103.604668
BOTTOM SAMPLE 7	N32.369577	W-103.604577

Remediation Parameters	Oxy will excavate the spill area as depicted on the following site diagram. The entire leak area will be excavated to a depth of 1 foot. Bottom and Sidewall confirmation samples will be collected every 75feet. The entire side will then be backfilled with clean soil and revegetated (if warranted) to the standards of the appropriate regulatory agency or private surface owner.
Remediation Activities:	8/29/19, 8/17/21, 9/14/21, 9/17/21

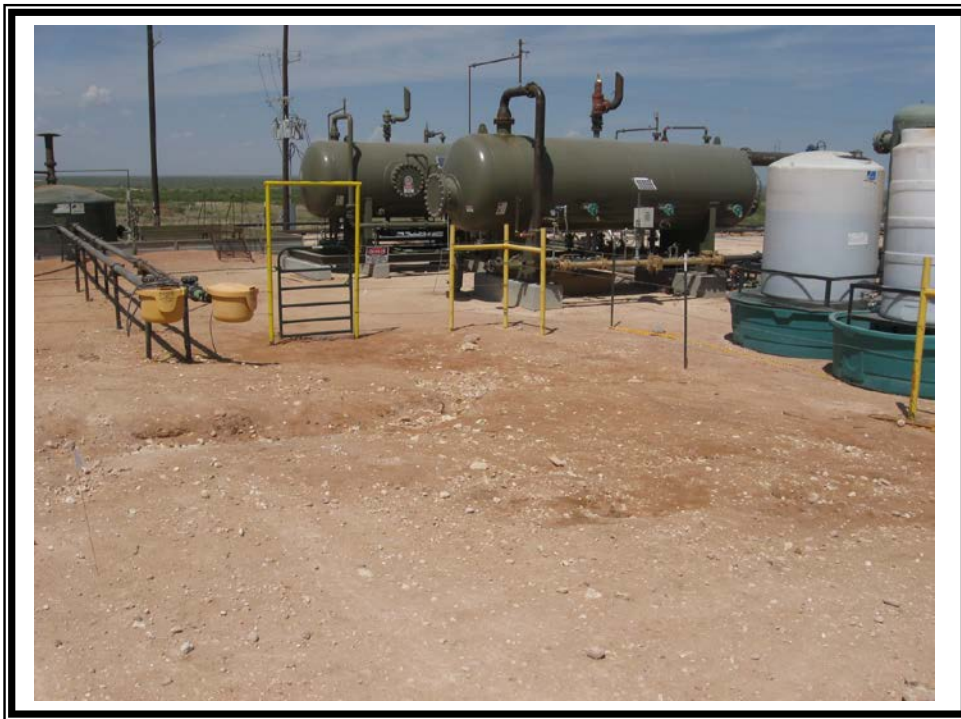
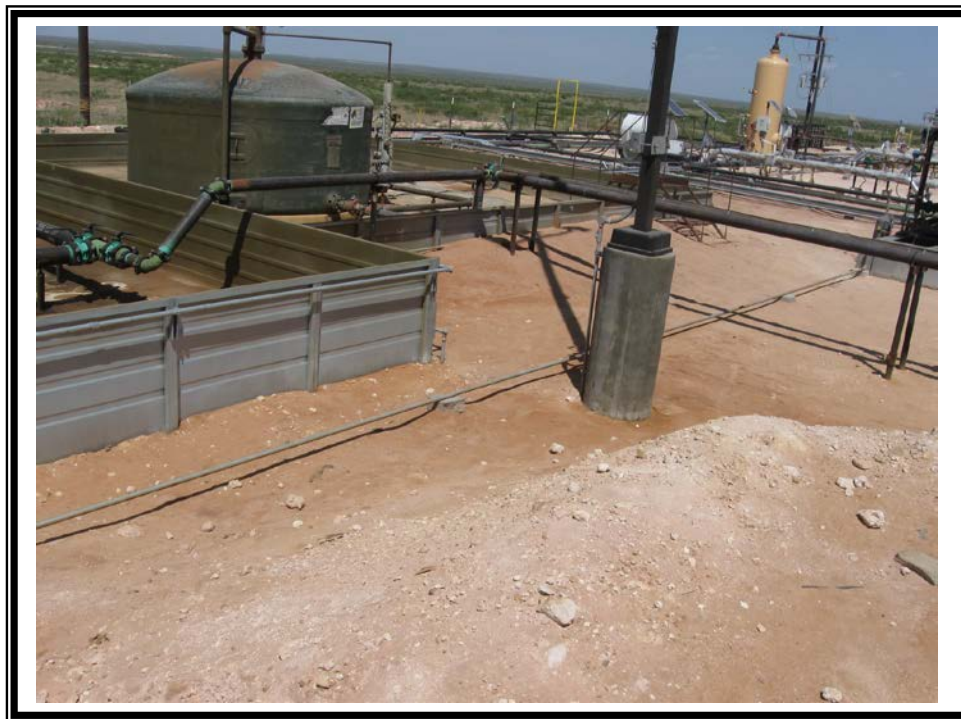
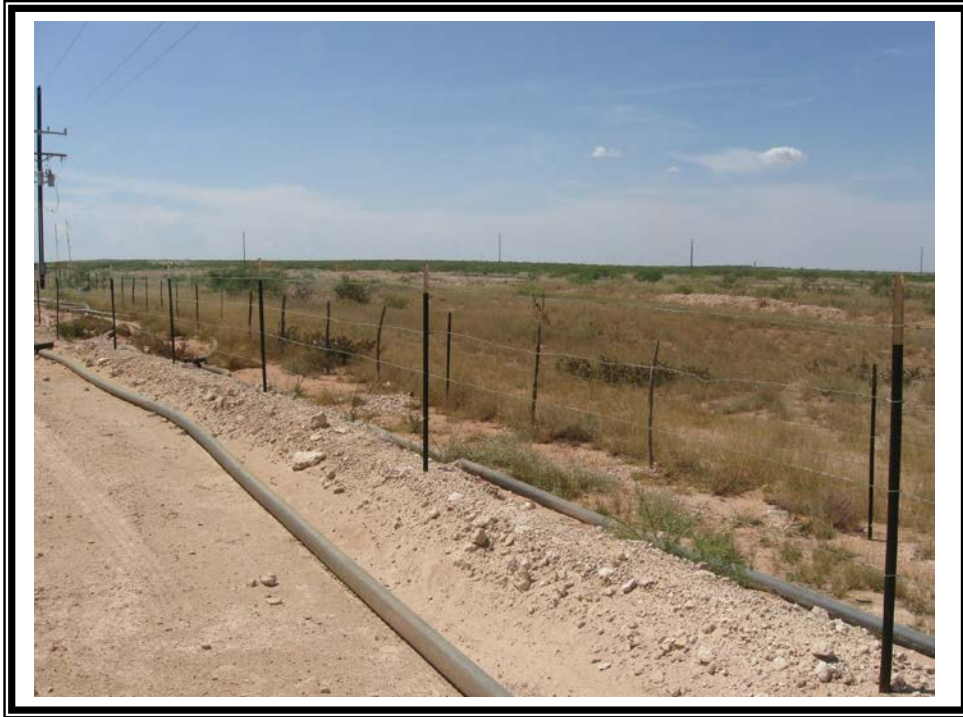
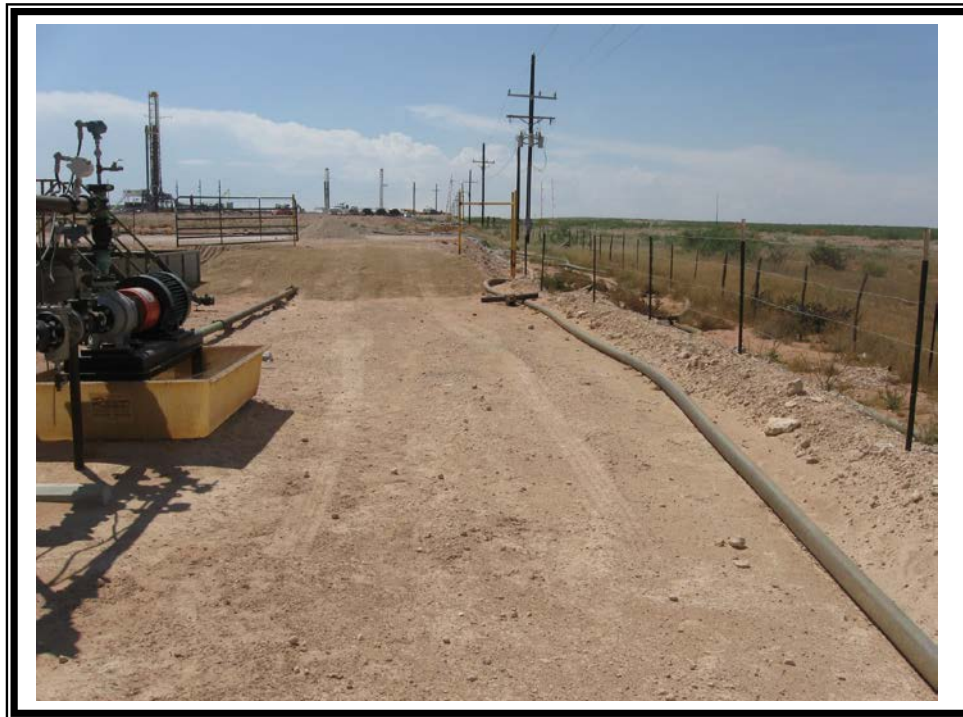
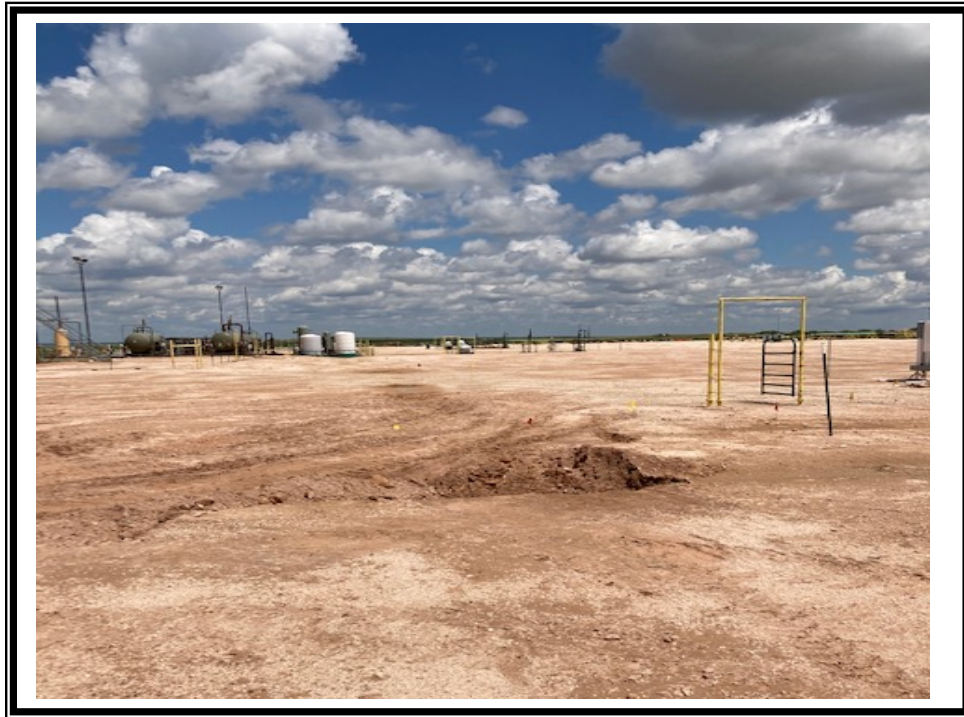
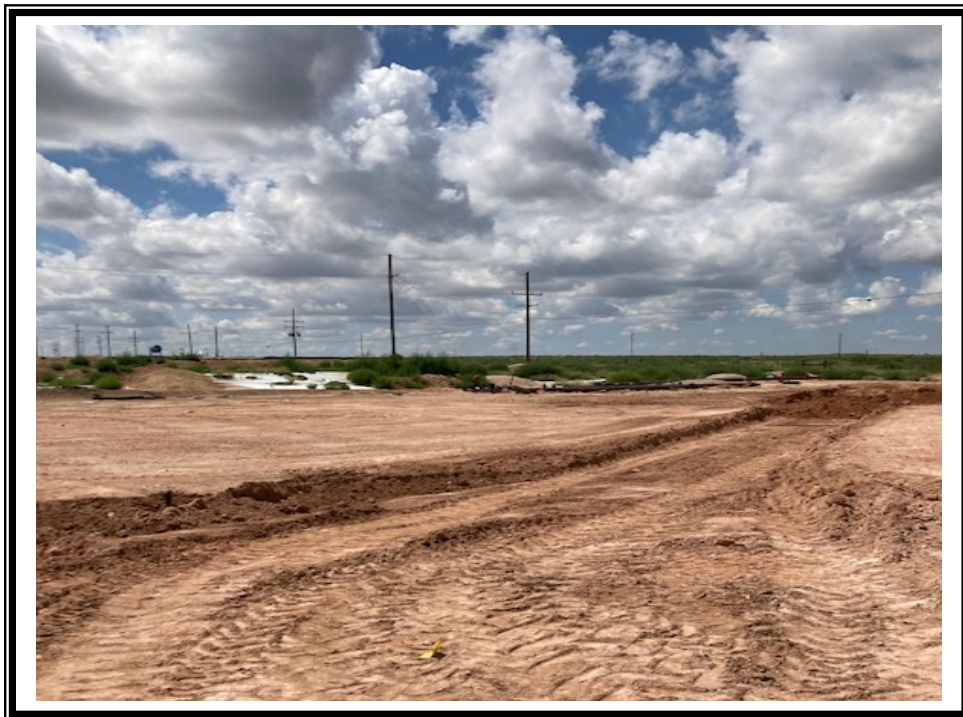
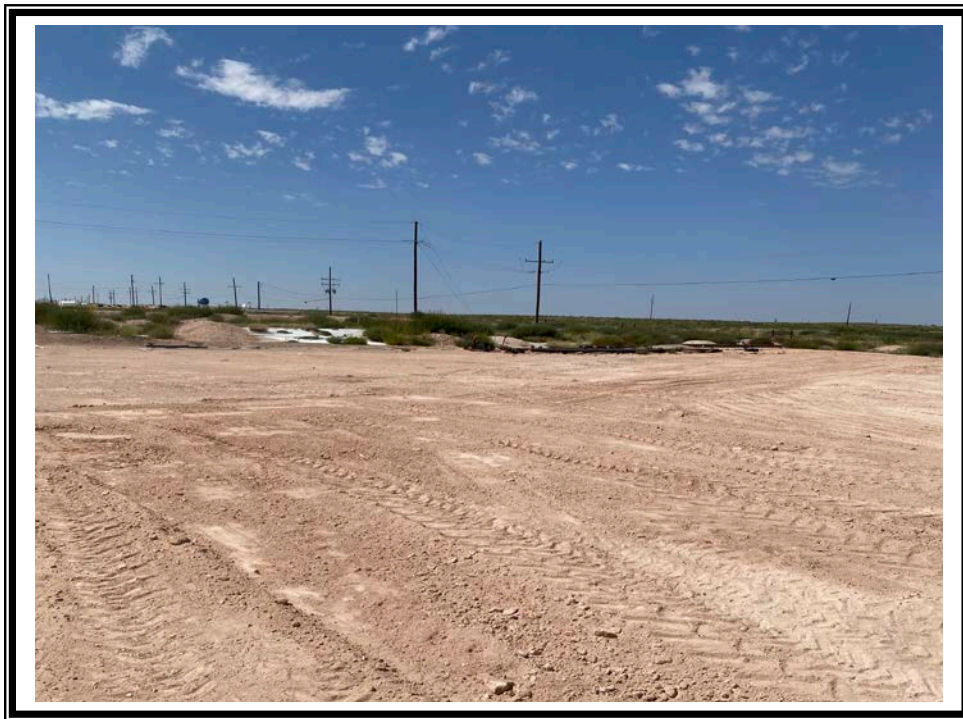
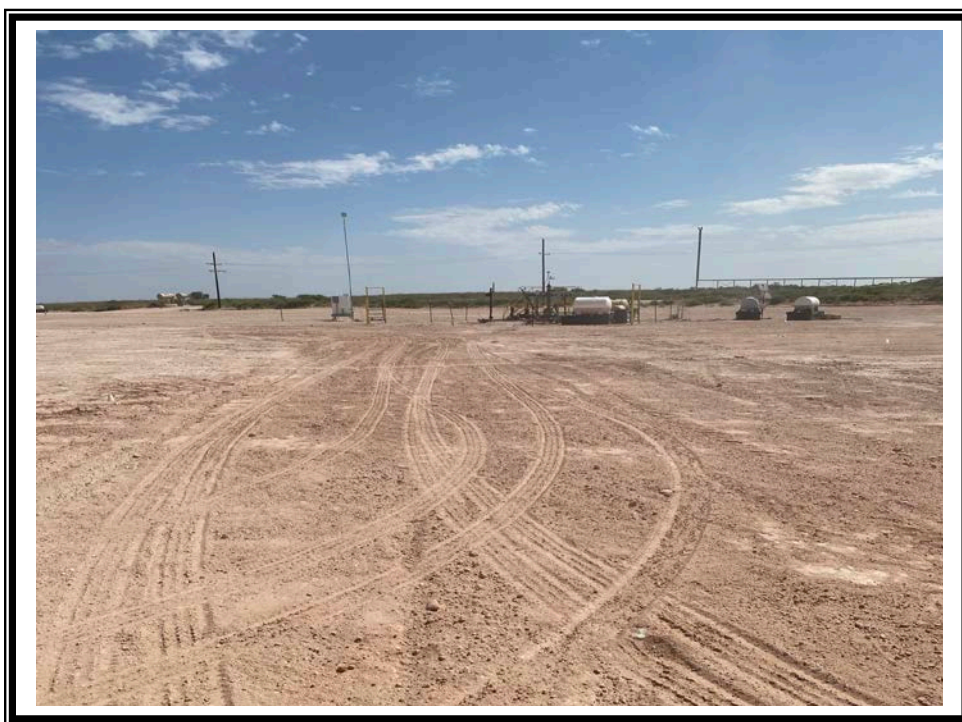
8/20/19

RED TANK 30-31 34H
8/20/19
