2RP-3871
REMEDIATION REPORT
Nash Draw Tank Battery #36
Eddy County, New Mexico

LAI Project No. 16-0108-06

March 24, 2017

XTO Energy, Inc.
500 W. Illinois Ave., Suite 100
Midland, Texas 79707

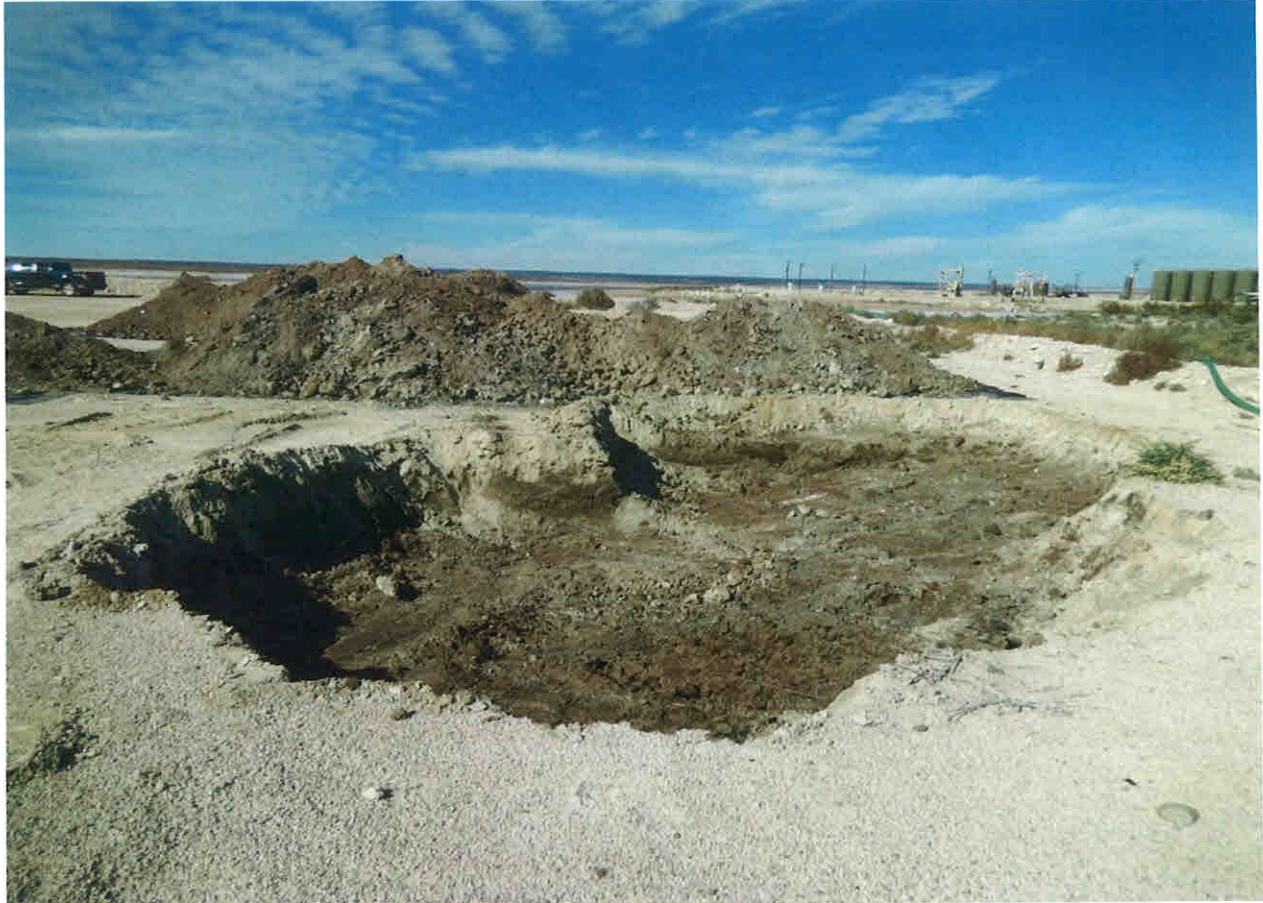
Expanded Excavation at DP-06-04 Viewing North, December 1, 2016

SDR excavated soil from the area of DP-06-04 measuring about 20 x 35 feet to about 1 foot bgs. The excavations were filled with caliche.

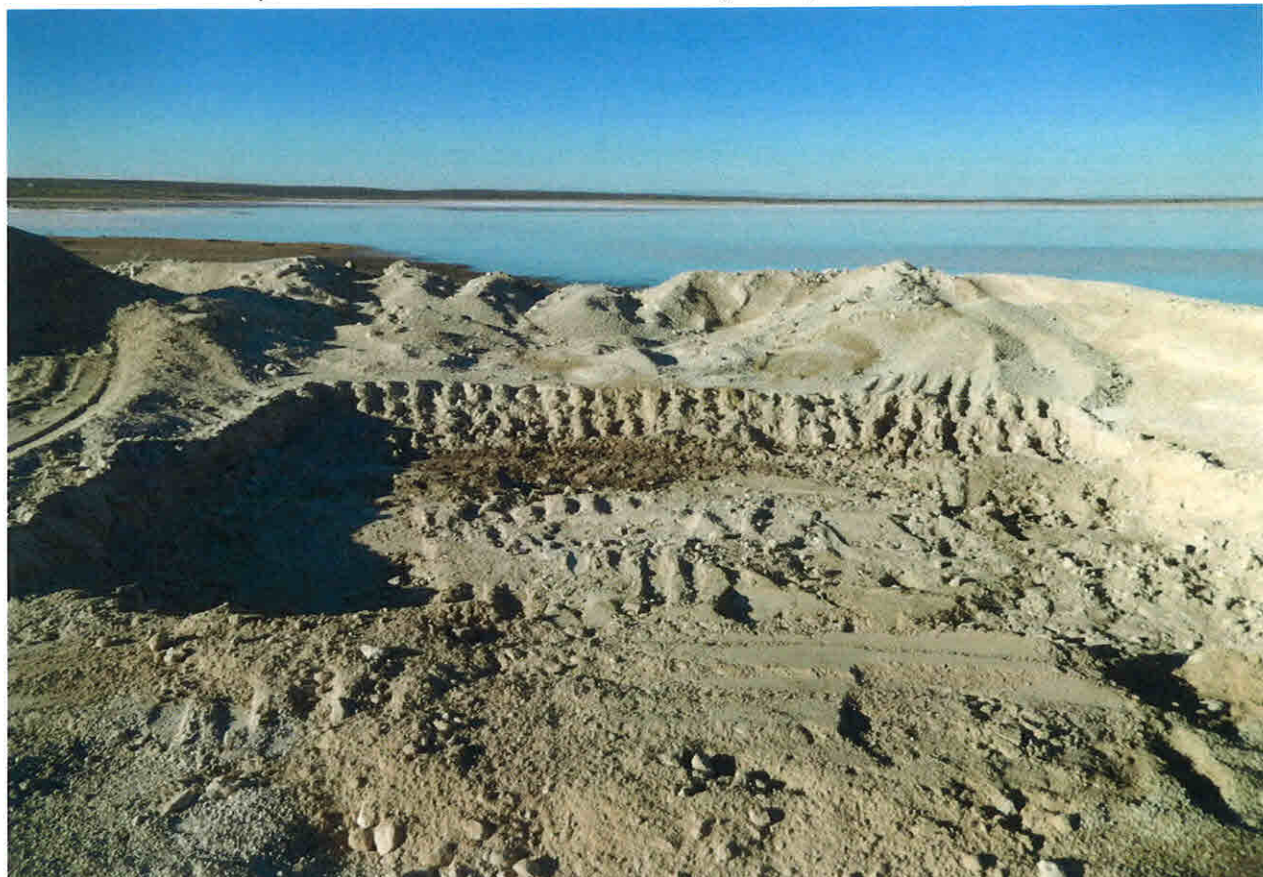
Excavation at DP-06-01 Viewing West, November 30, 2016

Soil remediation was performed between December 1 and 8, 2016, according to the plan approved by OCD District 2 on November 10, 2016. SDR, under supervision from LAI, excavated soil from the area of DP-06-01 measuring about 15 x 20 feet to about 1 foot bgs. The excavation was filled with caliche.

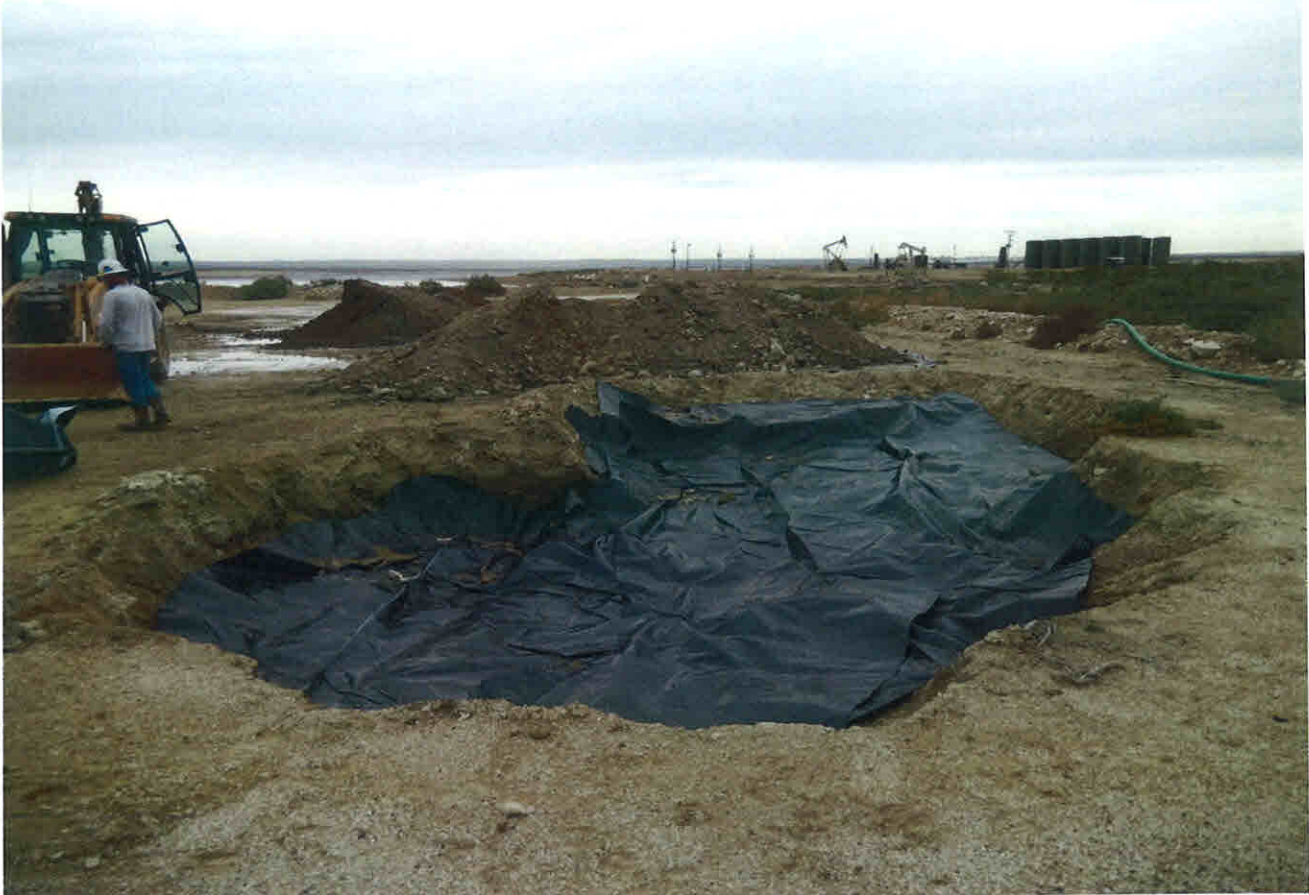
Liner Installed in Excavation (4 feet) DP-06-04 Viewing North, December 7, 2016

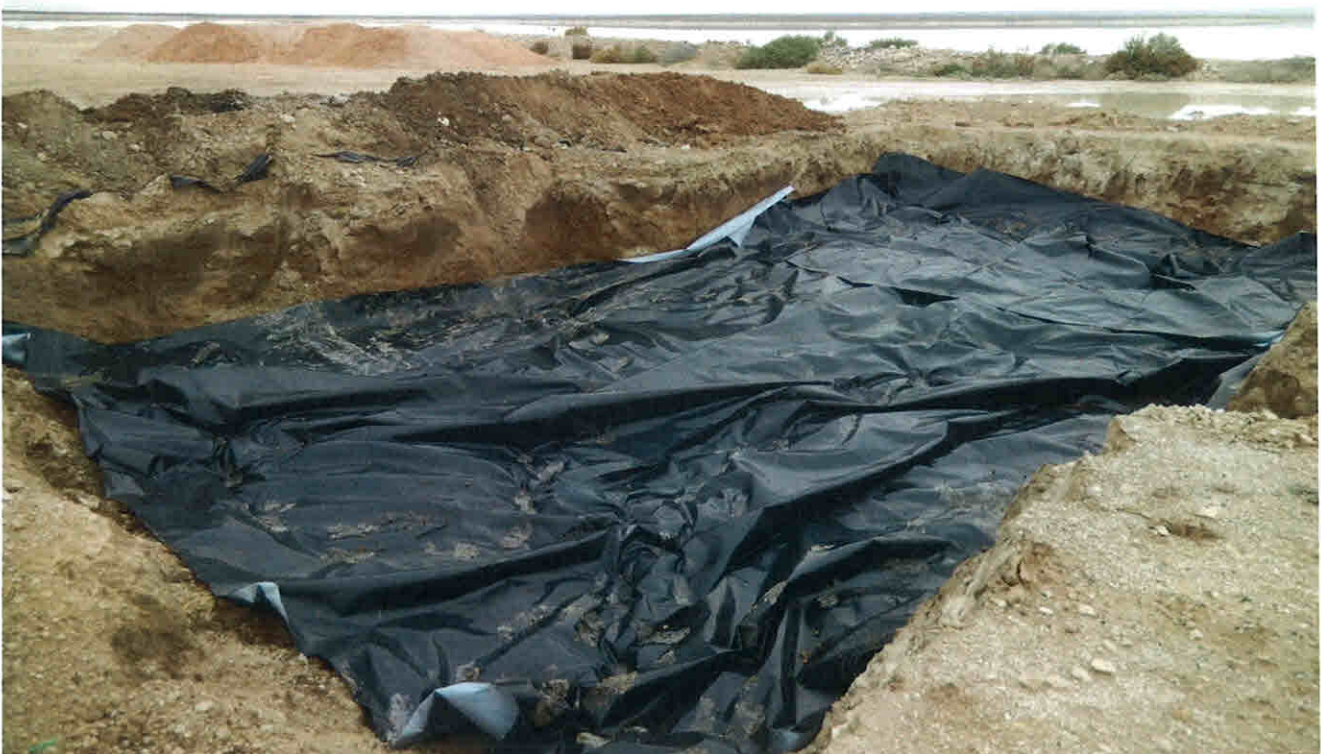
Released to Imaging: 2/20/2023 8:13:41 AM Excavation (4 feet) DP-06-03 Viewing West, December 7, 2016

SDR excavated soil from the area of DP-06-03 measuring about 20 x 45 feet to about 6 feet bgs. Soil samples were collected from the excavation sidewalls and analyzed by Permian Basin Environmental Lab (PBEL) for benzene, toluene, ethylbenzene and xylenes (BTEX) by EPA SW-846 Method 8020B and TPH by EPA SW-846 Method 8015 including GRO (C6 – C12), DRO (>C12 – C28) and ORO (>C28 – C35). BTEX and TPH were below the method reporting limit (RL) in the sidewall samples from excavation DP-06-03. A 20 mil thickness polyethylene liner was placed in the bottom of the excavation at approximately 4 feet bgs. The remainder of the excavation above the liner was filled with caliche.

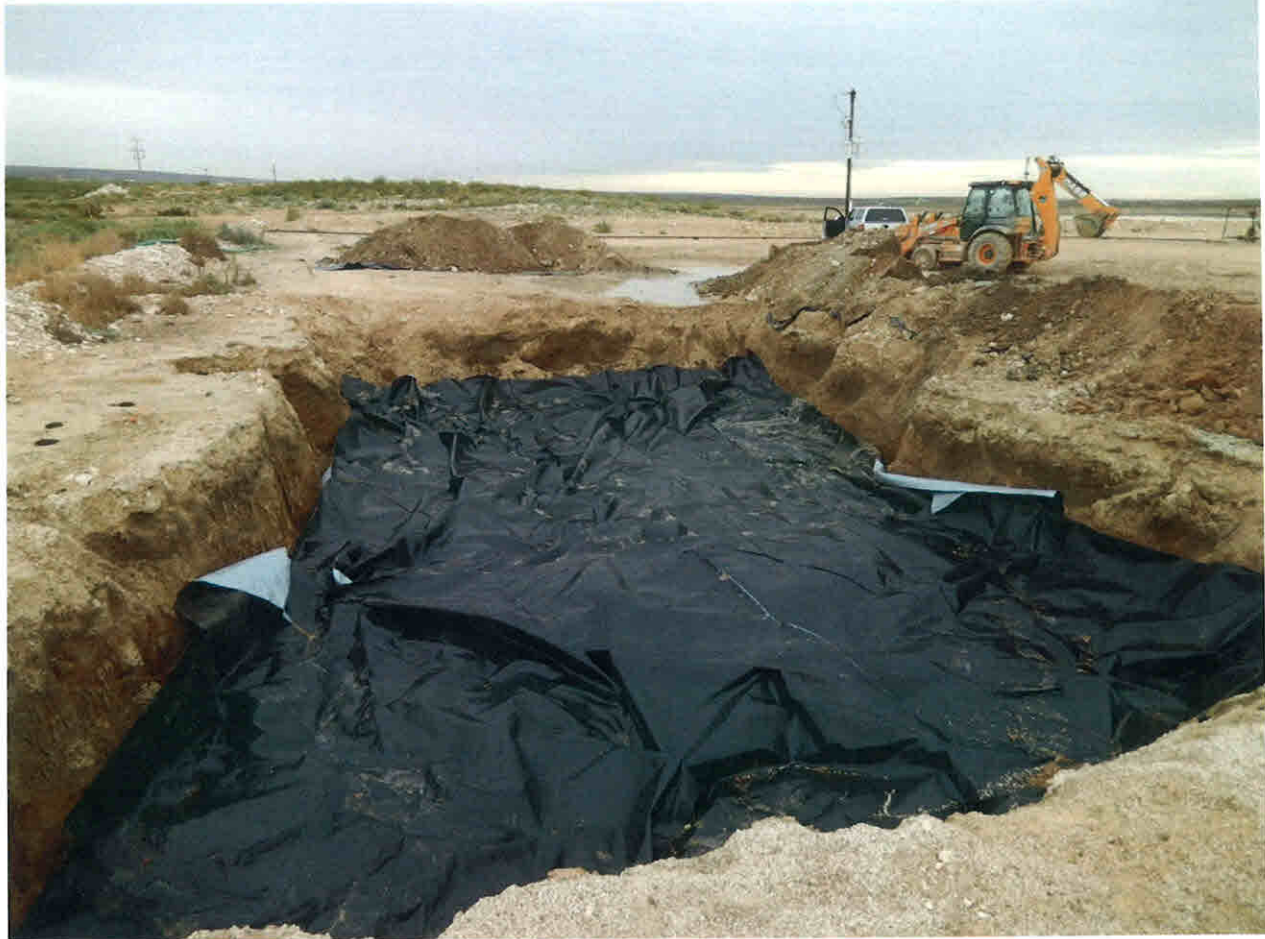
Liner Installed in Excavation (4 feet) DP-06-03 Viewing Southeast, December 7, 2016

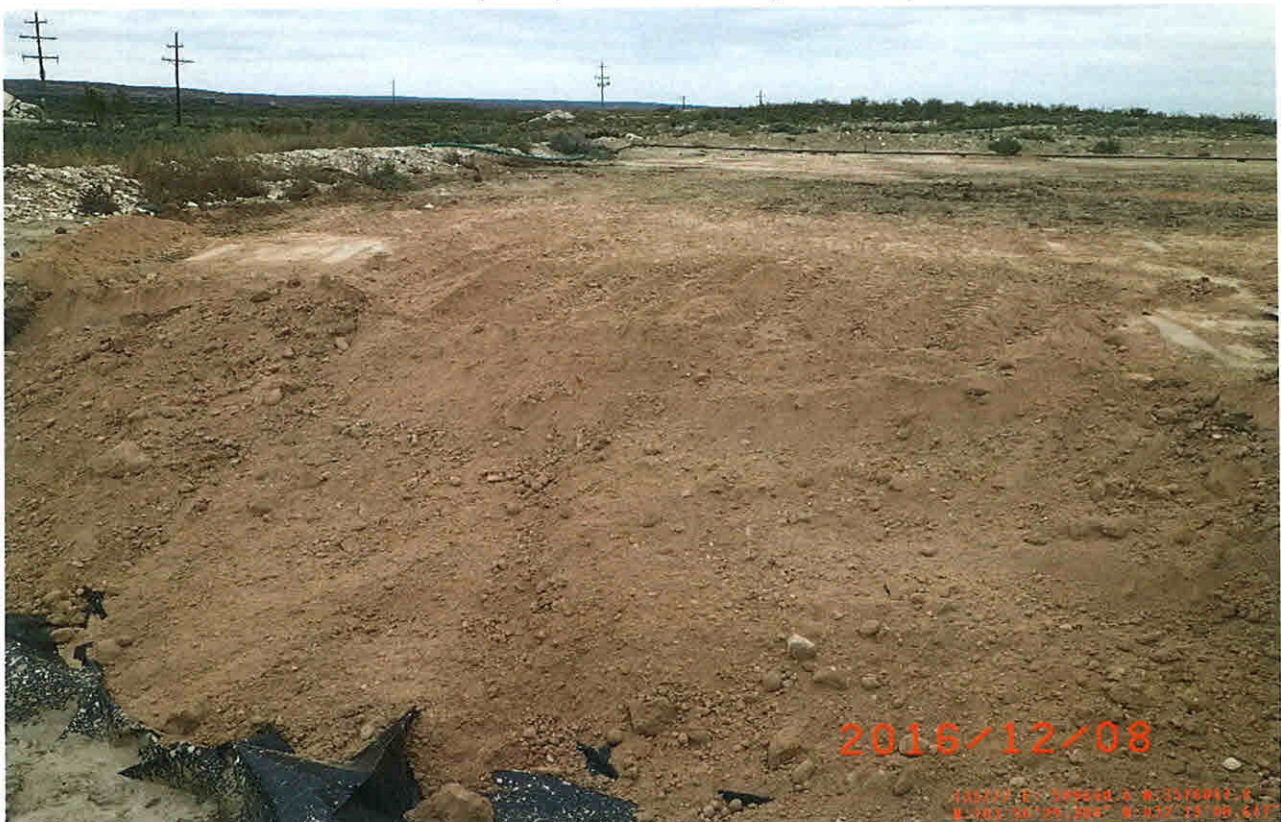
Backfilling Excavation at DP-06-03 Viewing Southeast, December 8, 2016

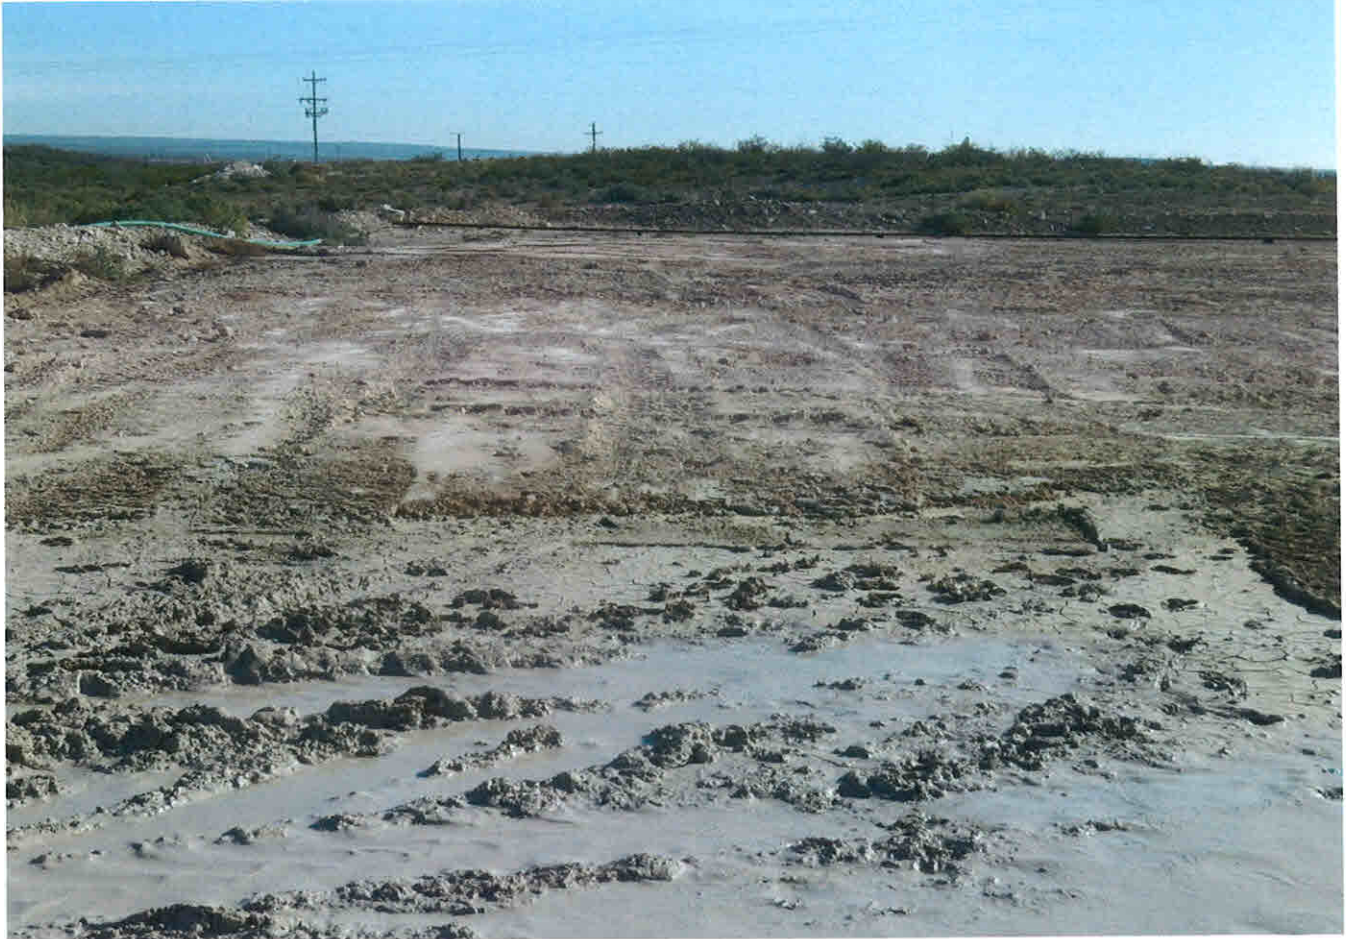
Completed Remediation at DP-06-03 and DP-06-04 Viewing Southeast, December 15, 2016

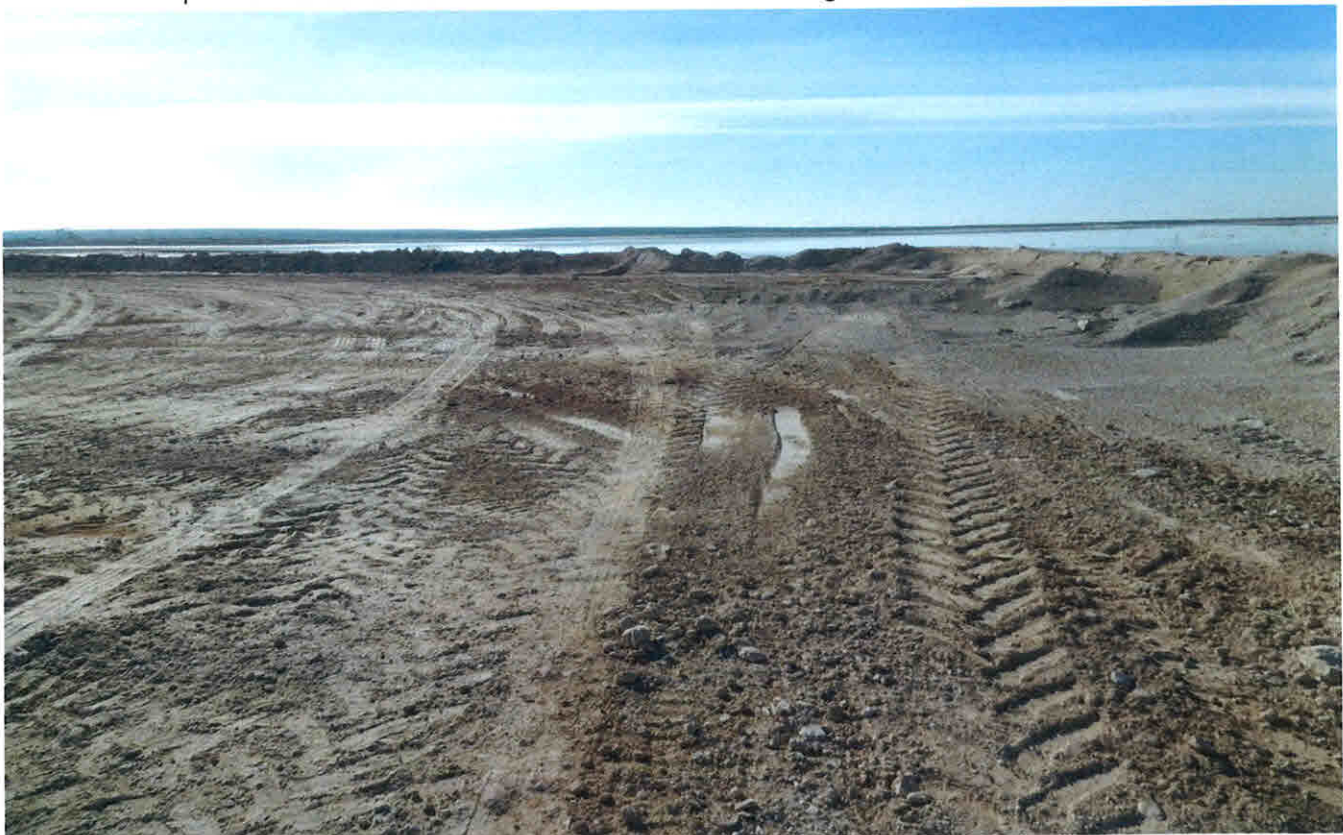
Completed Remediation at DP-06-01 Viewing West, December 8, 2016
