## Site Assessment/Characterization

**Re: Site Assessment, Remediation, and Closure Report**  
**Lusitano 27 34 Federal Com 528H**  
**API No. 30-015-44426**  
**GPS: Latitude 32.107400 Longitude -103.758753**  
**UL -- A, Sec. 27, T25S, R31E**  
**Lea County, NM**  
**NMOCD Ref. No. NAB1819143391**

# Lusitano 27 34 Federal Com 528H

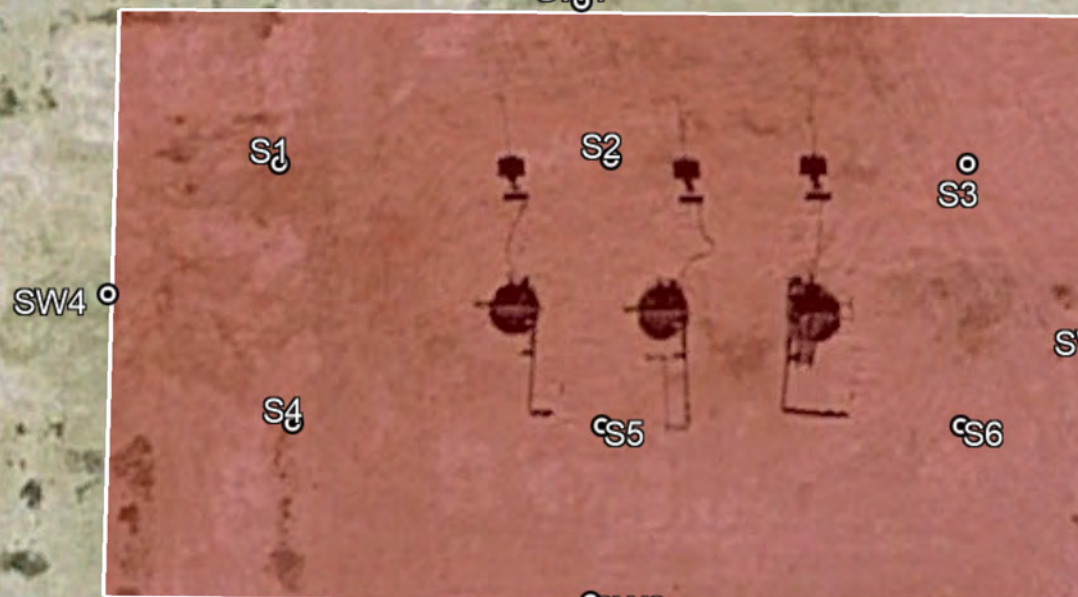
# Lusitano 27-34 Fed Com 528H

On February 18<sup>th</sup>, 2023, Pima Environmental mobilized personnel to assess the impacted area. Pima sampled the areas surrounding the well head and collected a total of twenty three soil samples for laboratory analysis. Six bottom samples (S1-S6) were collected at depths of 1, 3 and 4 feet to determine vertical delineation. Additionally, side wall samples (SW1-SW4) were collected at a depth of 6 inches to determine horizontal delineation. One background sample was collected to obtain a representation of naturally occurring chlorides surrounding the Lusitano. An initial site map can be found in Figure 4.

Devon Energy  
NAB1819452446  
API:30-015-44426  
Eddy County, NM  
Site Map

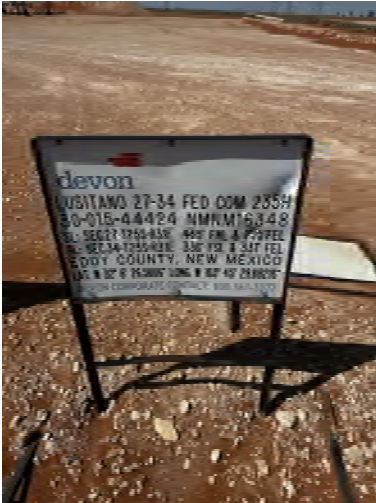
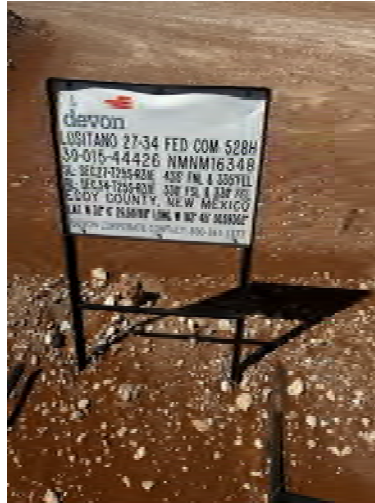
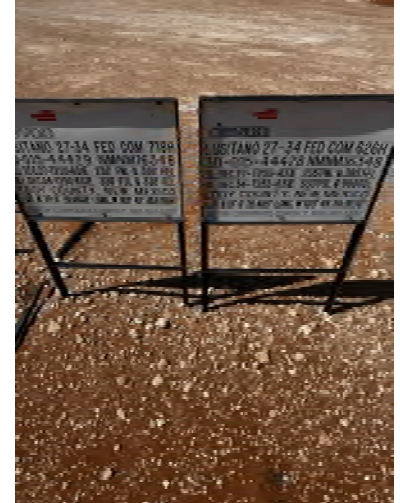
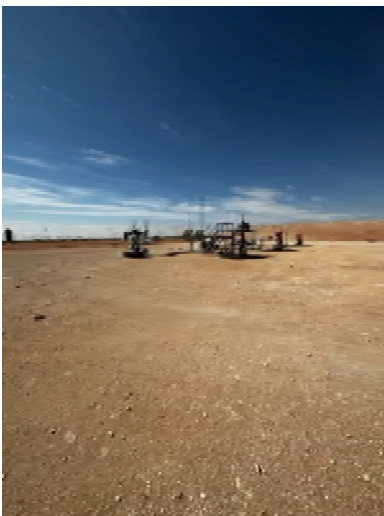
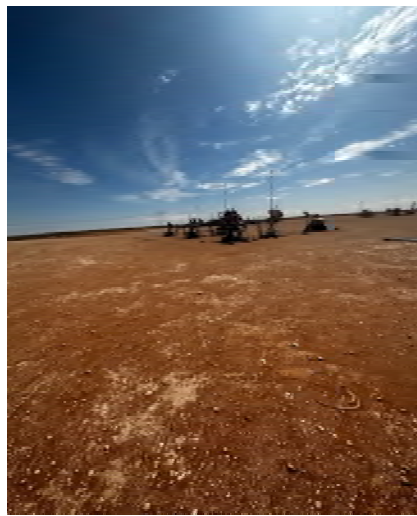
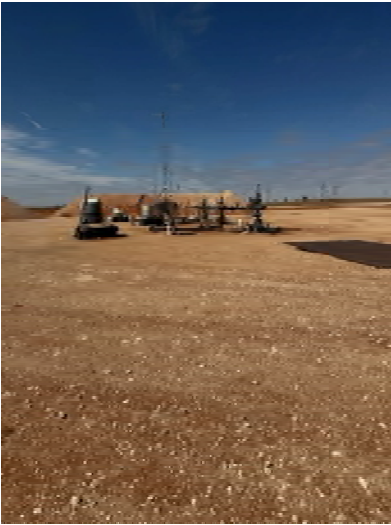
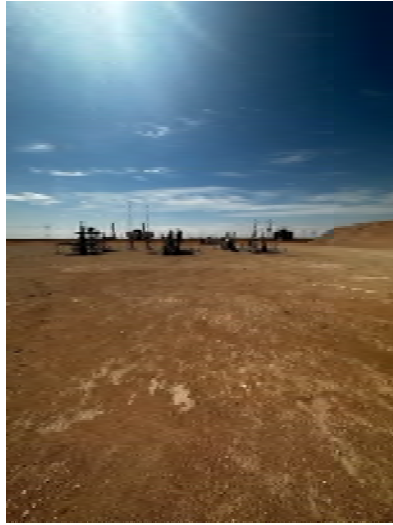
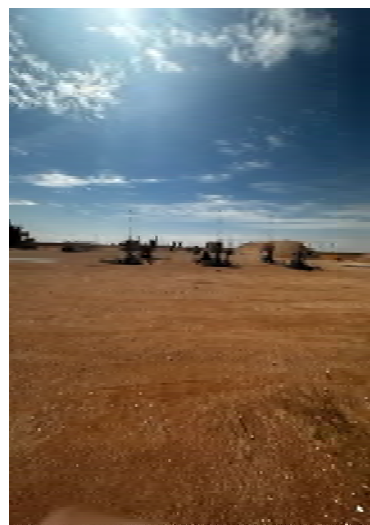
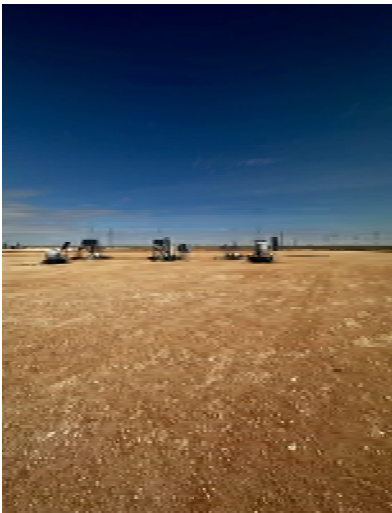
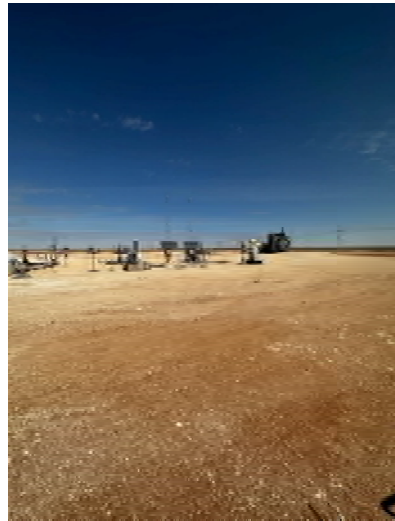
**SITE PHOTOGRAPHS  
PIMA ENVIORNMENTAL**

Based on the sample results, the bottoms and sidewalls are below NMOCD Closure Criteria 19.15.29 NMAC. See Appendix D for Photographic Documentation.
