**Re: Reclamation Report
MCA 95
Incident Number NAPP2306757137
Lea County, New Mexico**

Ensolum, LLC (Ensolum), on behalf of Maverick Permian, LLC (Maverick), has prepared the following *Reclamation Report* for the MCA 95 (Site). This *Reclamation Report* documents the Site history, reclamation activities completed to date, and proposes a vegetation monitoring plan.

Maverick Permian, LLC
Reclamation Report
MCA 95

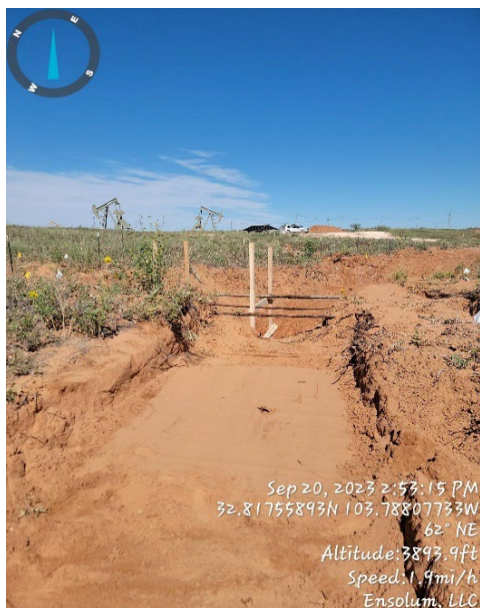
Photograph 1
Description Final excavation extent
View: Northeast

Date: 9/19/2023

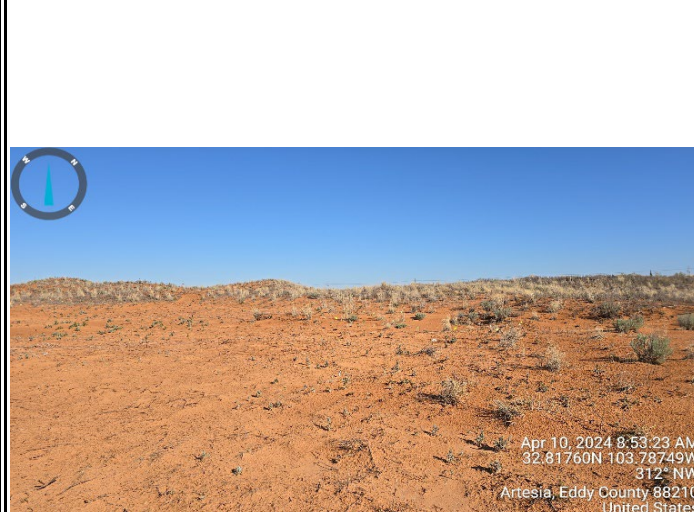
Photograph 2
Description: Backfilled excavation
View: Northwest

Date: 4/10/2024

Upon completion of excavation activities and receipt of final laboratory analytical results, the excavation was backfilled and the area was restored to its original condition. The excavation was backfilled with locally procured sandy topsoil, consistent with the surrounding native soil type. Following backfill

activities, the disturbed area was graded and contoured to match the surrounding topography. The excavation extent and reclamation area are shown on the attached Figure 1.

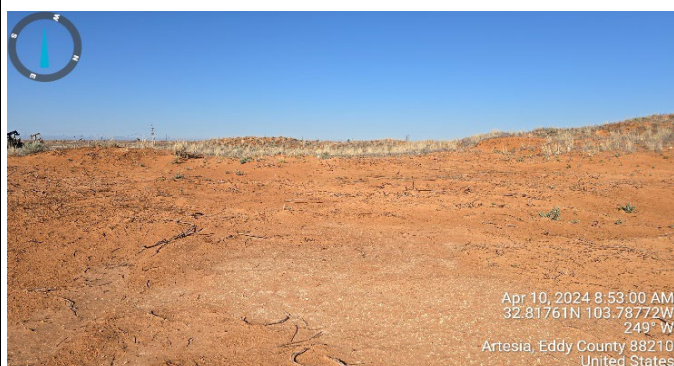
Photograph 3
Description Backfilled excavation
View: West

Date: 4/10/2024

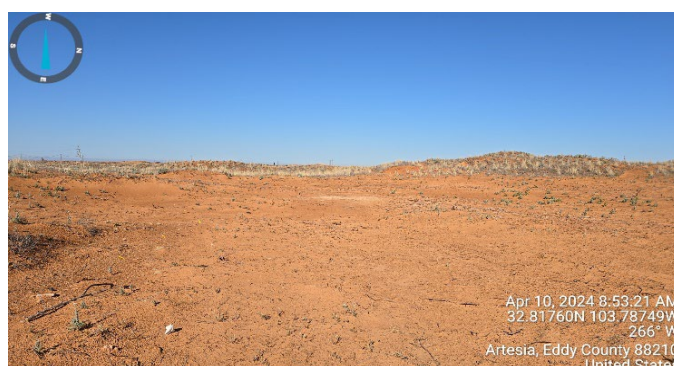
Photograph 4
Description: Backfilled excavation
View: West

Date: 4/10/2024
