**Re: Reclamation Report  
MCA #1 South Transfer Line  
Incident Number NAPP2314650185  
Lea County, New Mexico**

Ensolum, LLC (Ensolum), on behalf of Maverick Permian, LLC (Maverick), has prepared the following *Reclamation Report* for the MCA #1 South Transfer Line (Site). This *Reclamation Report* documents the Site history, reclamation activities completed to date, and proposes a vegetation monitoring plan.

Maverick Permian, LLC  
MCA #1 South Transfer Line  
Incident Number: NAPP2314650185  
Unit B, Sec 29, T17S, R32E  
Lea County, New Mexico

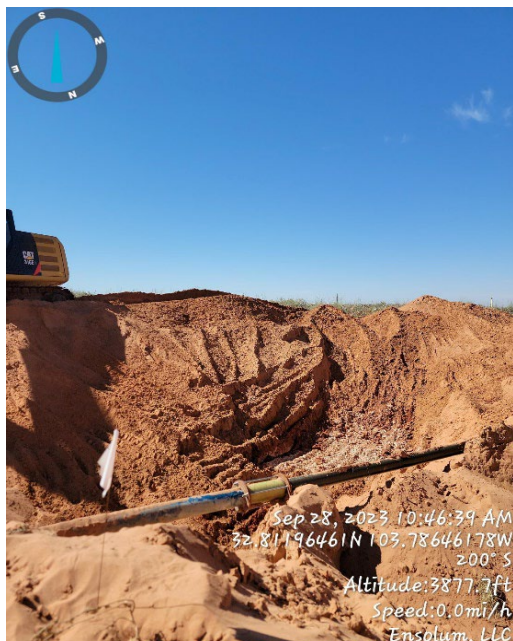
Photograph 1 Date: 9/28/2023

Description Final excavation extent

View: South

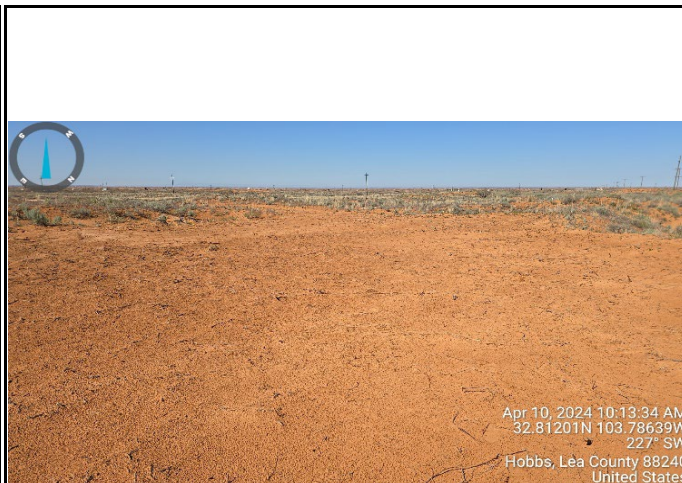
Photograph 2 Date: 4/10/2024

Description: Backfilled and re-contoured excavation

View: Southwest

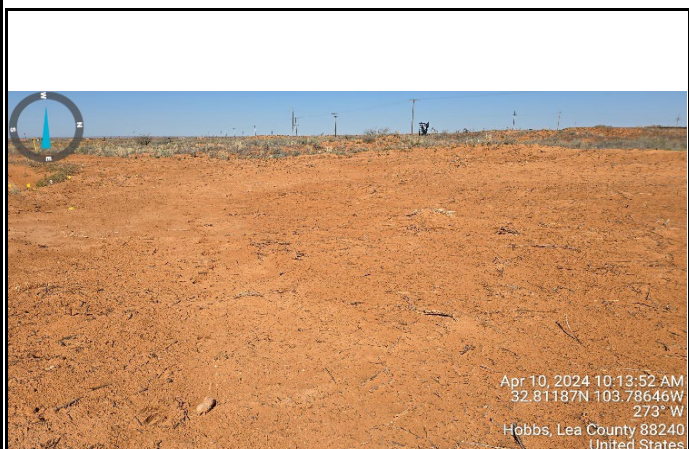
Photograph 3 Date: 4/10/2024

Description Backfilled and re-contoured excavation

View: West

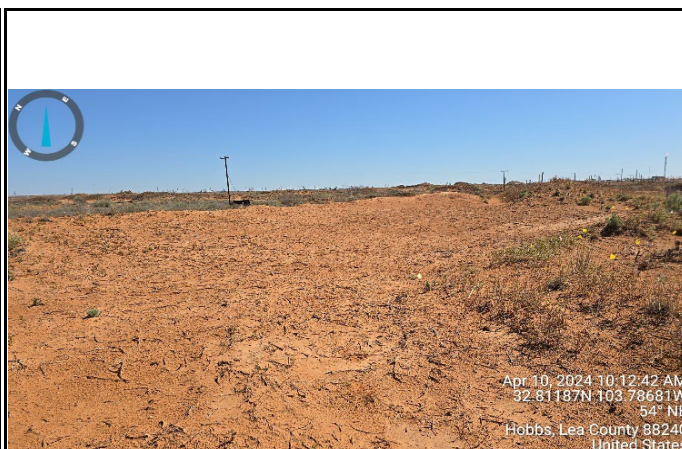
Photograph 4 Date: 4/10/2024

Description: Backfilled and re-contoured excavation

View: Northeast
