Subject: **2021 Annual Groundwater Monitoring Report**
Bruington Gas Com #1
NMOCD Administrative Order: 3R-425
San Juan County, New Mexico

WSP USA Inc. (WSP) presents this annual report on behalf of Hilcorp Energy Company (Hilcorp) to the New Mexico Oil Conservation Division (NMOCD) to document groundwater monitoring activities conducted at the Bruington Gas Com #1 natural gas production well (Site) during 2021. The Site is located within Unit Letter E, Section 14 within Township 29 North and Range 11 West, San Juan County, New Mexico (Figure 1).

SUBSURFACE INVESTIGATION REPORT

**BRUINGTON GAS COM #1
SECTION 14, TOWNSHIP 29 NORTH, RANGE 11 WEST
SAN JUAN COUNTY, NEW MEXICO**

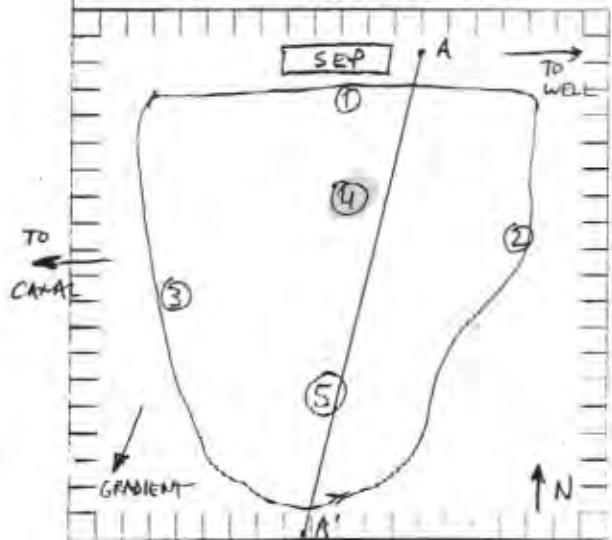
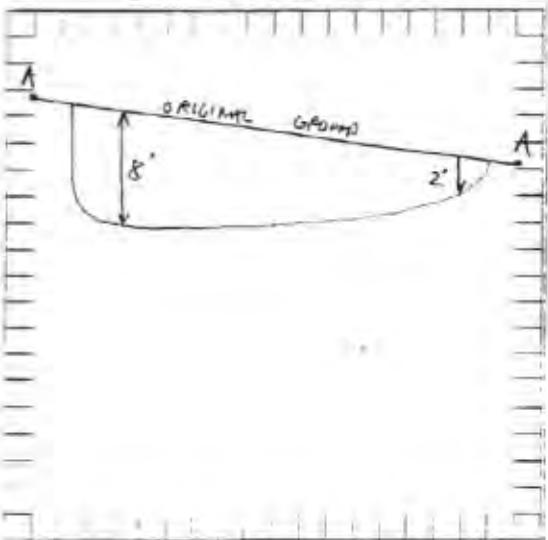
PIT SOILS CONSIST OF A SILTY SAND OVER SANDSTONE BEDROCK - GRAY CONTAMINATION STAIN APPARENT IN SURFACE OF SANDSTONE - DISAPPEARS SEVERAL INCHES INTO THE ROCK.

SAMPLE ID	FIELD HEADSPACE PT (PPM)
1 NS@6' 978	
2 ES@4' 1717	
3 WS@3' 84	
4 NB@8' 555	
5 SB@4' 605

Recommend Conditional Closure Pending Removal of 2'-3' Contaminated Sand layer directly above Sandstone @ Sample Point ②, covering entire bench area on north side.

Recommend Monitor wells for Ground-water Monitoring.

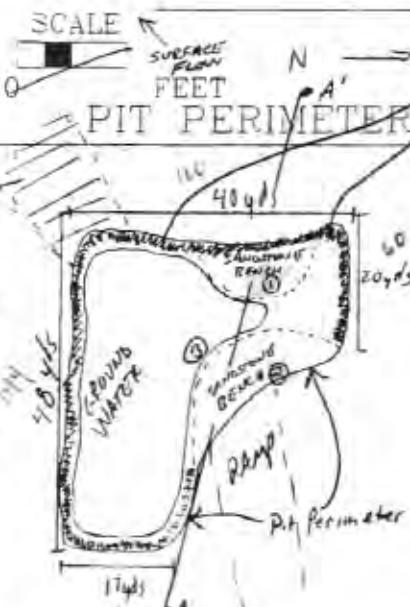
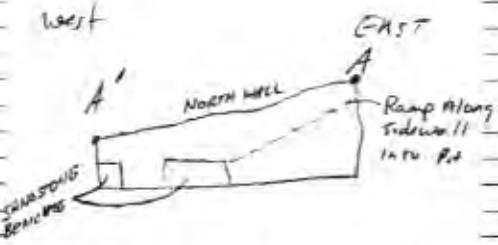
SAMPLE TEST HEADSPACE
 ① 0.10' 1.77 ppm
 ② 0.9' 6.04 ppm

SIDEWALLS ARE 3M/ML ON SANDSTONE.
 0'-10' SILTY SAND, LOOSE, UNCONSOLIDATED, PALE
 YELLOWISH BROWN, VISIBLE
 10'-15' GRAY DISCOLORATION IN EAST
 SANDSTONE BENCH

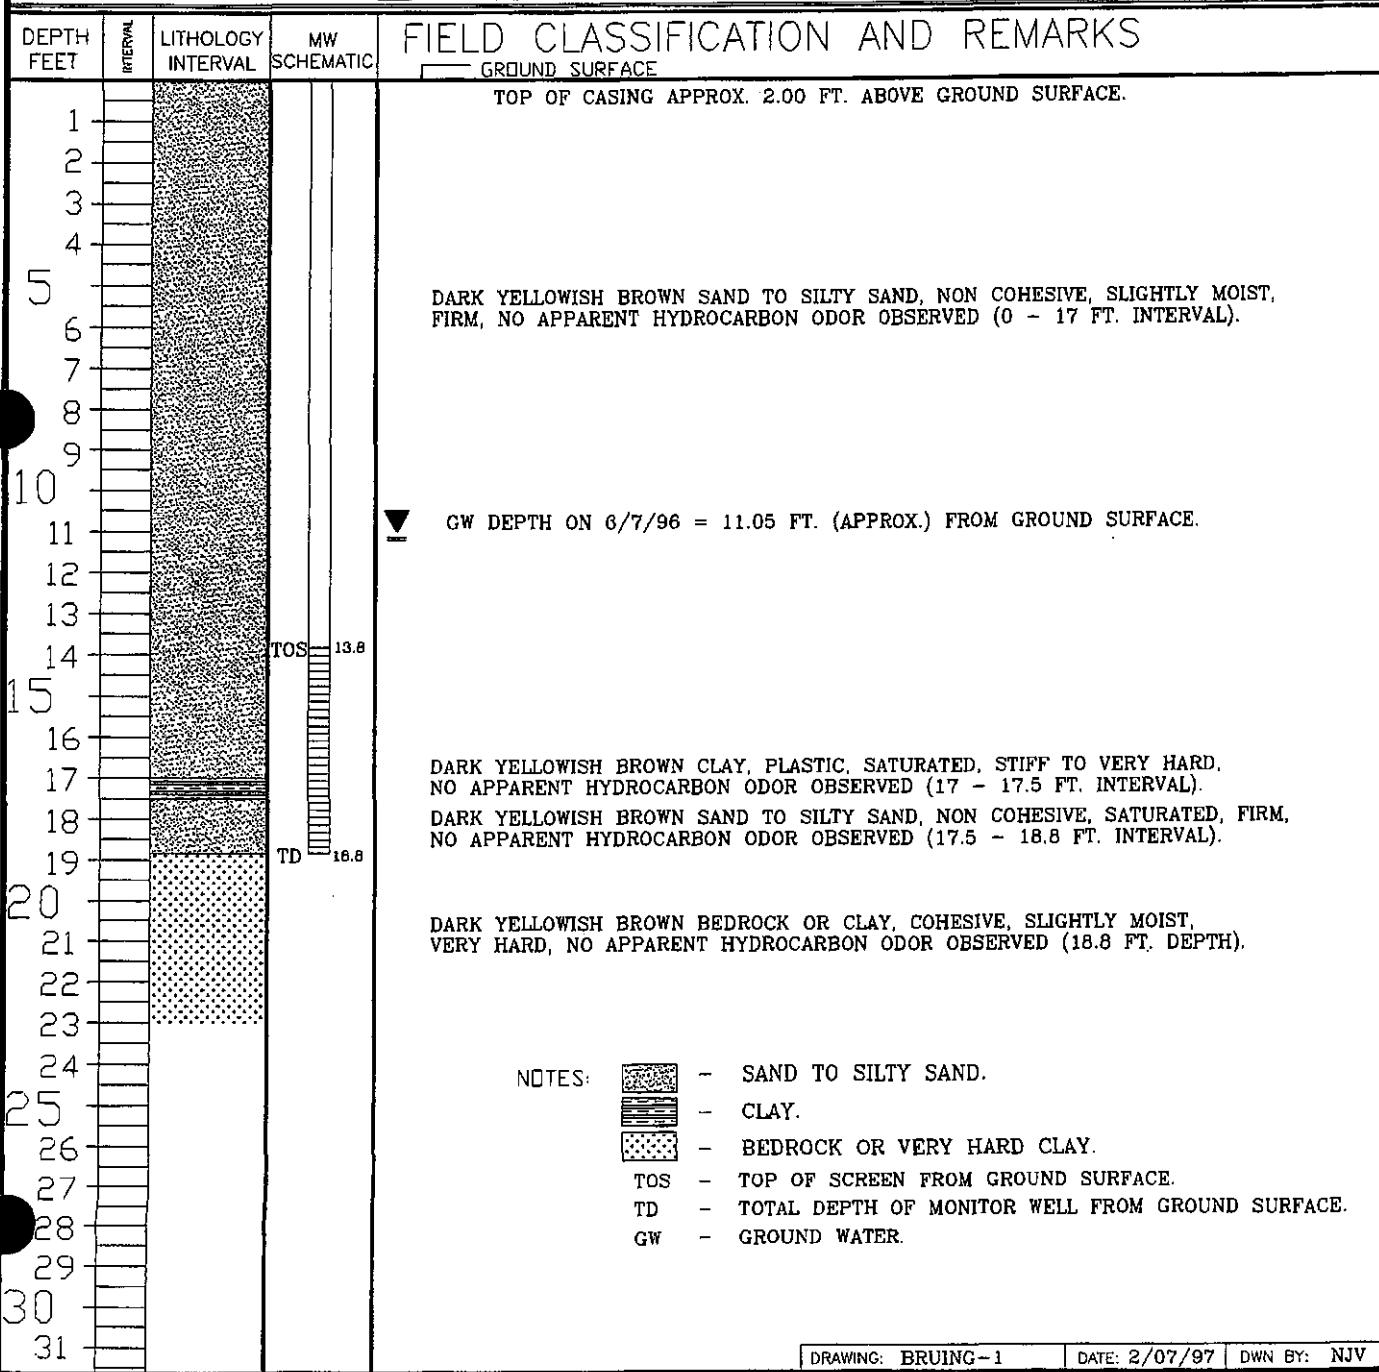
BORING #..... BH - 1
 MW #..... 1
 PAGE #..... 1
 DATE STARTED 4/25/96
 DATE FINISHED 4/25/96
 OPERATOR..... JCB
 PREPARED BY NJV

LOCATION NAME: BRUINGTON GC # 1
 CLIENT: AMOCO PRODUCTION COMPANY
 CONTRACTOR: BLAGG ENGINEERING, INC.
 EQUIPMENT USED: MOBILE DRILL RIG (EARTHPROBE)
 BORING LOCATION: S20W, 156 FEET FROM WELL HEAD.

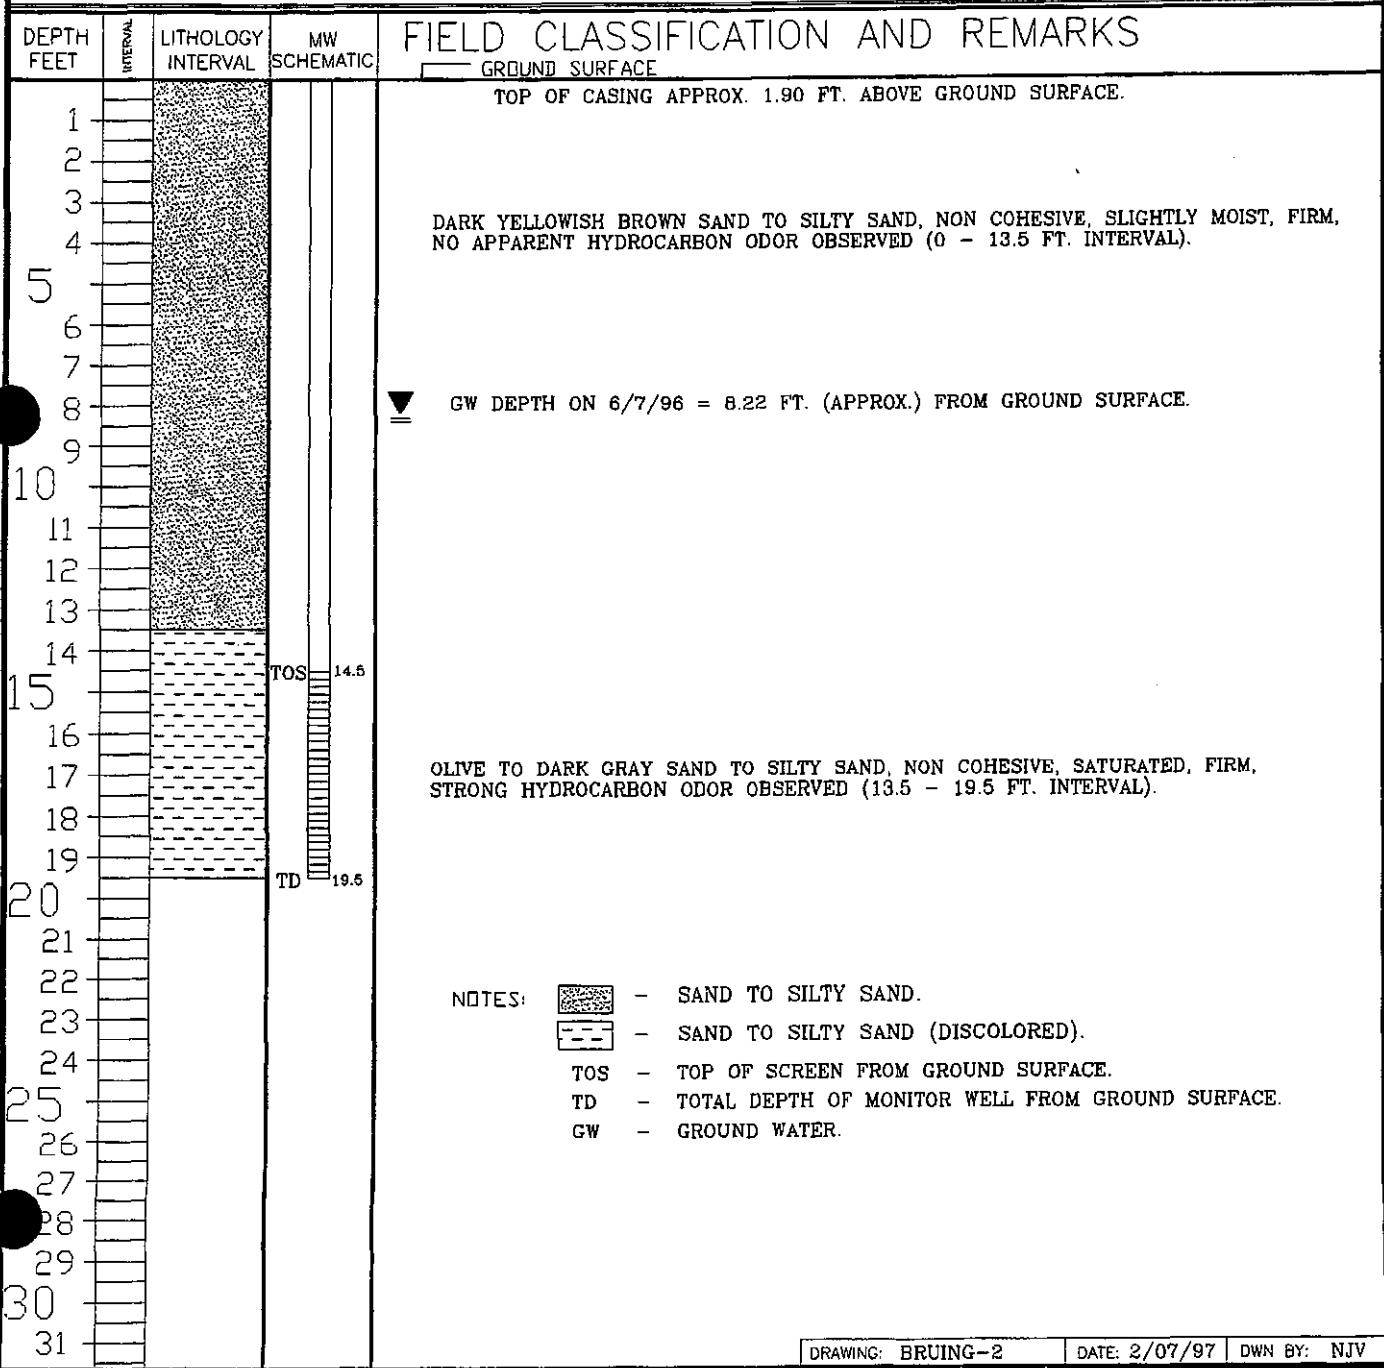
BORING #..... BH - 2
 MW #..... 2
 PAGE #..... 2
 DATE STARTED 4/25/96
 DATE FINISHED 4/25/96
 OPERATOR..... JCB
 PREPARED BY NJV

LOCATION NAME: BRUINGTON GC # 1
 CLIENT: AMOCO PRODUCTION COMPANY
 CONTRACTOR: BLAGG ENGINEERING, INC.
 EQUIPMENT USED: MOBILE DRILL RIG (EARTHPROBE)
 BORING LOCATION: S34W, 171 FEET FROM WELL HEAD.

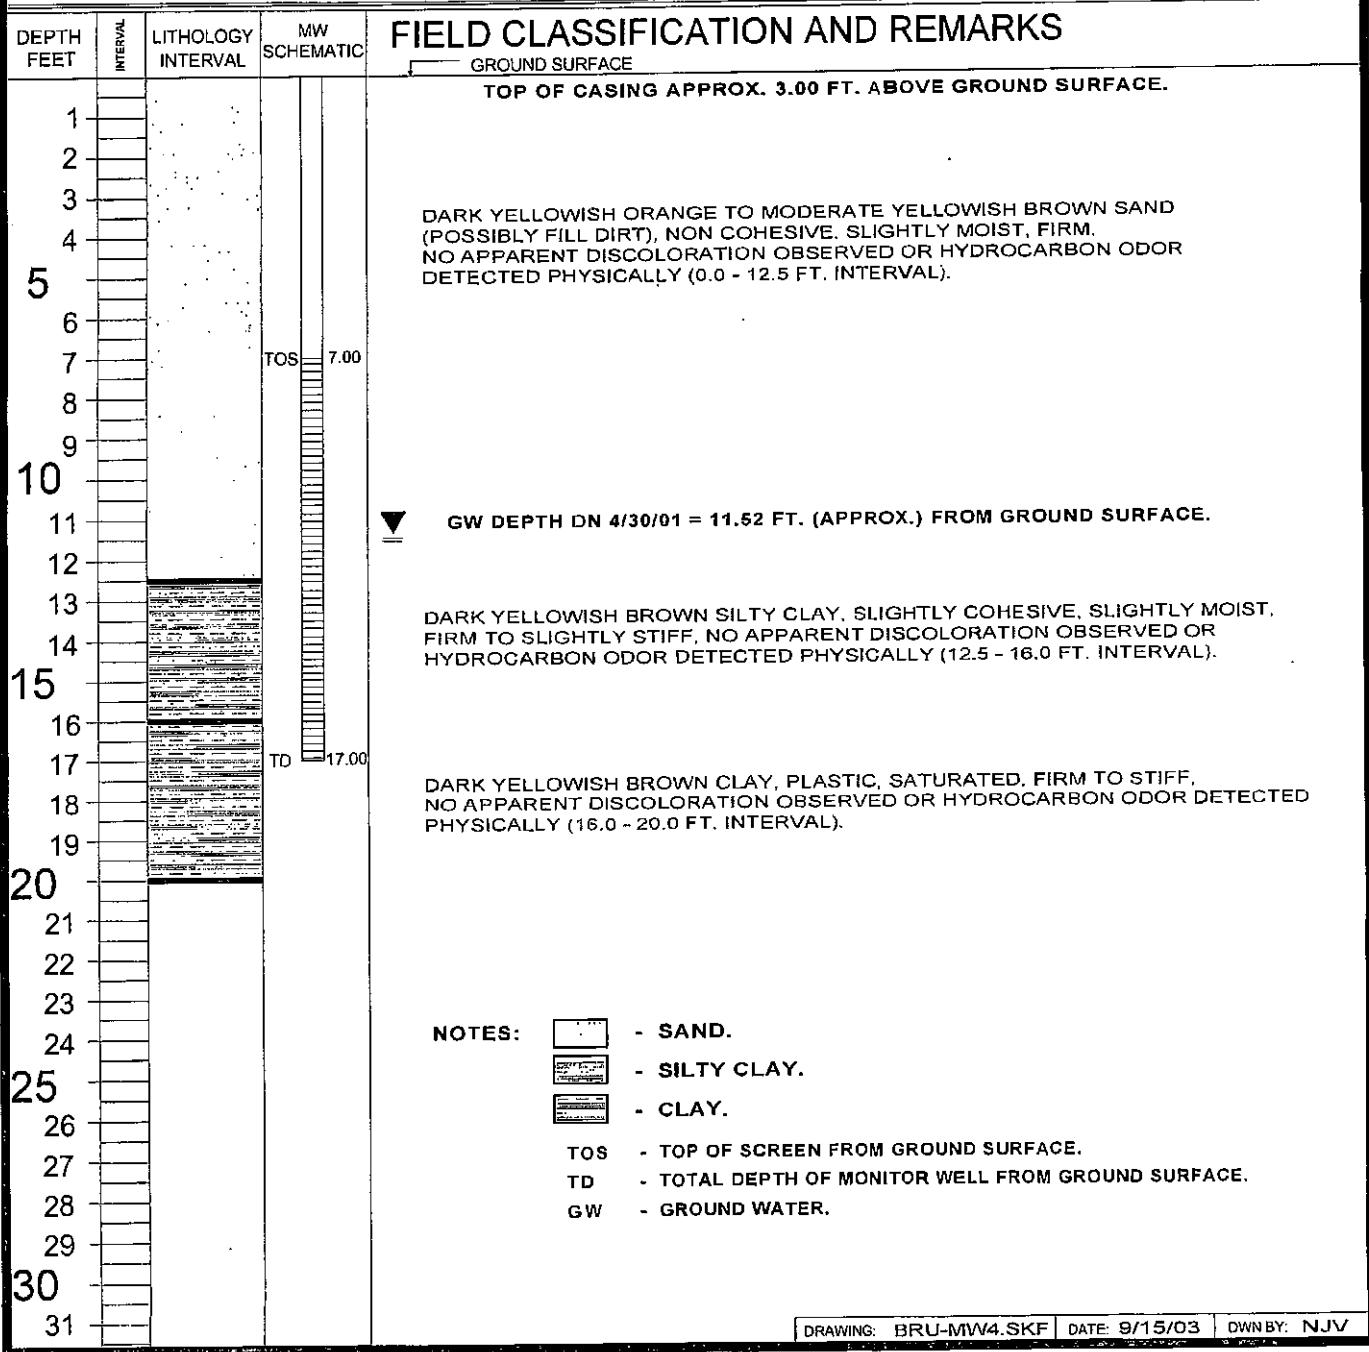
BORING #.....	BH - 4
MW #.....	4
PAGE #.....	4
DATE STARTED	2/20/01
DATE FINISHED	2/20/01
OPERATOR.....	JCB
PREPARED BY	NJV

BORE / TEST HOLE REPORTLOCATION NAME: **BRUINGTON GC # 1**CLIENT: **XTO ENERGY INC.**CONTRACTOR: **BLAGG ENGINEERING, INC.**EQUIPMENT USED: **MOBILE DRILL RIG (EARTHPROBE)**BORING LOCATION: **N30W, 39.5 FEET FROM MW # 2R.**

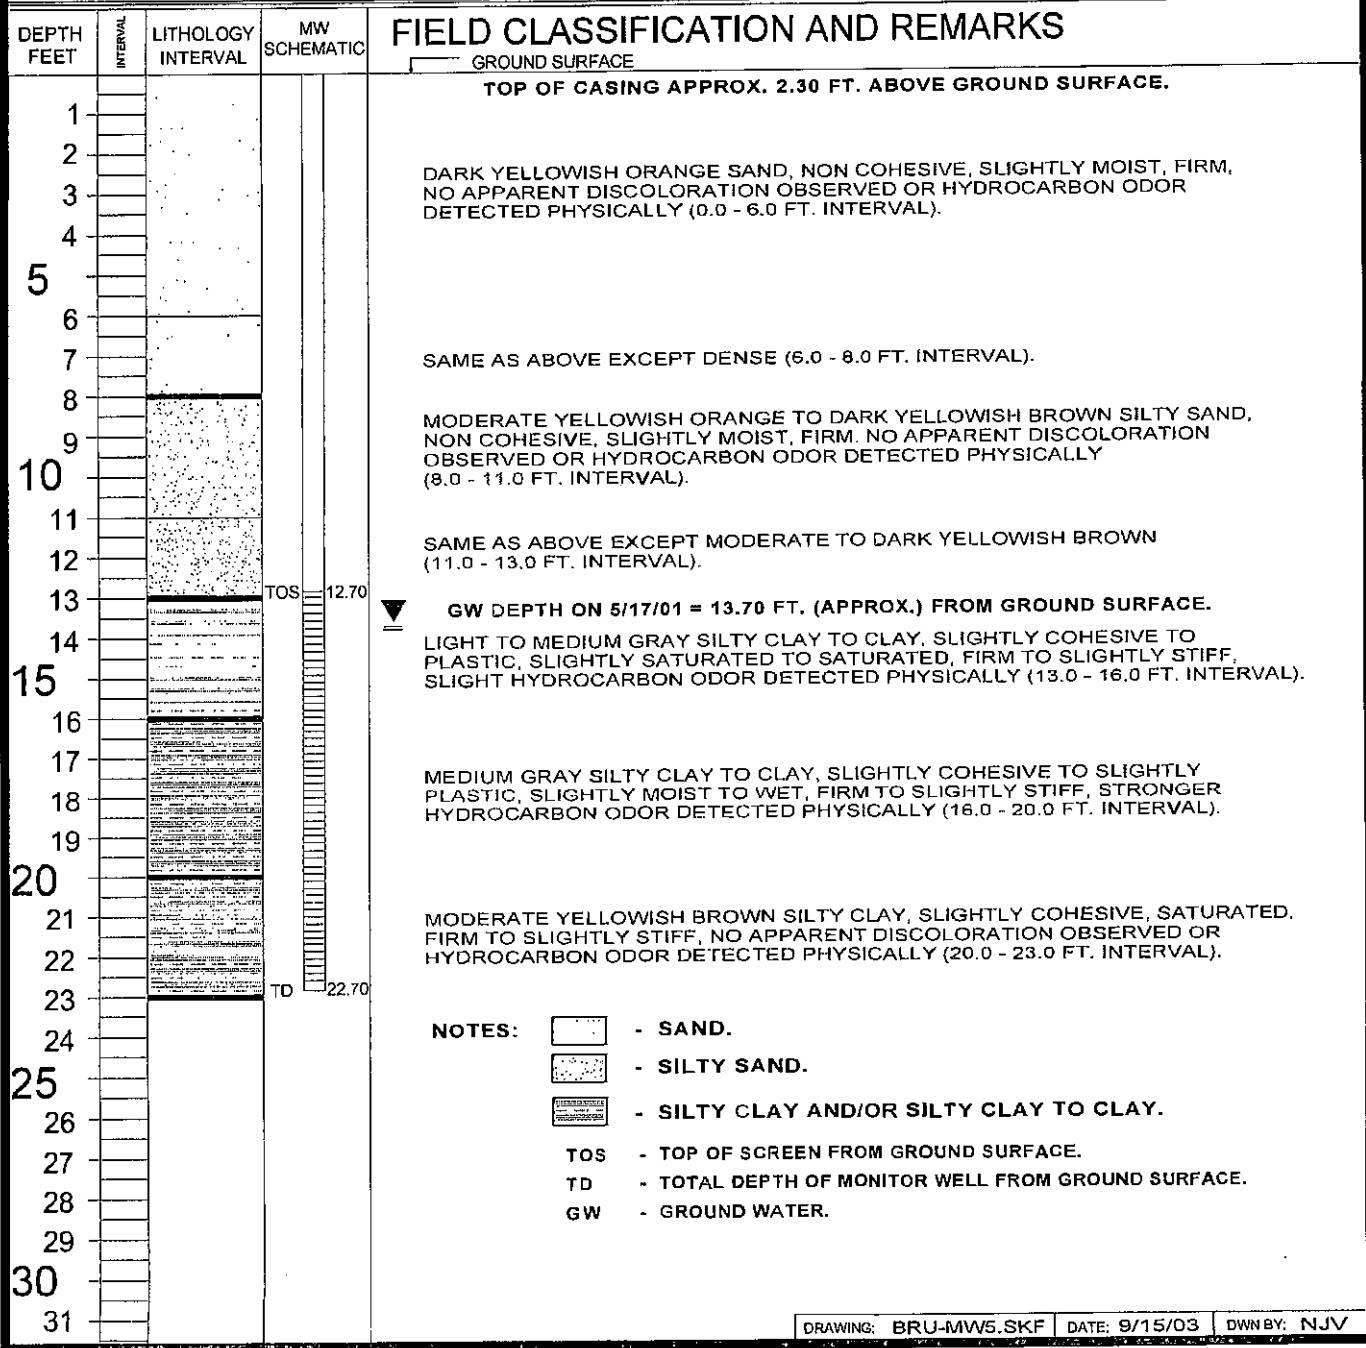
BORING #..... BH-5
 MW #..... 5
 PAGE #..... 5
 DATE STARTED 2/20/01
 DATE FINISHED 2/20/01
 OPERATOR..... JCB
 PREPARED BY NJV

LOCATION NAME: **BRUINGTON GC # 1**
 CLIENT: **XTO ENERGY INC.**
 CONTRACTOR: **BLAGG ENGINEERING, INC.**
 EQUIPMENT USED: **MOBILE DRILL RIG (EARTHPROBE)**
 BORING LOCATION: **N42E, 64.2 FEET FROM MW # 2R.**

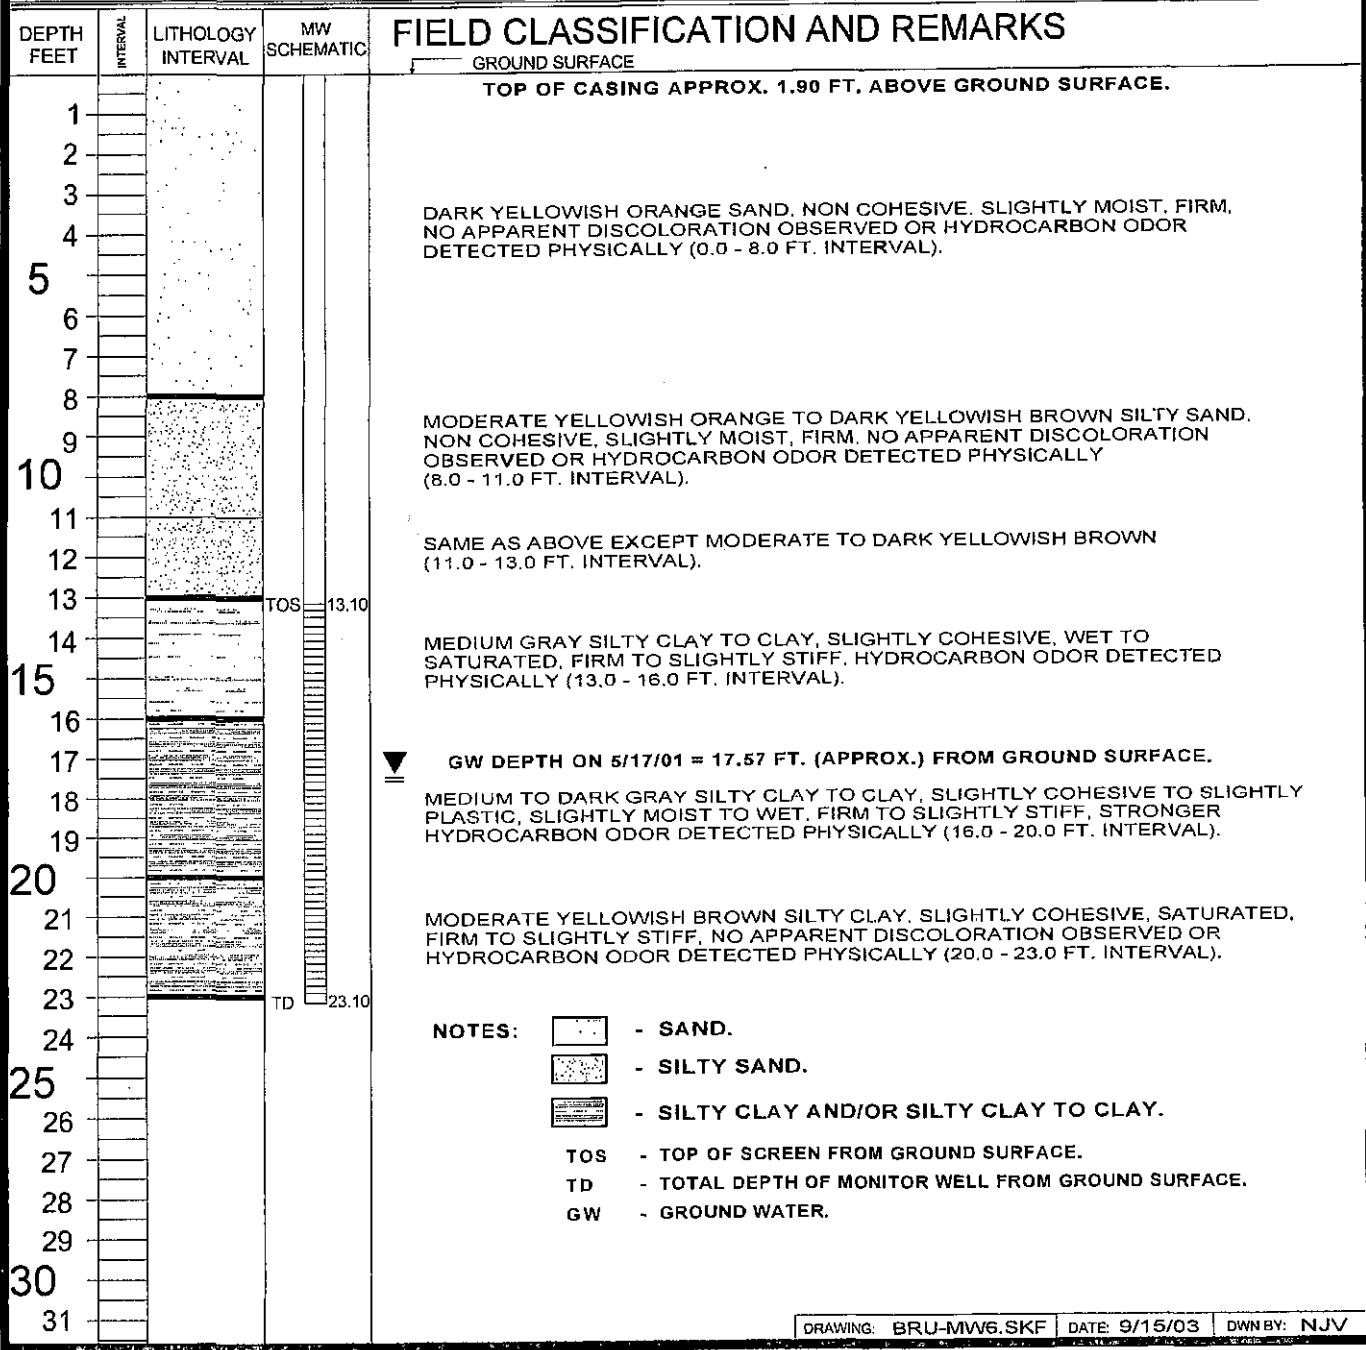
BORING #..... BH-6
 MW #..... 6
 PAGE #..... 6
 DATE STARTED 2/20/01
 DATE FINISHED 2/20/01
 OPERATOR..... JCB
 PREPARED BY NJV

LOCATION NAME: **BRUINGTON GC # 1**
 CLIENT: **XTO ENERGY INC.**
 CONTRACTOR: **BLAGG ENGINEERING, INC.**
 EQUIPMENT USED: **MOBILE DRILL RIG (EARTHPROBE)**
 BORING LOCATION: **N47E, 106.8 FEET FROM MW # 2R.**

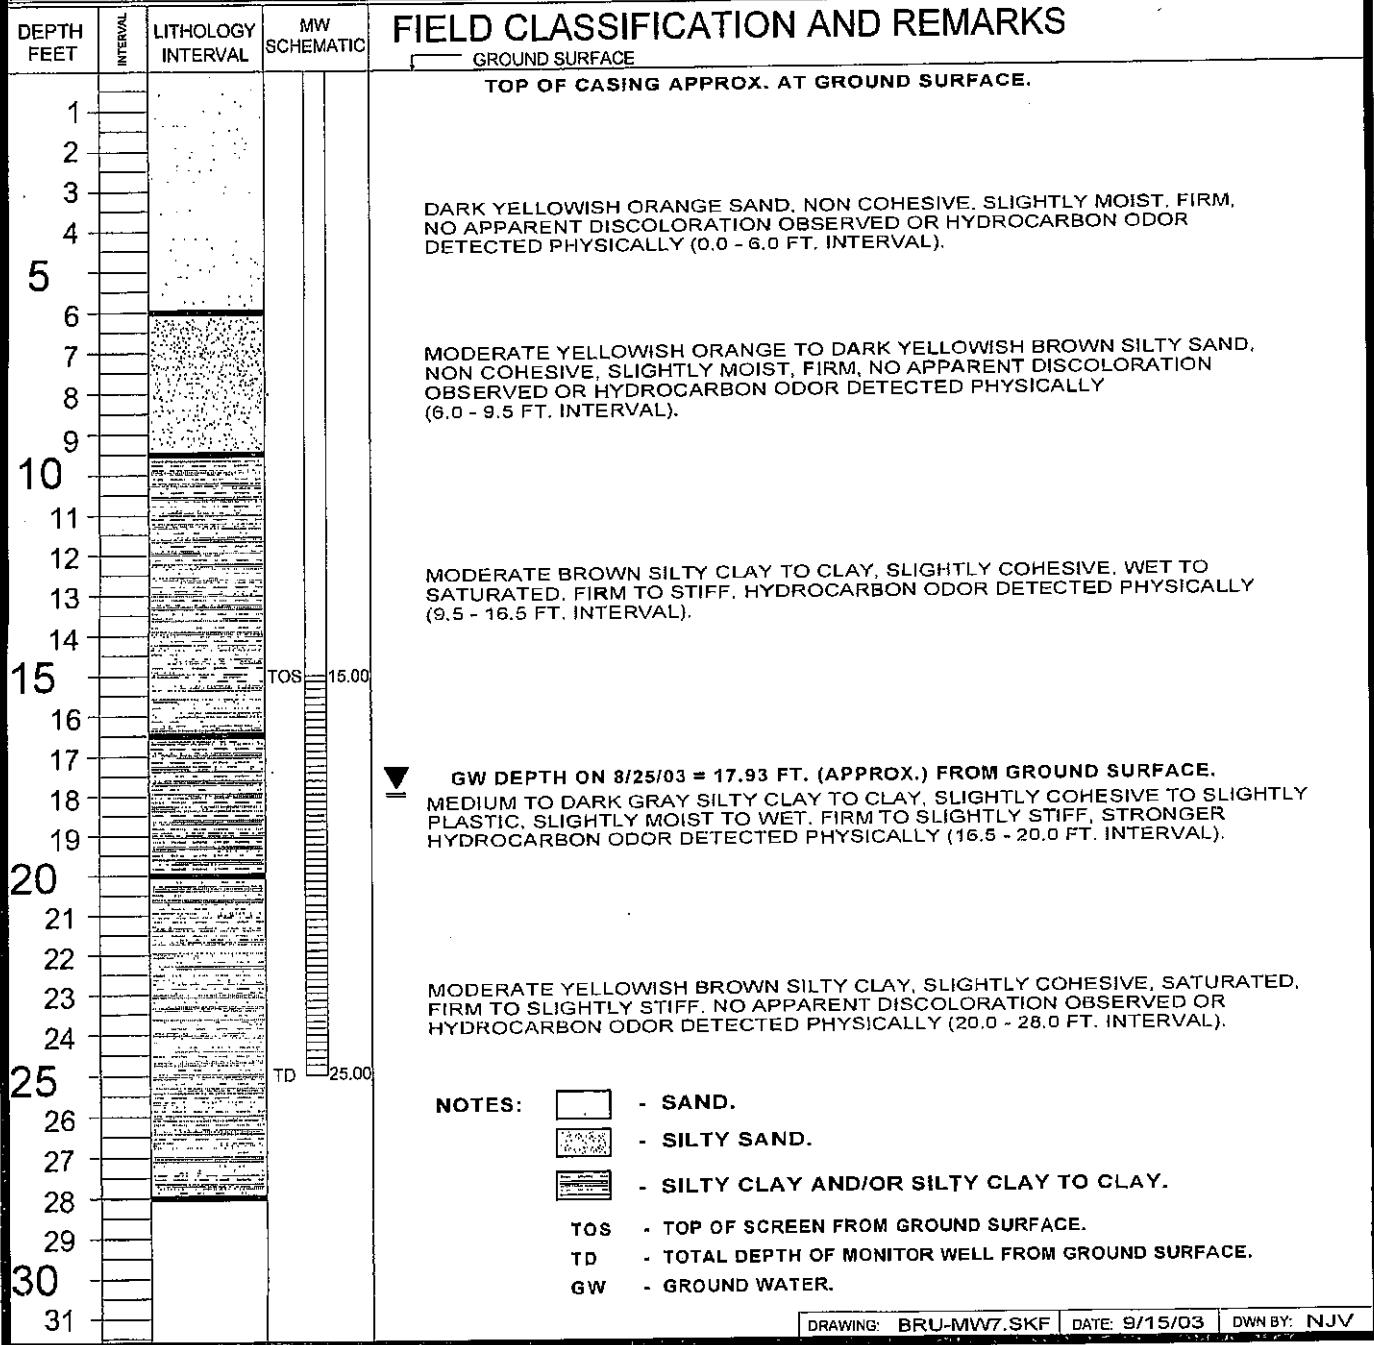
BORING #.....	BH - 7
MW #.....	7
PAGE #.....	7
DATE STARTED	7/10/03
DATE FINISHED	7/10/03
OPERATOR.....	JCB
PREPARED BY	NJV

LOCATION NAME: **BRUINGTON GC # 1**
 CLIENT: **XTO ENERGY INC.**
 CONTRACTOR: **BLAGG ENGINEERING, INC.**
 EQUIPMENT USED: **MOBILE DRILL RIG (EARTHPROBE)**
 BORING LOCATION: **S34.5E, 93 FEET FROM WELL HEAD.**
