# B-16-18-2-1-3-2-1-1 LINE LEAK Remediation Summary & Closure Report

**NMOCD Incident No. nAPP2406542880  
UL "P", Sec. 20, T23S, R21E  
32.282810, -103.794450  
Eddy County, New Mexico**

April 9, 2024

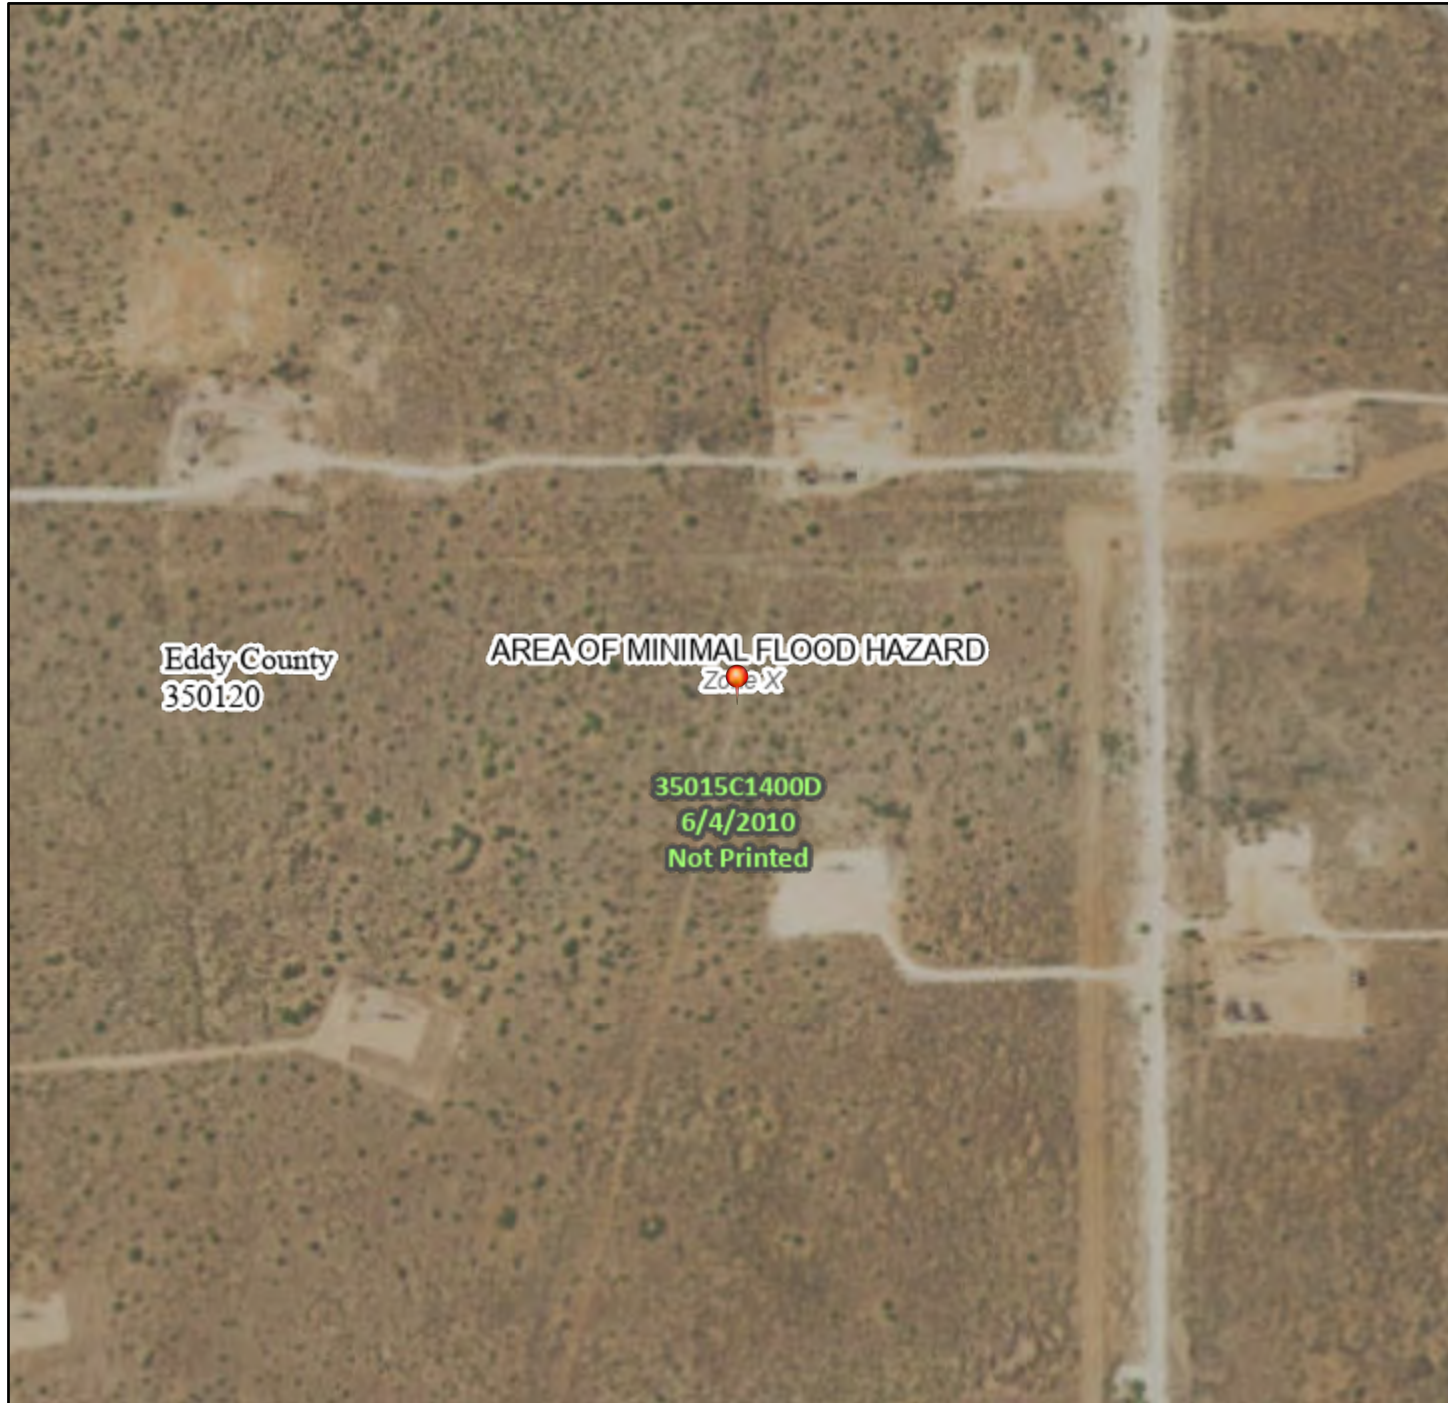
## Legend Figure 4

Review of flood map data published by the Federal Emergency Management Agency (FEMA) indicates the site is not located within a 100-year floodplain. A copy of the FEMA FIRMeTe Map can be found attached as Figure 4.
