NVA 215

## **Release Notification**

On 01/05/2023, Cross Timbers Energy, LLC reported a release at the NVA 215. The release was due to cold weather. The 2" hammer union froze and came apart on flowline. Approximately 4,049 sqft. of the Pasture was found to be damp upon initial inspection.

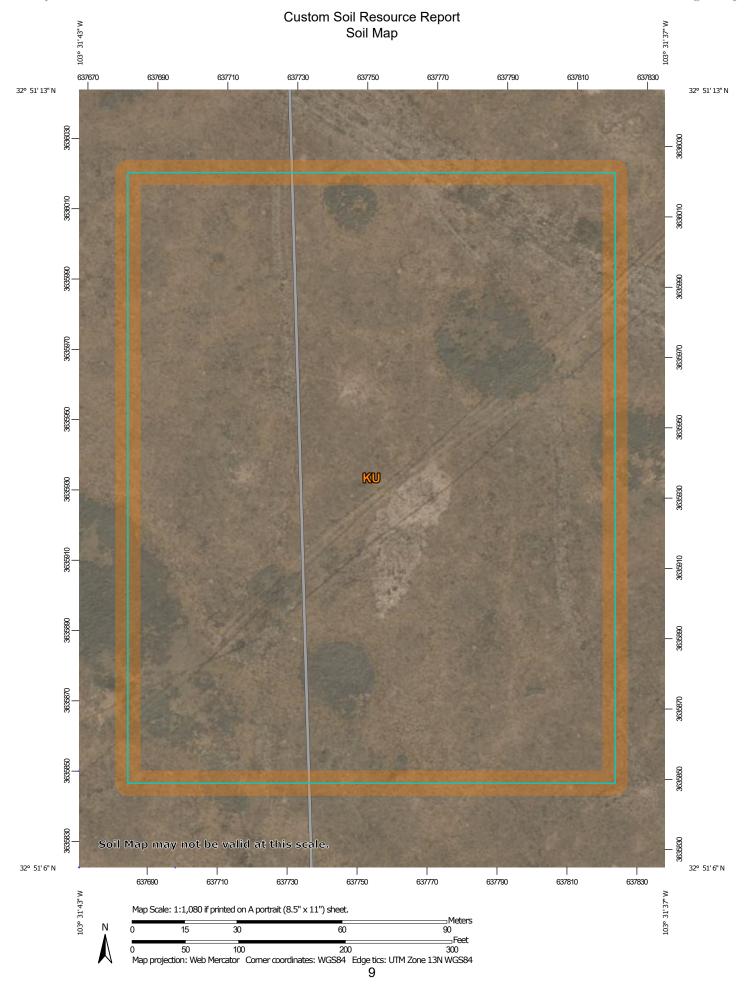
# Soil Map

The soil map section includes the soil map for the defined area of interest, a list of soil map units on the map and extent of each map unit, and cartographic symbols displayed on the map. Also presented are various metadata about data used to produce the map, and a description of each soil map unit.

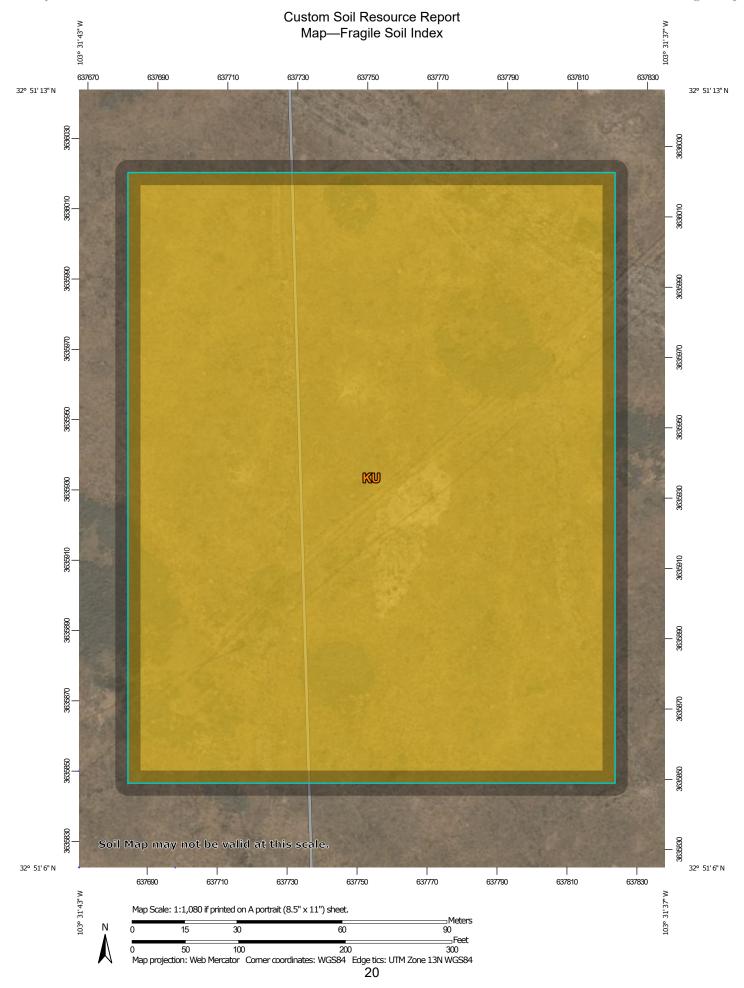
# Tables—Fragile Soil Index

Soils can be rated based on their susceptibility to degradation in the "Fragile Soil Index" interpretation. Fragile soils are those that are most vulnerable to degradation. In other words, they can be easily degradedthey have a low resistance to degradation processes. They tend to be highly susceptible to erosion and can have a low capacity to recover after degradation has occurred (low resilience). Fragile soils are generally characterized by a low content of organic matter, low aggregate stability, and weak soil structure. They are generally located on sloping ground, have sparse plant cover, and tend to be in arid or semiarid regions. The index can be used for conservation and watershed planning to assist in identifying soils and areas highly vulnerable to degradation.

The interpretive rating is based on soils that occur in the dominant land use for the map unit component and may not represent soils that occur in site-specific land uses.

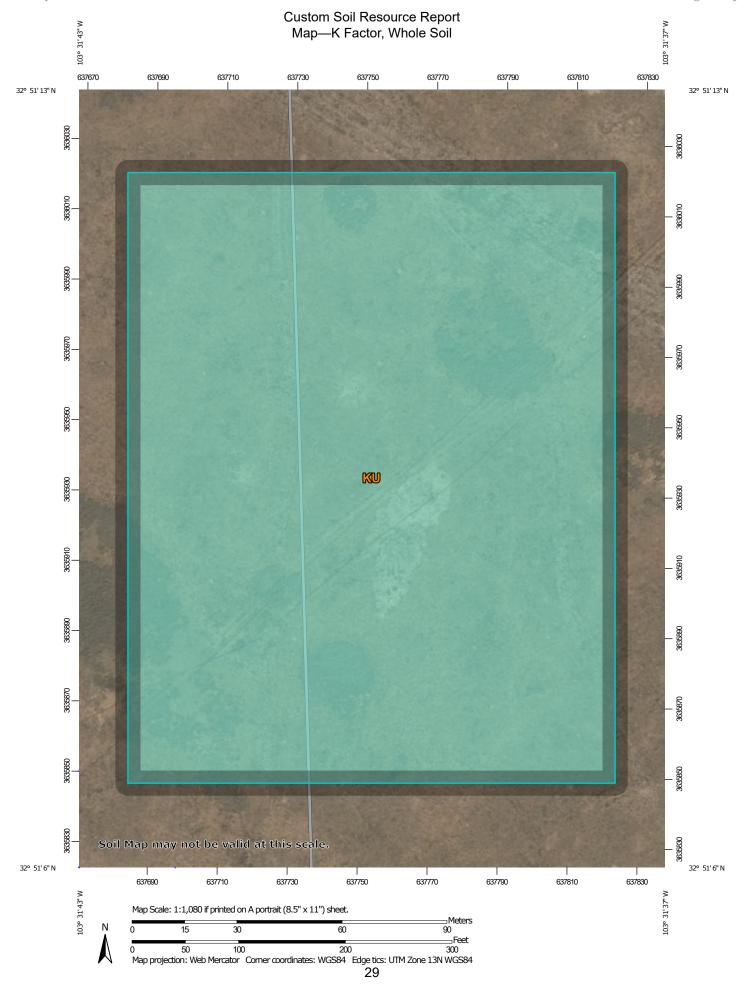
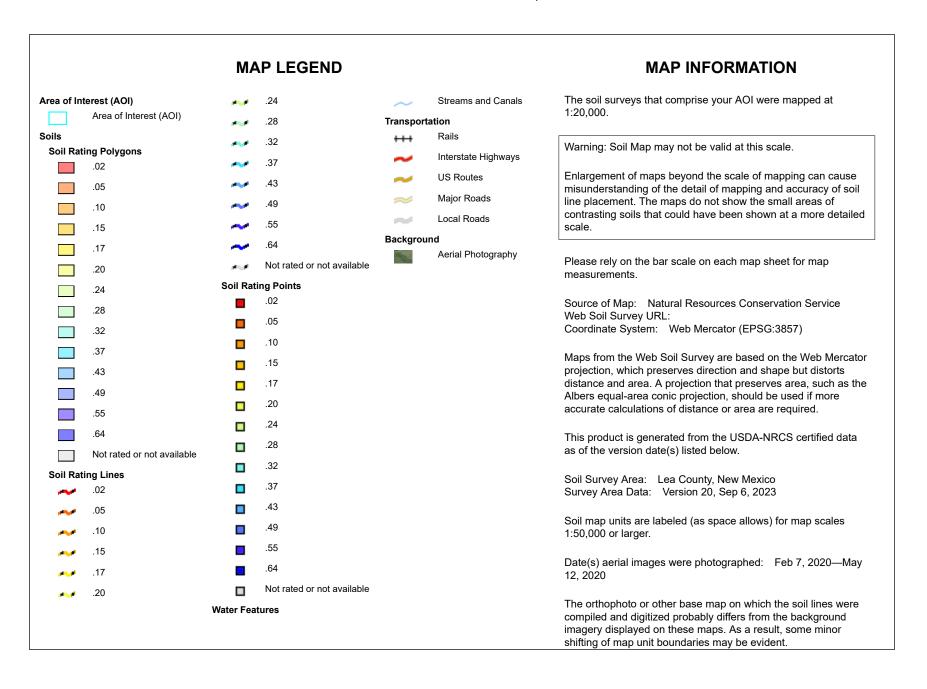
# Table—K Factor, Whole Soil

"Erosion factor Kw (whole soil)" indicates the erodibility of the whole soil. The estimates are modified by the presence of rock fragments.

Map unit symbol	Map unit name	Rating	Acres in AOI	Percent of AOI
KU	Kimbrough-Lea complex, dry, 0 to 3 percent slopes	.32	6.0	100.0%
Totals for Area of Interest			6.0	100.0%

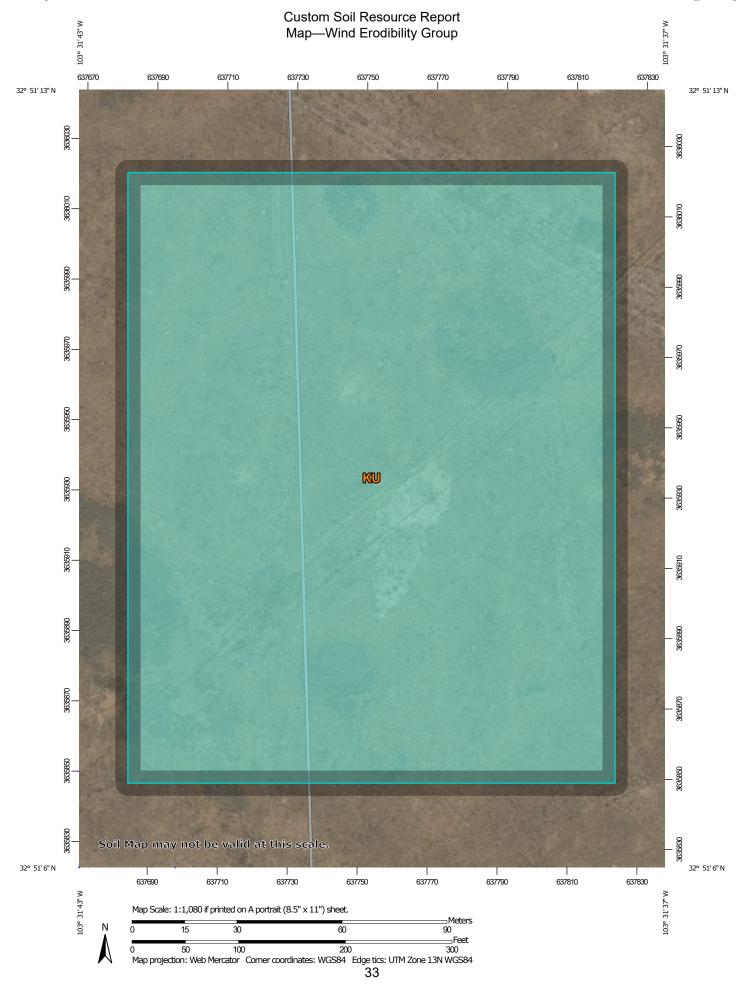
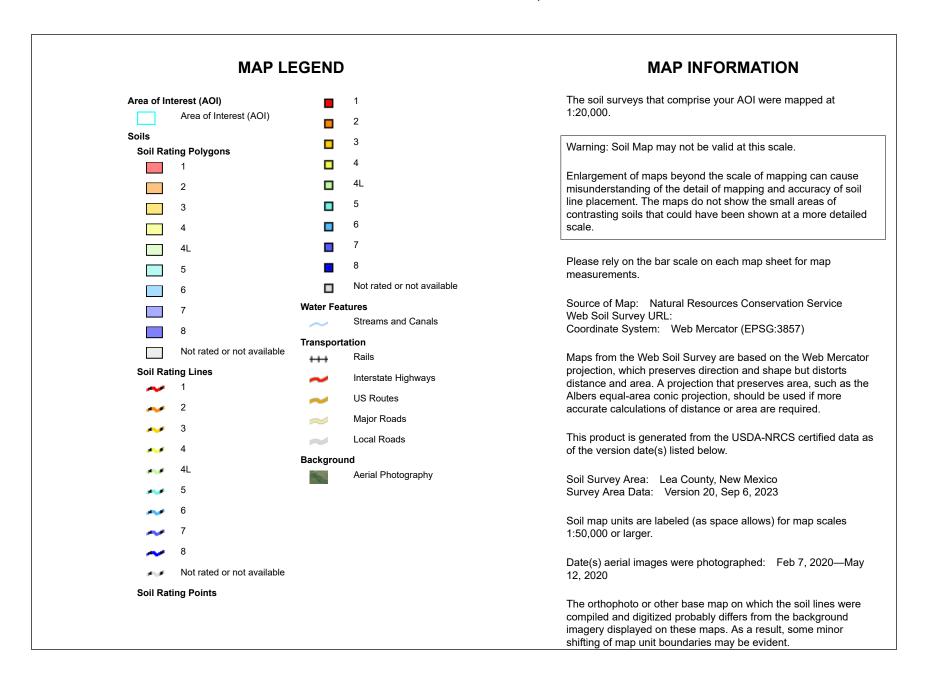
# Table—Wind Erodibility Group

A wind erodibility group (WEG) consists of soils that have similar properties affecting their susceptibility to wind erosion in cultivated areas. The soils assigned to group 1 are the most susceptible to wind erosion, and those assigned to group 8 are the least susceptible.

Map unit symbol	Map unit name	Rating	Acres in AOI	Percent of AOI	
KU	Kimbrough-Lea complex, dry, 0 to 3 percent slopes	5	6.0	100.0%	
Totals for Area of Interest			6.0	100.0%

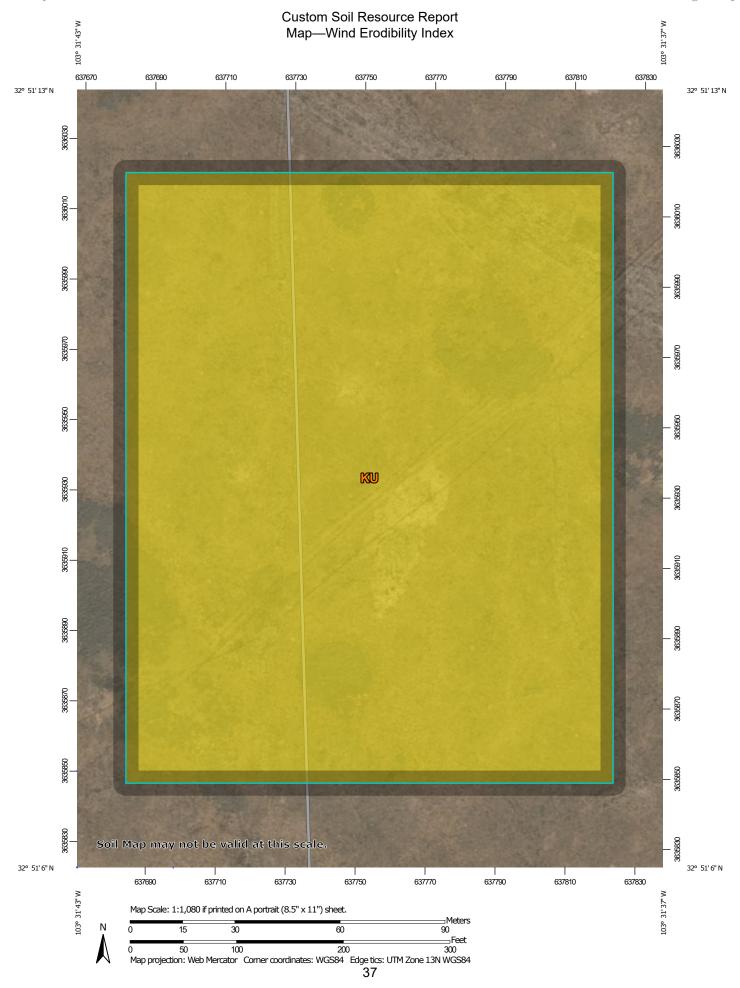
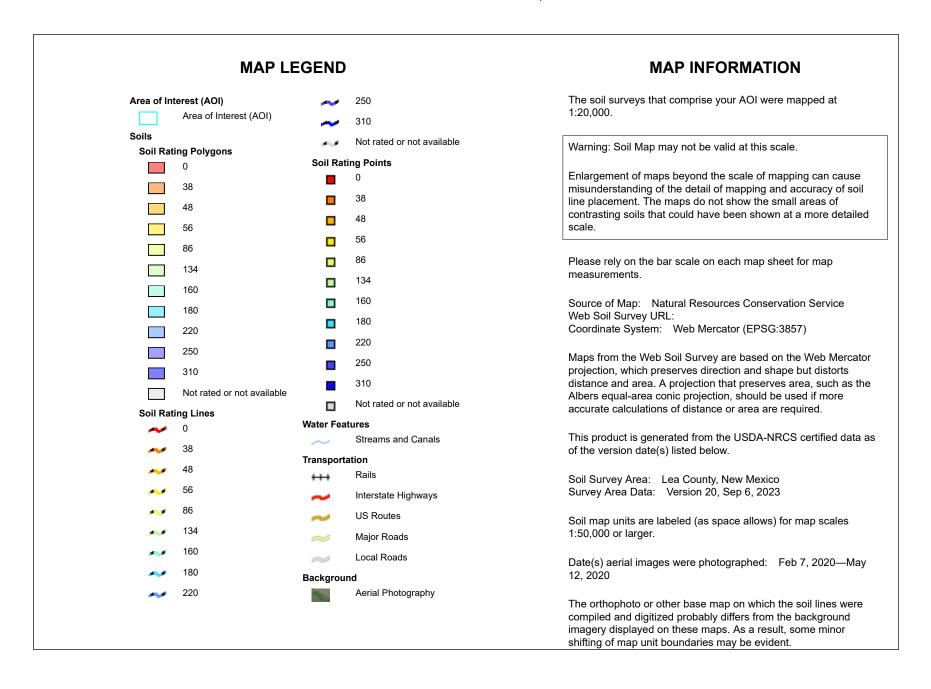
# **Table—Wind Erodibility Index**

The wind erodibility index is a numerical value indicating the susceptibility of soil to wind erosion, or the tons per acre per year that can be expected to be lost to wind erosion. There is a close correlation between wind erosion and the texture of the surface layer, the size and durability of surface clods, rock fragments, organic matter, and a calcareous reaction. Soil moisture and frozen soil layers also influence wind erosion.

Map unit symbol	Map unit name	Rating (tons per acre per year)	Acres in AOI	Percent of AOI
KU	Kimbrough-Lea complex, dry, 0 to 3 percent slopes	56	6.0	100.0%
Totals for Area of Interest			6.0	100.0%

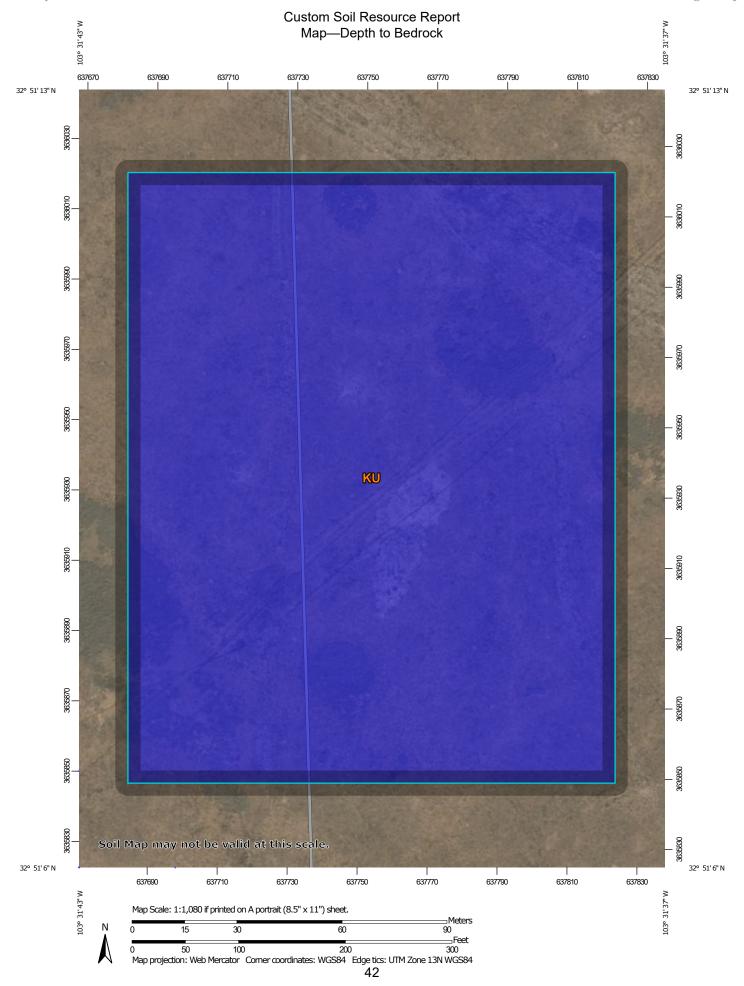
# Table—Depth to Bedrock

Depth to bedrock is actually recorded as three separate values in the database. A low value and a high value indicate the range of this attribute for the soil

component. A "representative" value indicates the expected value of this attribute for the component. For this soil property, only the representative value is used.

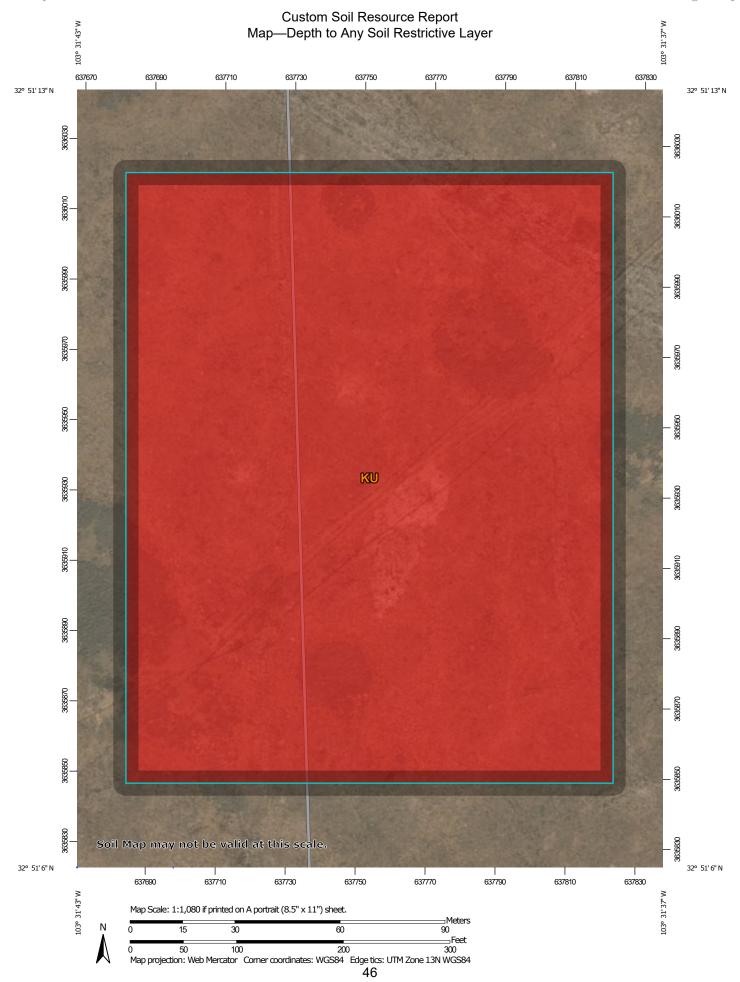
# Table—Depth to Any Soil Restrictive Layer

This theme presents the depth to any type of restrictive layer that is described for each map unit. If more than one type of restrictive layer is described for an individual soil type, the depth to the shallowest one is presented. If no restrictive layer is described in a map unit, it is represented by the "greater than 200" depth class.
