From: Zack Thomas <zthomas@mewbourne.com>
Sent: Tuesday, September 18, 2018 8:46 AM
To: Bratcher, Mike, EMNRD <mike.bratcher@state.nm.us>
Cc: Griswold, Jim, EMNRD <Jim.Griswold@state.nm.us>
Subject: Queen 23 24 Water Transfer Line 2RP-4712

From: [Zack Thomas](#)
To: [Bratcher, Mike, EMNRD](#)
Cc: [Griswold, Jim, EMNRD](#); [Pruett, Maria, EMNRD](#)
Subject: [EXT] RE: 2RP-4712 & 2RP-4730
Date: Thursday, November 1, 2018 10:04:25 AM
Attachments: [image001.png](#)
[image002.png](#)
[\(3\) 2RP-4712 & 2RP-4730 Background Sample Locations & Results.pdf](#)

CLIENT: Souder, Miller & Associates
Project: Queenie BGs

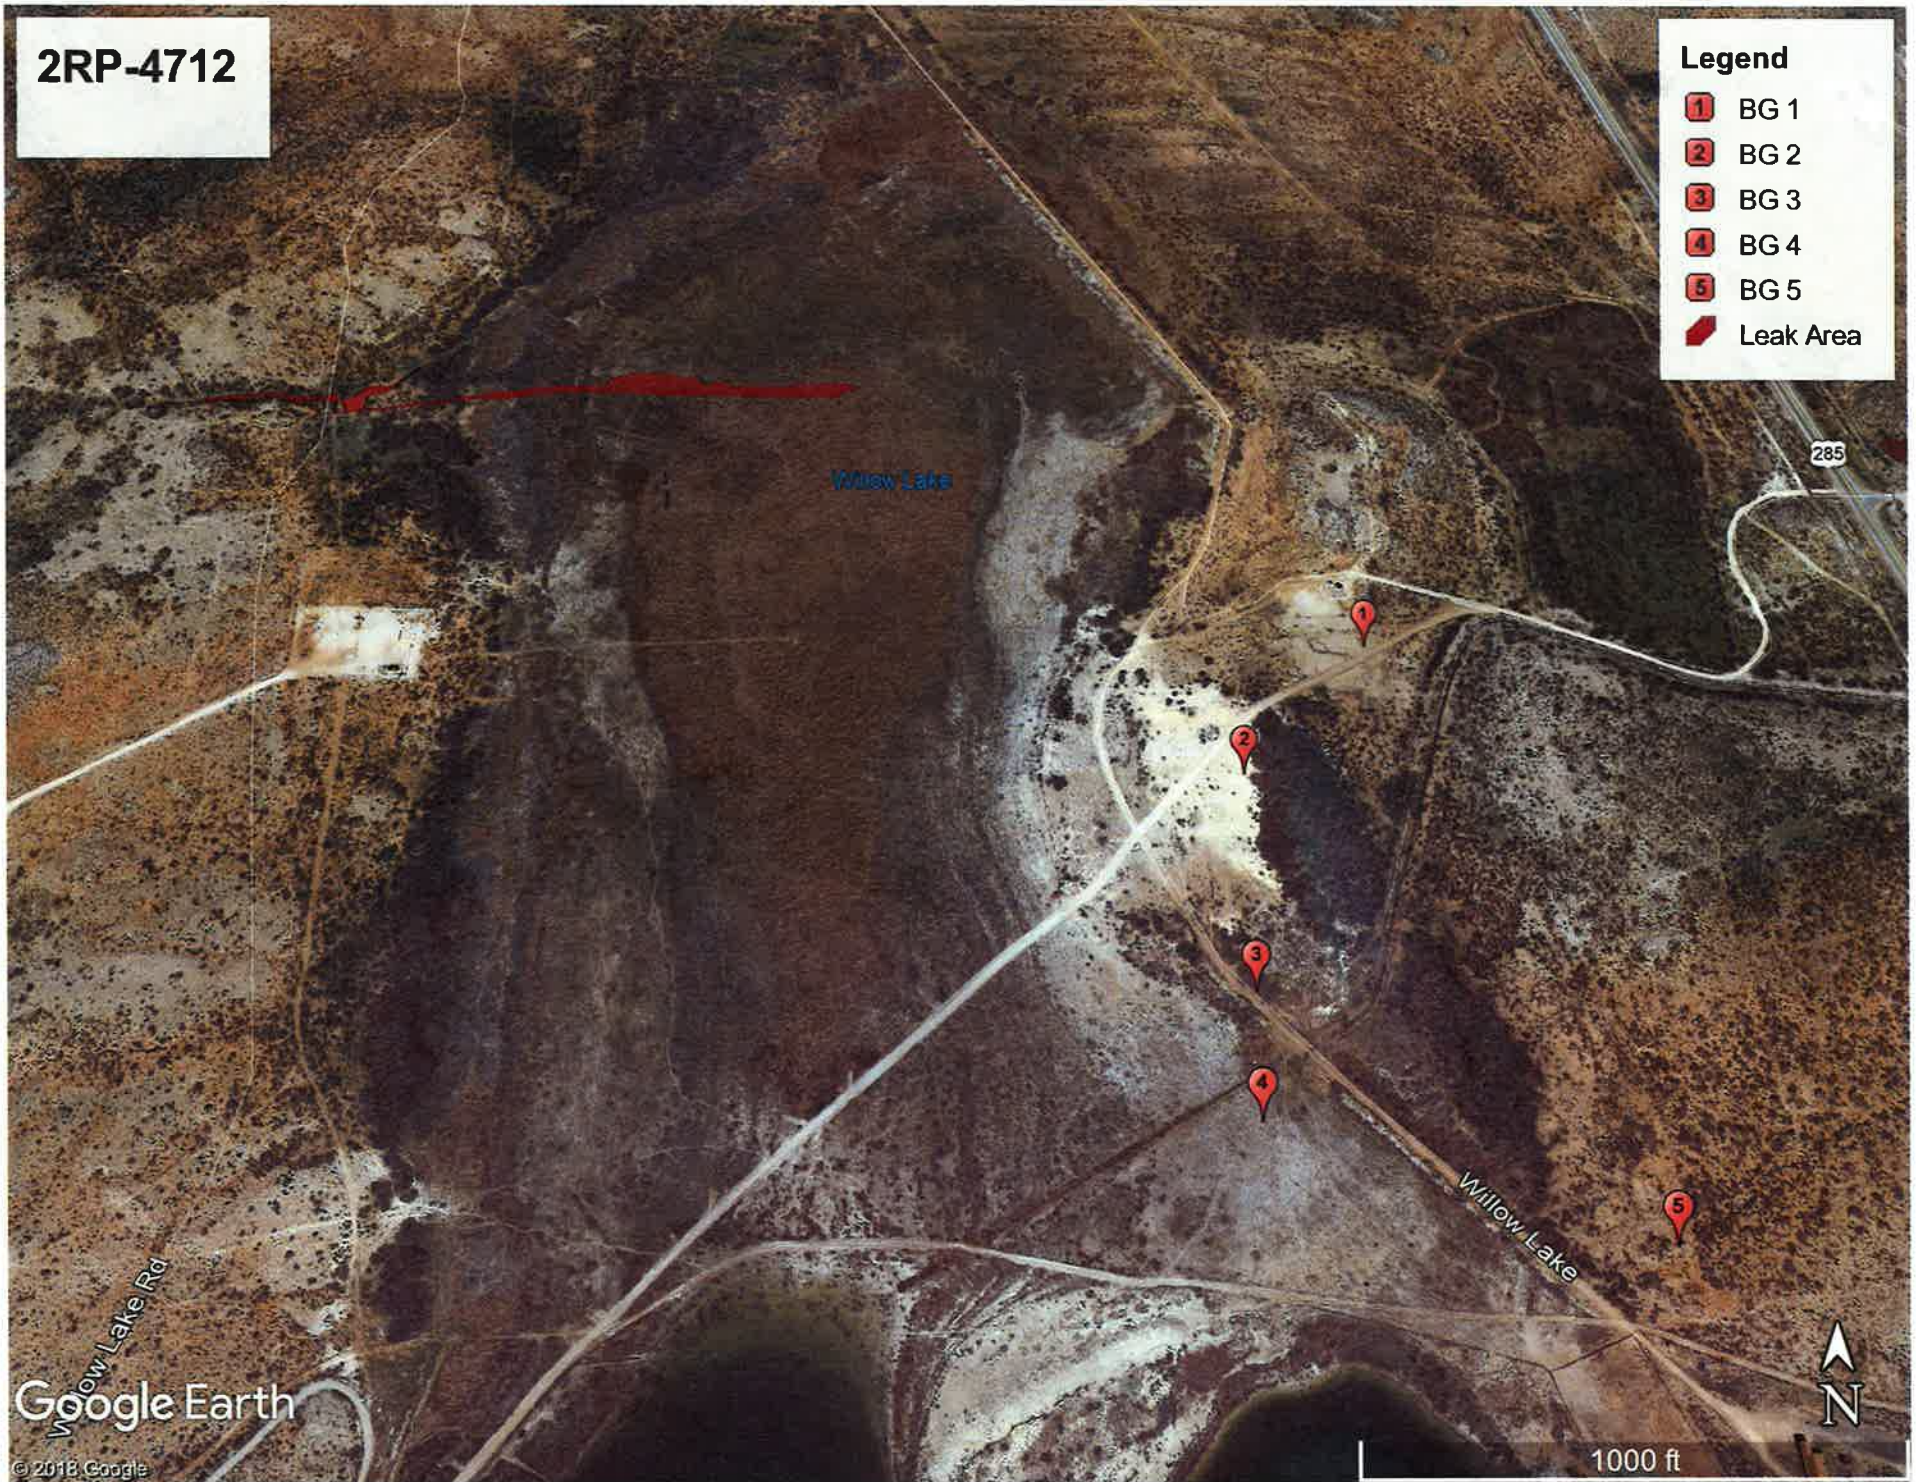
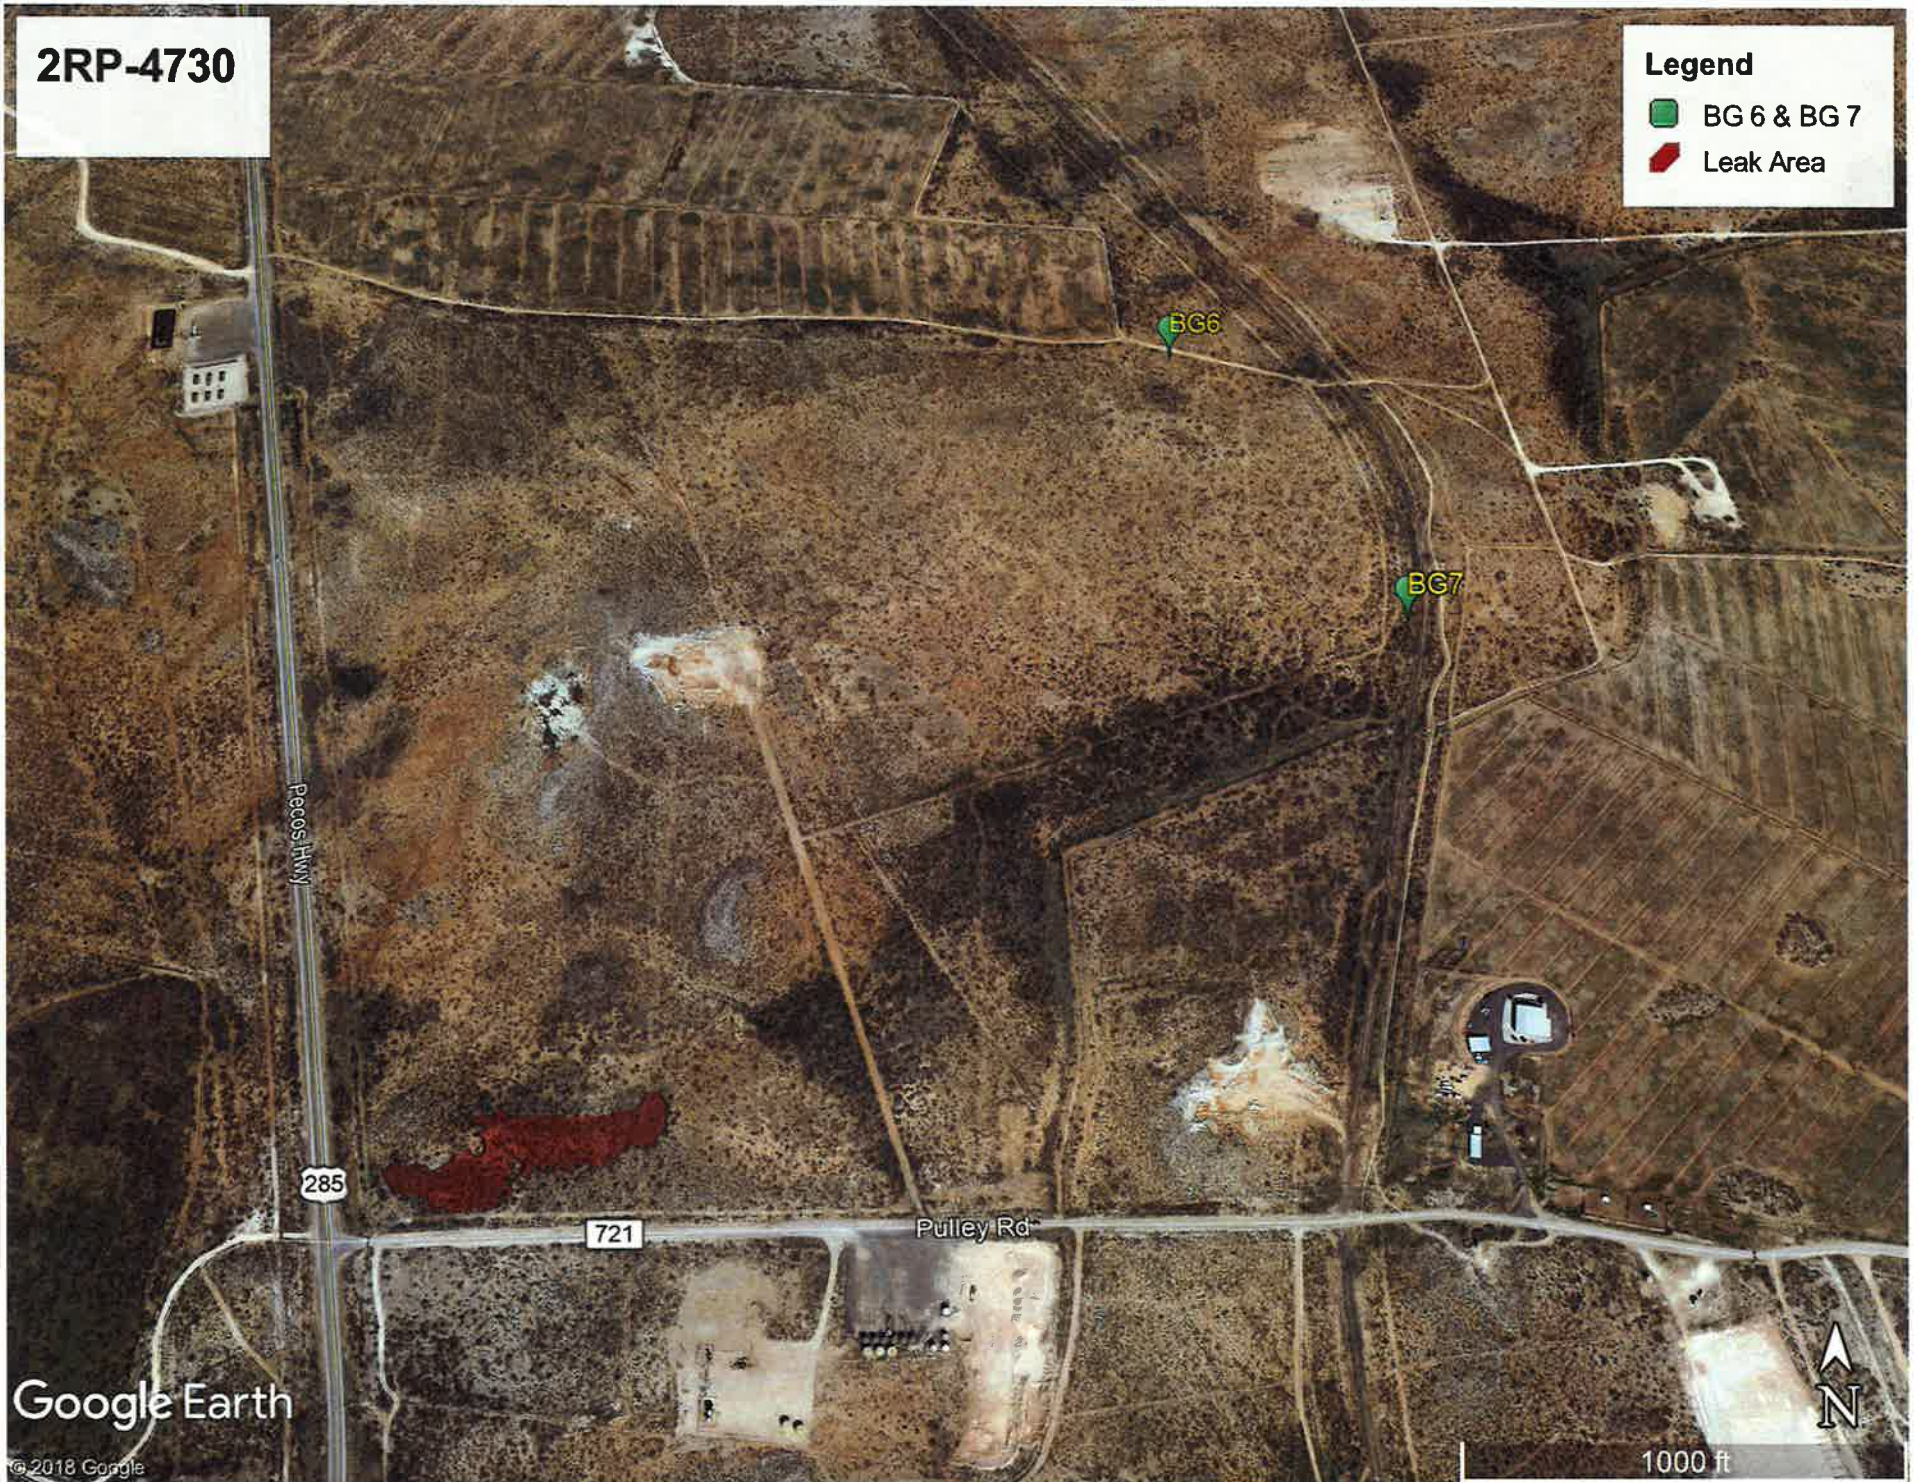
We collected 7 background samples from the area around these two leaks. I've attached the KMZ files and the lab data for said backgrounds. BG5 (3000 ppm) & BG6 (1000 ppm) tested positive for elevated chlorides. With this in mind, do we have grounds to request that we only need to clean up to these background levels?

Sample Point	Depth	Chloride Levels
BG1	0.5'	28000
BG1	1'	ND
BG2	0.5'	ND
BG2	1'	ND
BG3	Surface	ND
BG3	0.5'	ND
BG3	1'	ND
BG4	0.5'	ND
BG5	1	3000
BG6	1	1000
BG7	1	ND

You need to go ahead and submit remediation proposals, individually, for each release. I can save you some time by telling you that 28,000 is not going to be accepted as a background level, even in this area. OCD will review proposals, closures, etc. as they come in, pursuant to 19.15.29, so please submit a complete packet for each release.

This should be in the correct format in order for you all to see exactly where our hotspots are located and also how hot they actually are. I built this packet not meant as a remediation plan but as an info packet showing you that there are natural chlorides in the area and whenever it rains, it mostly likely drains straight into Willow Lake. That is why I believe all sample points taken are relevant to the release and should be taken into account. All I'm trying to accomplish is getting approval to only have to clean-up to already natural occurring chloride levels. Please get back to me asap. thanks
