Re: Third Quarter 2024 – SVE System Update

Sullivan GC D #1E
San Juan County, New Mexico
Hilcorp Energy Company
NMOCD Incident Number: NCS1518952648

Ensolum, LLC (Ensolum), on behalf of Hilcorp Energy Company (Hilcorp), presents this *Third Quarter 2024 – SVE System Update* report summarizing the soil vapor extraction (SVE) system performance at the Sullivan GC D #1E natural gas production well (Site), located in Unit F of Section 26, Township 29 North, Range 11 West in San Juan County, New Mexico (Figure 1). Specifically, this report summarizes Site activities performed in July, August, and September of 2024 to the New Mexico Oil Conservation Division (NMOCD).

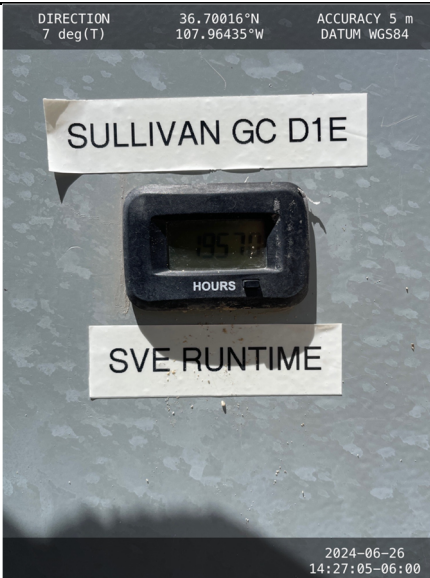
<p>Photograph 1</p> <p>Runtime meter taken on June 26, 2024 at 2:27 PM Hours = 19,570</p>

<p>Photograph 1 shows a digital runtime meter mounted on a metal surface. Above the meter is a white label that reads "SULLIVAN GC D1E". Below the meter is another white label that reads "SVE RUNTIME". The meter's display shows "19570". The meter has a black casing and a small screen. The background is a metallic, slightly textured surface. At the top of the image, there is a black header bar with white text: "DIRECTION 7 deg(T)", "36.70016°N 107.96435°W", and "ACCURACY 5 m DATUM WGS84". At the bottom right, there is a timestamp: "2024-06-26 14:27:05-06:00".</p>
<p>Photograph 2</p> <p>Runtime meter taken on September 16, 2024 at 2:36 PM Hours = 21,519</p>

photographs of the runtime meter for calculating the runtime efficiency. Table 1 presents the SVE system operational hours and percent runtime.
