# **Dugan Production Corp**

## **Spill Closure Report and Site Characterization**

**Satchmo Com # 001**

Incident ID: nAPP2222355993

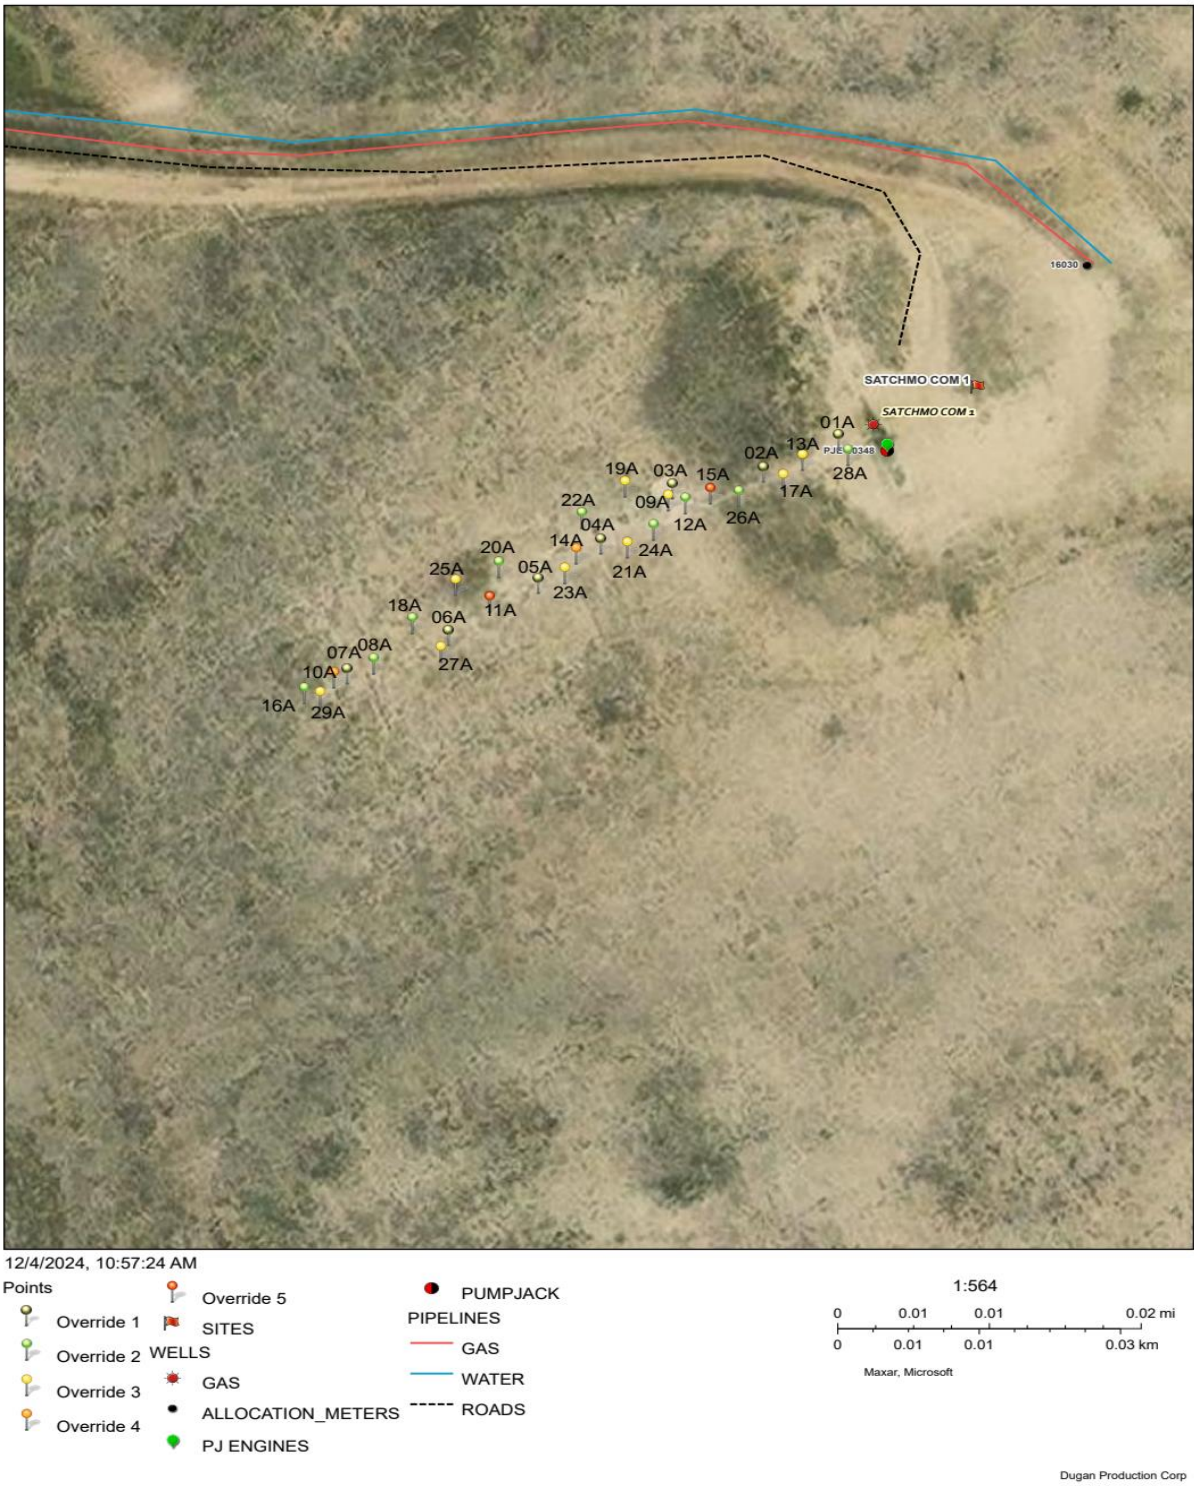
Map 3: Final Sample Diagram

**Appendix A: Map 3** is a map identifying the approximate final soil sample locations and depicts the approximate dimensions of the spill area with respect to the well location. Photographic documentation of the remediation is included in **Appendix C: Figure 3 & Appendix C: Figure 4**.

On October 1, 2024, the final sampling was performed at the Site. The NM OCD was notified of the collection of samples which no representative was present during collection. Composite samples E410004-01A through E410004-07A were collected from the surface area within the spill perimeter. Composite samples E410004-08A, and E410004-12A were collected at a depth of six inches within the spill perimeter. Composite samples E410004-16A, E410004-18A, E410004-20A, E410004-22A, E410004-24A, E410004-26A and E-410004-28A were collected at a depth of six inches outside of the spill perimeter. Composite samples E410004-09A and E410004-13A were collected at a depth of twelve inches within the spill perimeter. Composite samples E410004-17A, E410004-19A, E410004-21A, E410004-23A, E410004-25A, E410004-27A, and E410004-29A were collected at a depth of twelve inches outside of the spill perimeter. Composite samples E410004-10A and E410004-14A were collected at a depth of twenty-four inches within the spill perimeter. Composite sample E410004-10A and E410004-14A were collected at a depth of eighteen inches within the spill perimeter.

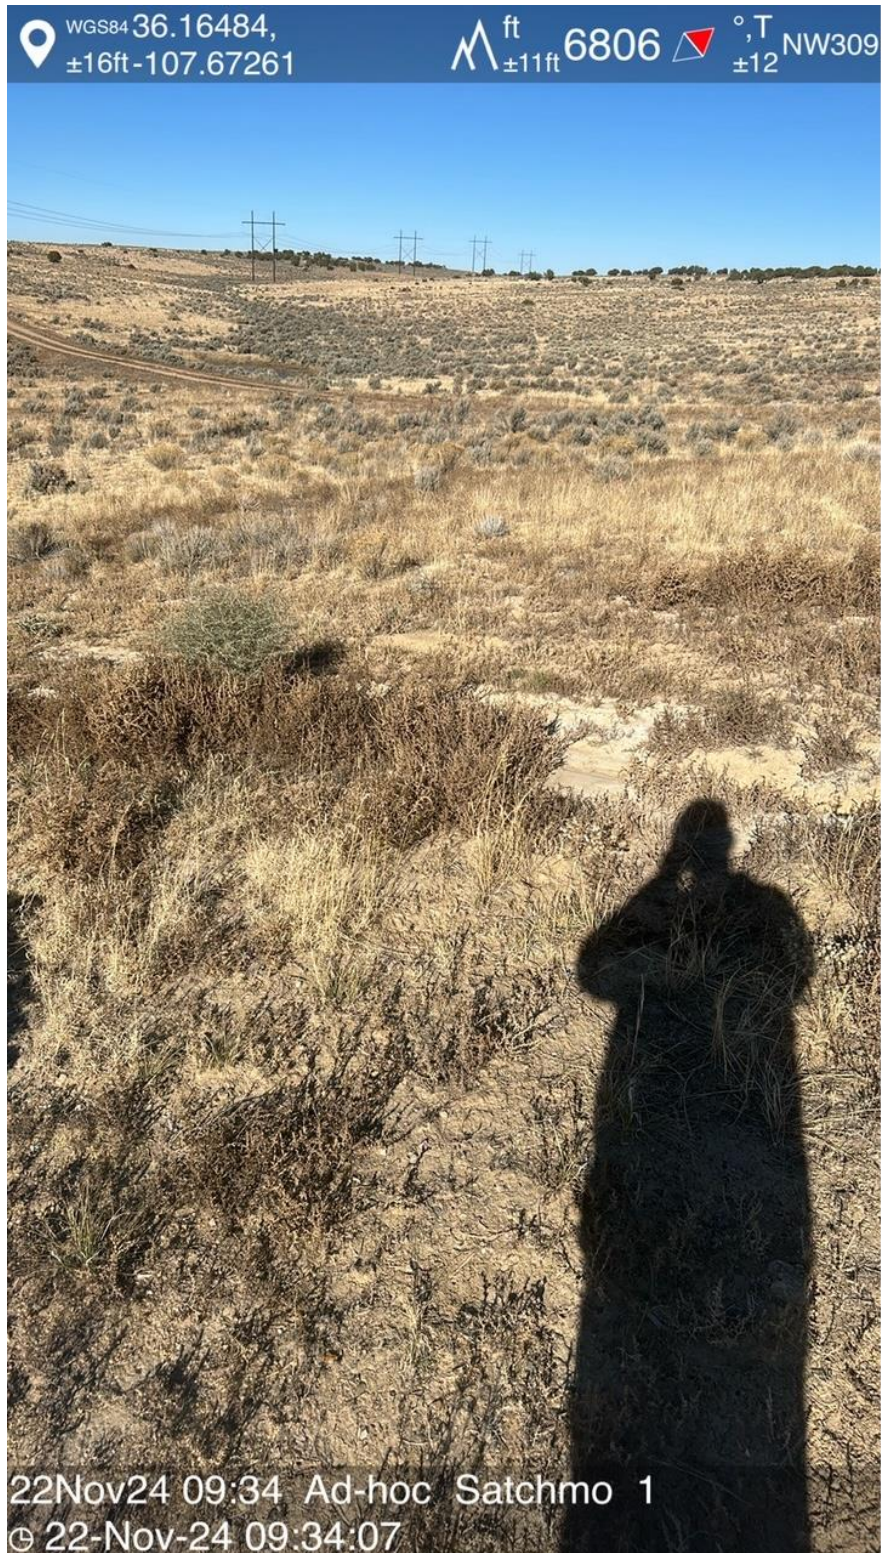
Figure 3: Spill Area After Reclamation

Dugan has restored the impacted surface area to the condition that existed prior to the release. Restoration of the Site includes the replacement of treated soil to the relative positions and contoured to the topography of the area. The disturbed area contains a minimum of four feet of non-waste containing, uncontaminated, earthen material with chloride concentrations less than 600 mg/kg as analyzed by EPA Method 300.0/9056A. The topsoil cover includes a top layer, which is suitable material to establish vegetation at the Site. The disturbed area was reseeded with a uniformed vegetative cover was established that reflects a life-form ratio within range of the total percent plant cover of the minimum seventy percent of pre-disturbance levels, excluding noxious weeds. Reclamation photos are included in **Appendix C: Figure 3 & Appendix C: Figure 4**.

Approximately 2,800 ft<sup>2</sup> of petroleum hydrocarbon-affected soils were treated with gypsum and soaked with fresh water for remediation. The soil was re-placed, contoured to match area topography, and seeded uniformly with the established vegetation of the area.
