December 10, 2024

**Re: Reclamation Report
ConocoPhillips
Airacuda 31 Federal #002H Flare Fire Release
Unit Letter B, Section 31, Township 25 South, Range 33 East
DOR: 10/18/2023
Approximate Release Point 32.093131, -103.609394
Lea County, New Mexico
Incident ID: NAPP2329636934**

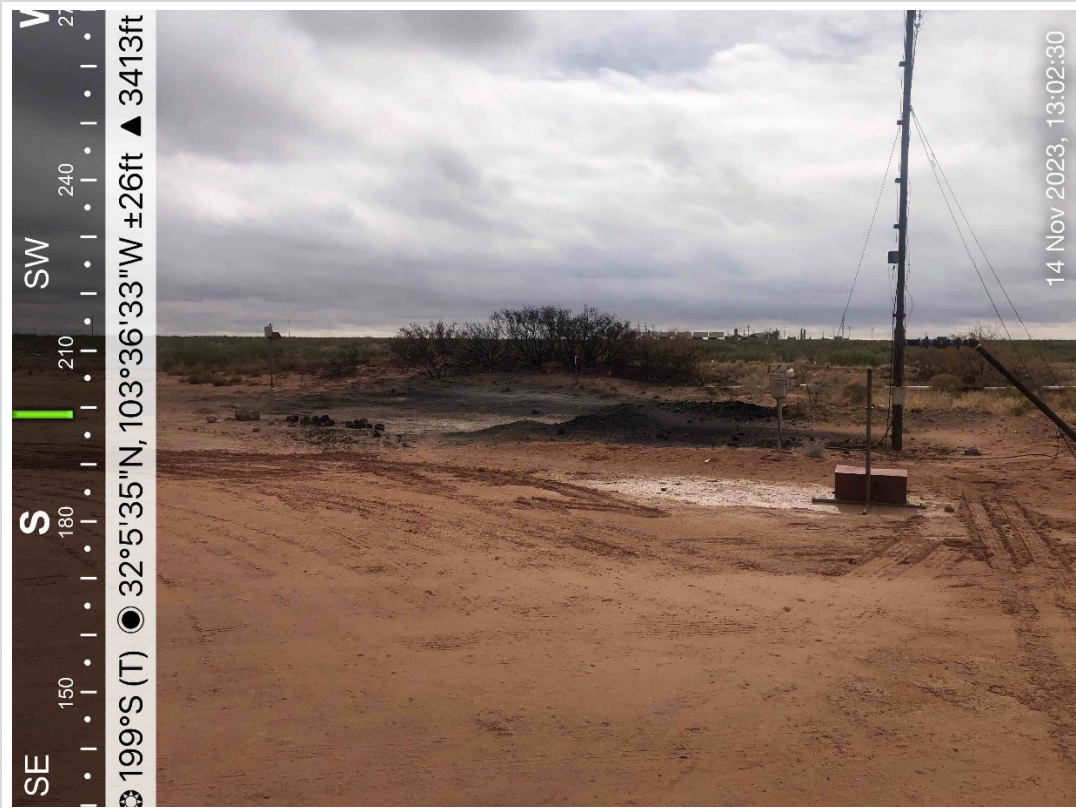
TETRA TECH, INC. PROJECT NO. 212C-MD-03266	DESCRIPTION	View south-southwest. View of approximate release point. View of release before surface scrape.	7
	SITE NAME	AIRACUDA 31 FEDERAL 2H FLARE FIRE Release	11/14/2023

The observed release extent consisted of approximately 3,476 square feet; however, the surface scrape was conducted over an area of approximately 5,000 square feet. As shown in Appendix D, the release was limited to the shallow surface and was not consistent in shape. Samples were collected such that each discrete sample (horizontal and vertical) was representative of approximately 200 square feet of remediated area. A total of eight (8) floor sample locations and eight (8) sidewall sample locations were used during the sampling activities. Confirmation sidewall sample locations were labeled with “SW”-#, and confirmation floor sample locations were labeled with “FS”-#. Analytical results for all confirmation soil samples (floor and sidewall) were below the applicable Site RRALs for chloride, BTEX, and TPH. The results of the 2023 confirmation sampling events are summarized in Table 2. Laboratory analytical data is included in Appendix C. The initial response remedial action was successful in removing the contaminant mass to meet the standards of Table I of 19.15.29.12 NMAC.

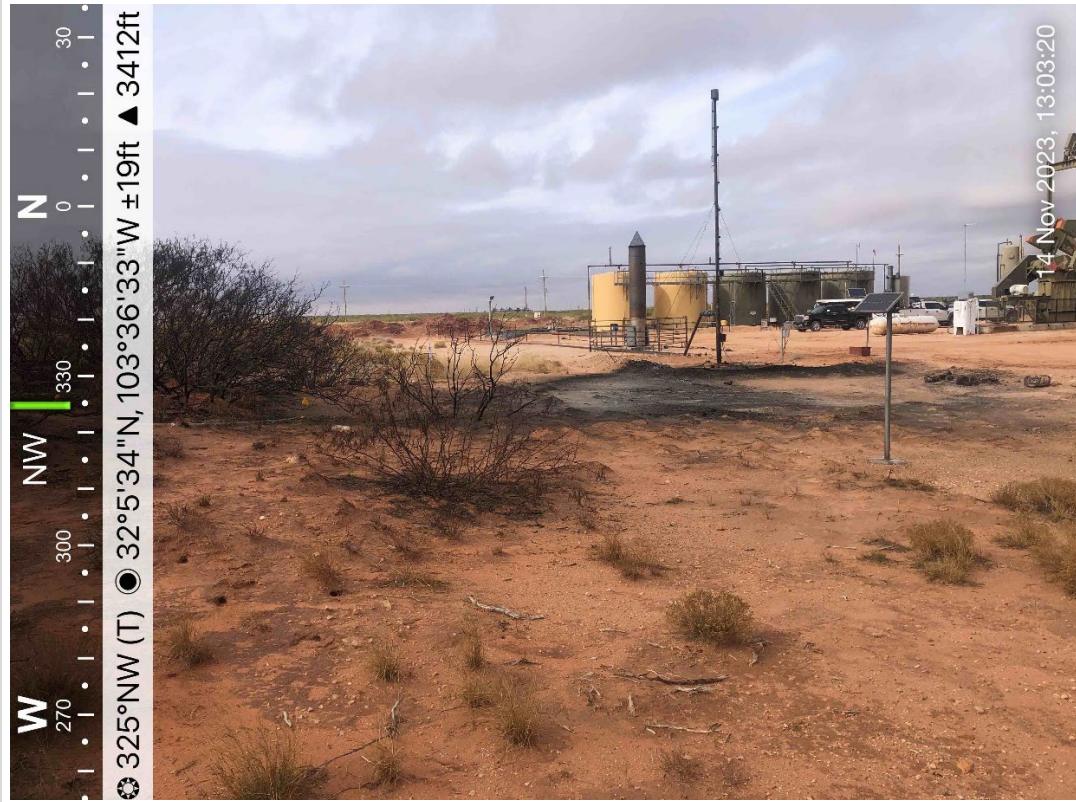
TETRA TECH, INC. PROJECT NO. 212C-MD-03266	DESCRIPTION	View northwest of site conditions before surface scrape.	8
	SITE NAME	AIRACUDA 31 FEDERAL 2H FLARE FIRE Release	11/16/2023

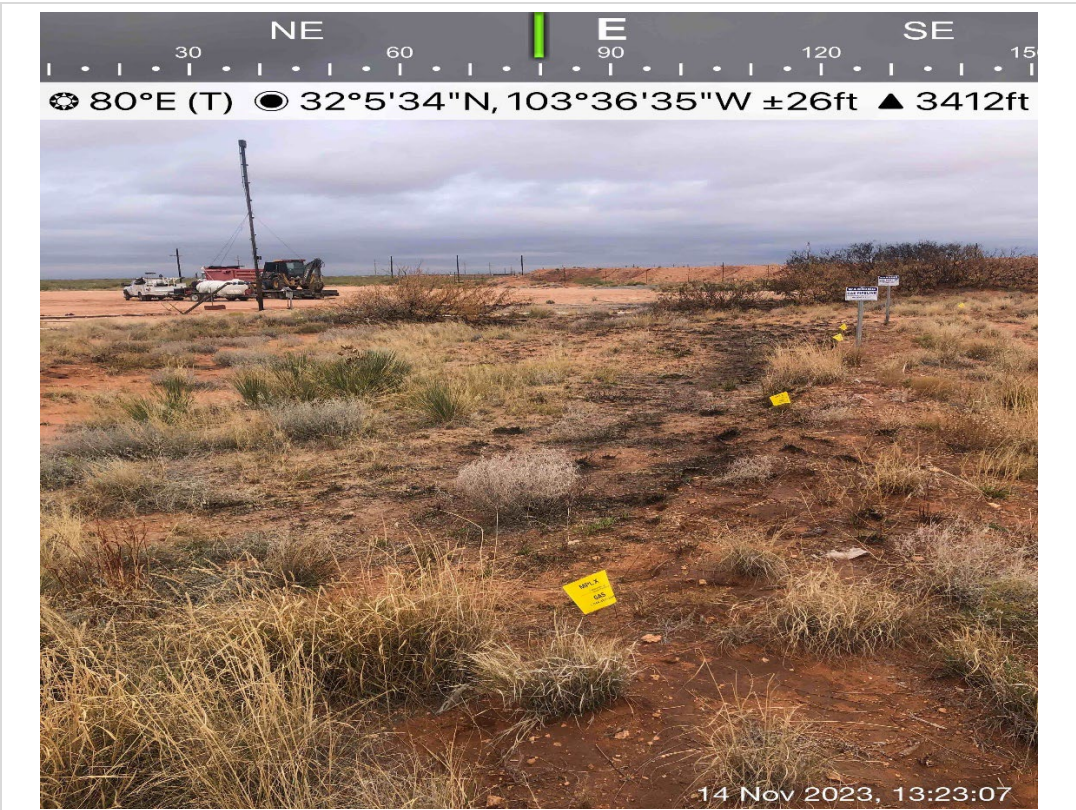
TETRA TECH, INC. PROJECT NO. 212C-MD-03266	DESCRIPTION	View northeast. View site conditions before surface scrape of approximate release area.	10
	SITE NAME	AIRACUDA 31 FEDERAL 2H FLARE FIRE Release	11/14/2023

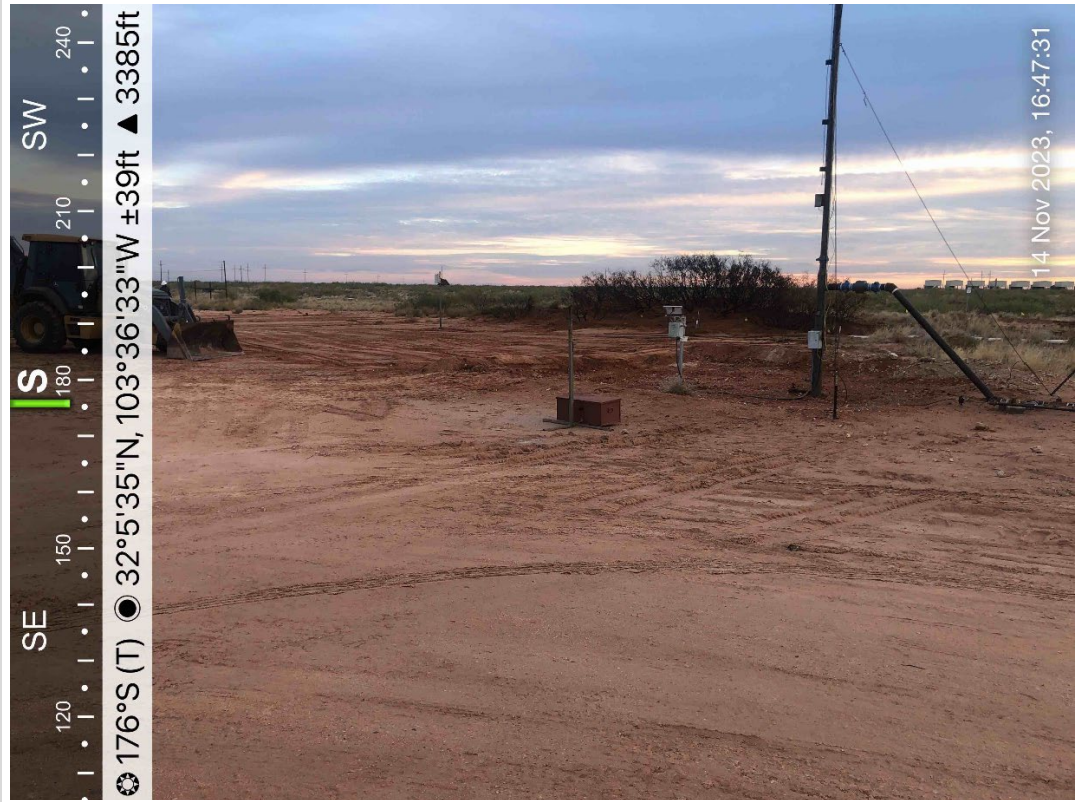
TETRA TECH, INC. PROJECT NO. 212C-MD-03266	DESCRIPTION	View south of site conditions following surface scrape. View of release point.	11
	SITE NAME	AIRACUDA 31 FEDERAL 2H FLARE FIRE Release	11/16/2023

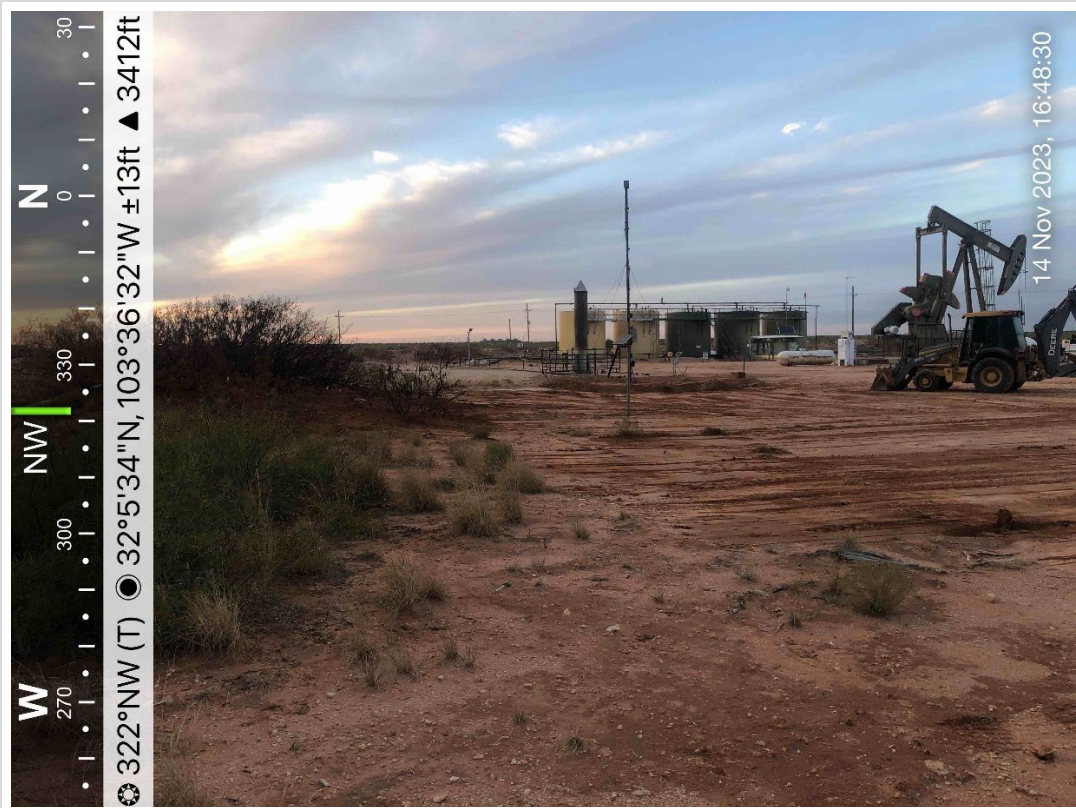
TETRA TECH, INC. PROJECT NO. 212C-MD-03266	DESCRIPTION	View northwest. View following surface scrape of approximate release area.	12
	SITE NAME	AIRACUDA 31 FEDERAL 2H FLARE FIRE Release	11/14/2023

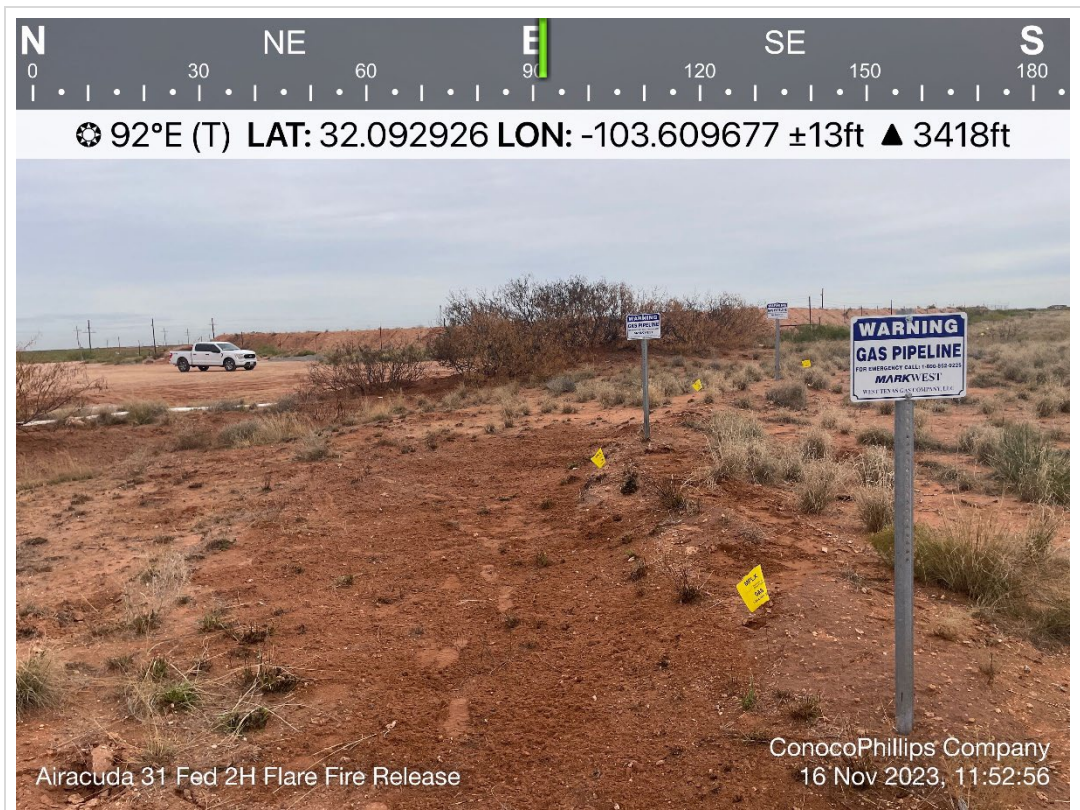
TETRA TECH, INC. PROJECT NO. 212C-MD-03266	DESCRIPTION	View east of site conditions following surface scrape.	14
	SITE NAME	AIRACUDA 31 FEDERAL 2H FLARE FIRE Release	11/16/2023

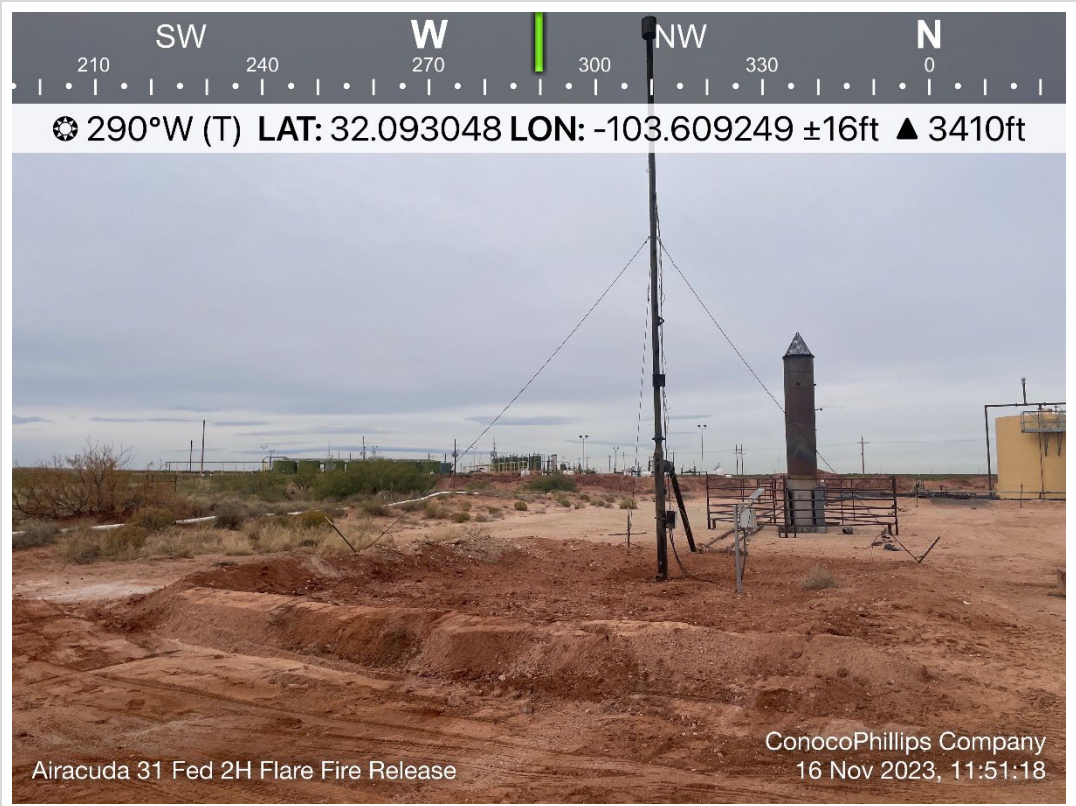
TETRA TECH, INC. PROJECT NO. 212C-MD-03266	DESCRIPTION	View west-northwest of site conditions following surface scrape near approximate release point.	16
	SITE NAME	AIRACUDA 31 FEDERAL 2H FLARE FIRE Release	11/16/2023

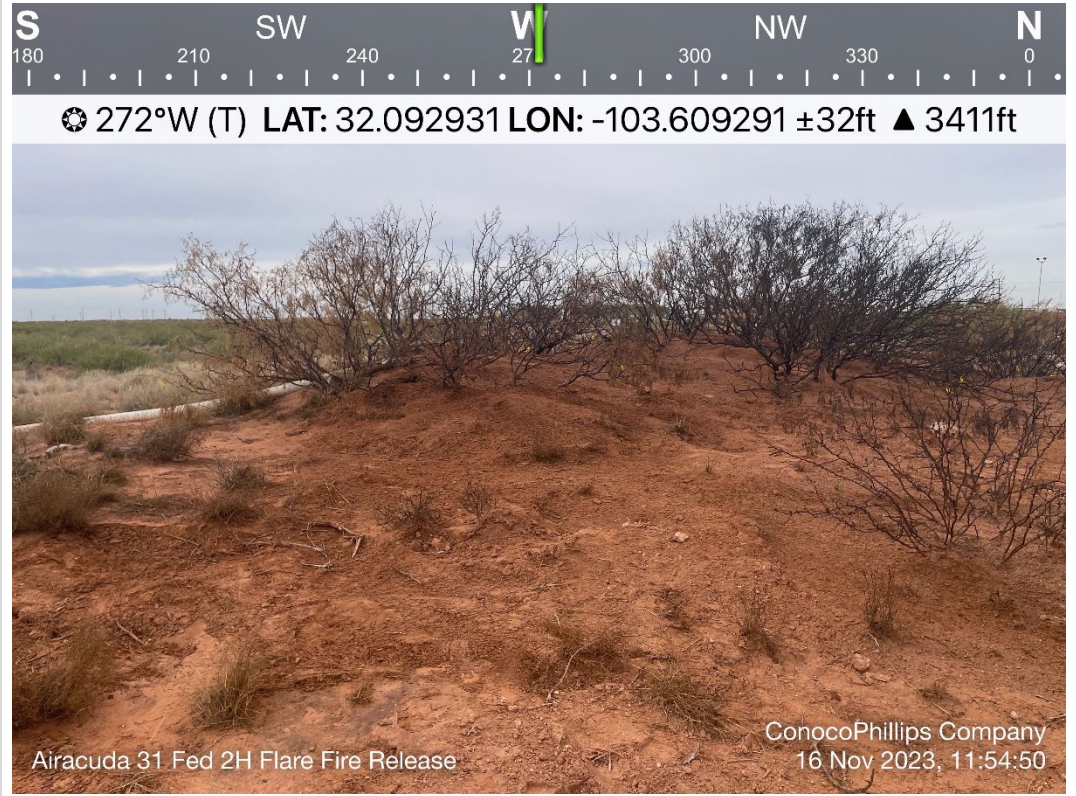
TETRA TECH, INC. PROJECT NO. 212C-MD-03266	DESCRIPTION	View west of site conditions following surface scrape.	17
	SITE NAME	AIRACUDA 31 FEDERAL 2H FLARE FIRE Release	11/16/2023

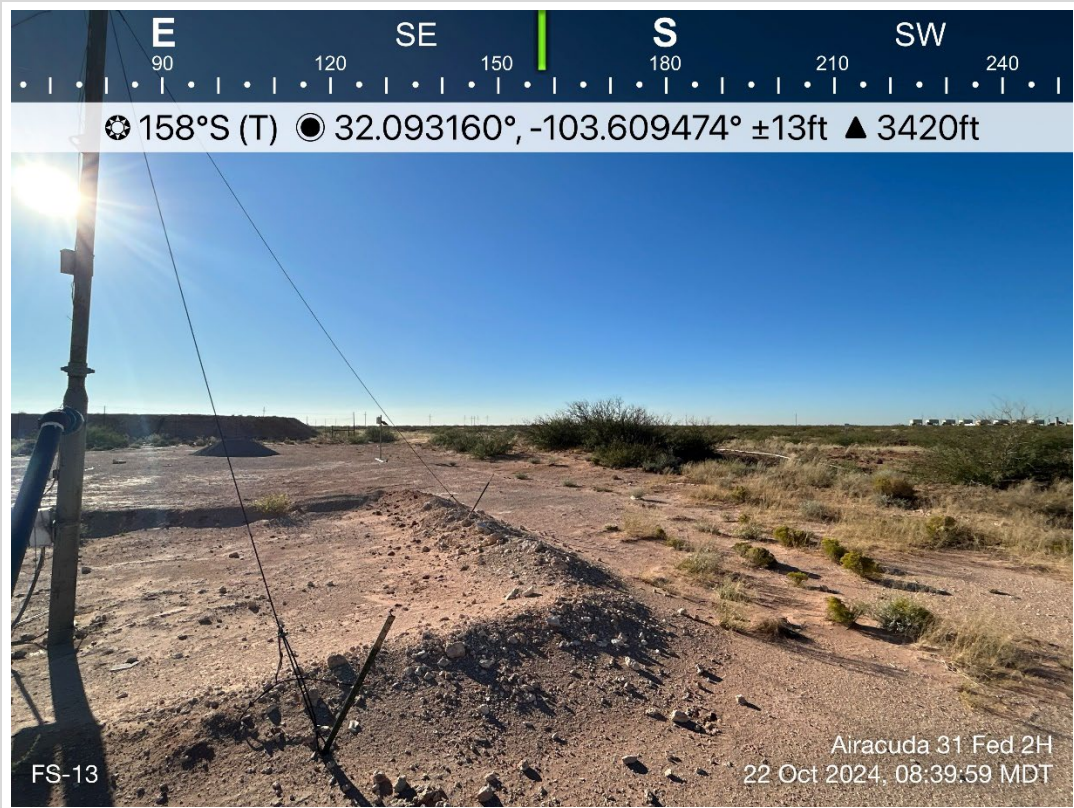
TETRA TECH, INC. PROJECT NO. 212C-MD-03266	DESCRIPTION	View Southeast. View of Flare. Vegetation present. View of the remediated release footprint.	18
	SITE NAME	AIRACUDA 31 FEDERAL 2H FLARE FIRE Release	10/22/2024

Tetra Tech personnel conducted a visual Site inspection on October 22, 2024, to assess the revegetation progress and evaluate current site conditions. At the time of the visual Site inspection, moderate uniform vegetative cover was observed in the reclaimed area in the pasture. Sparse vegetation was observed on the pad, this pad is currently active. Site inspections will be performed annually to assess the revegetation progress and evaluate the site for the presence of primary or secondary noxious weeds. If noxious weeds are identified, the BLM will be contacted to determine an effective method for eradication. If the Site does not show revegetation in the next growing season, the area will be reseeded as appropriate. Photographic documentation of the Site remediation and reclamation activities are presented in Appendix D.

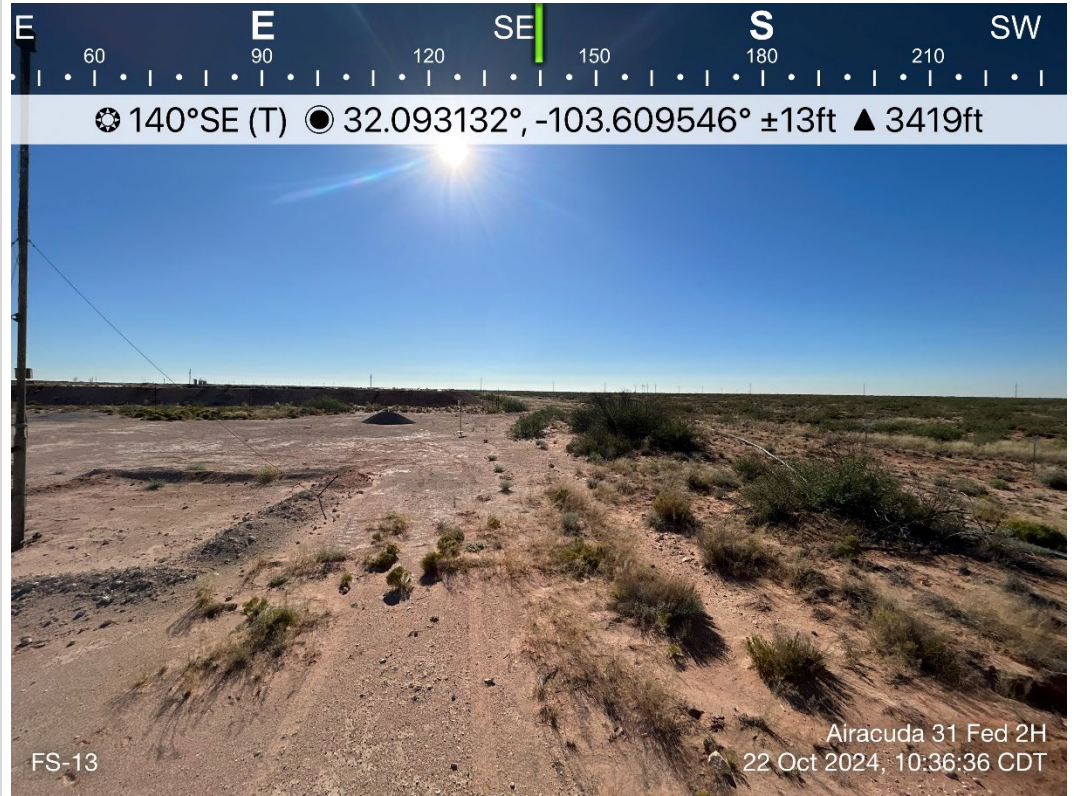
TETRA TECH, INC. PROJECT NO. 212C-MD-03266	DESCRIPTION	View southeast. Vegetation present. View of the remediated release footprint.	19
	SITE NAME	AIRACUDA 31 FEDERAL 2H FLARE FIRE Release	10/22/2024

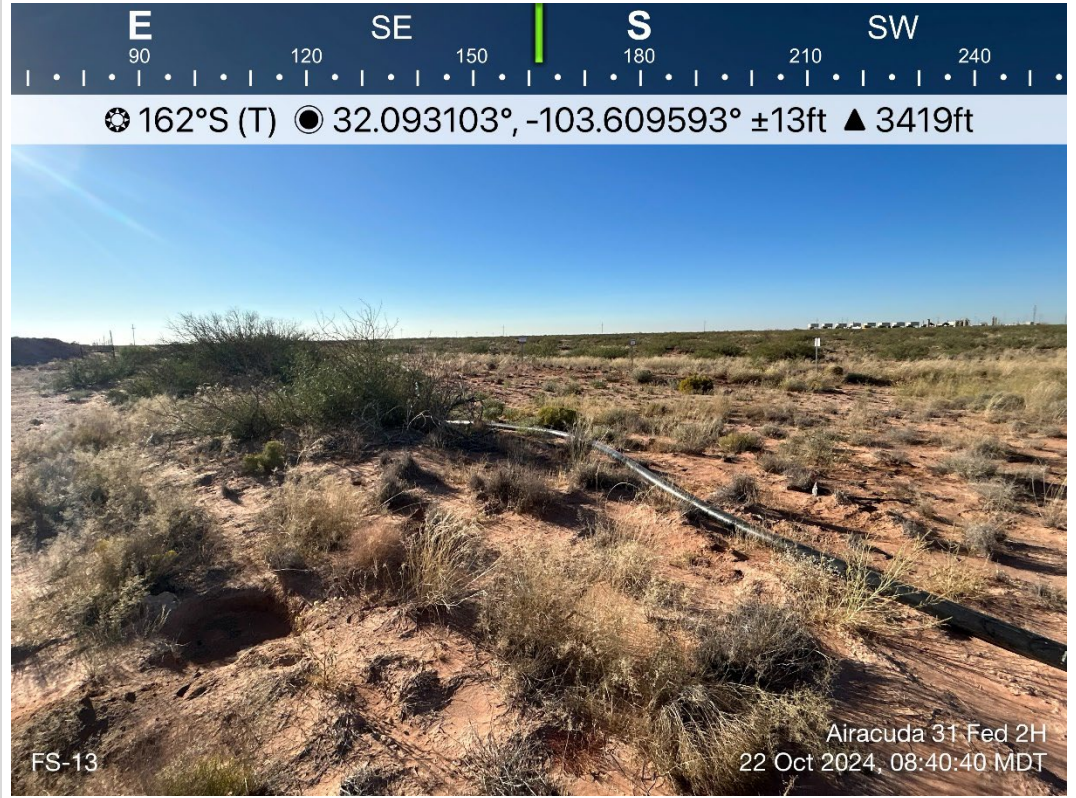
TETRA TECH, INC. PROJECT NO. 212C-MD-03266	DESCRIPTION	View southeast. View of moderate vegetation cover present. View of reclamation area. View of surface polyline.	21
	SITE NAME	AIRACUDA 31 FEDERAL 2H FLARE FIRE Release	10/22/2024

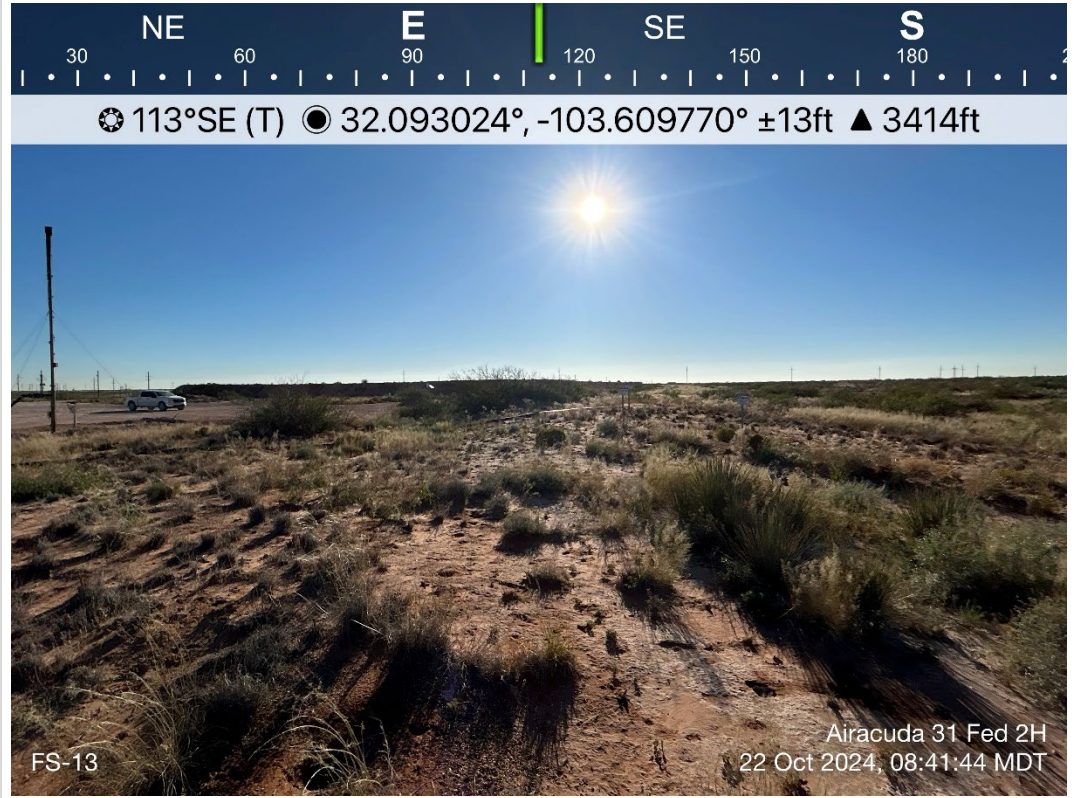
TETRA TECH, INC. PROJECT NO. 212C-MD-03266	DESCRIPTION	View east. View of moderate vegetation cover present. View of reclamation area.	23
	SITE NAME	AIRACUDA 31 FEDERAL 2H FLARE FIRE Release	10/22/2024
