**C-141 - CO2 GAS RELEASE ONLY (No Liquids)**  
**EVENT SUMMARY, VARIANCE REQUEST & CLOSURE REQUEST REPORT**

| <b>Facility ID:</b> | fJXK1520829861 | <b>Incident #:</b> | nAPP2512740009 |
| <b>Facility Name:</b> | South Hobbs CTB | <b>Flare Date:</b> | 04/26/2025 |
| <b>Cause:</b> | Controlled gas release only, no liquids involved - Combusted in a flare to reduce emissions | | |

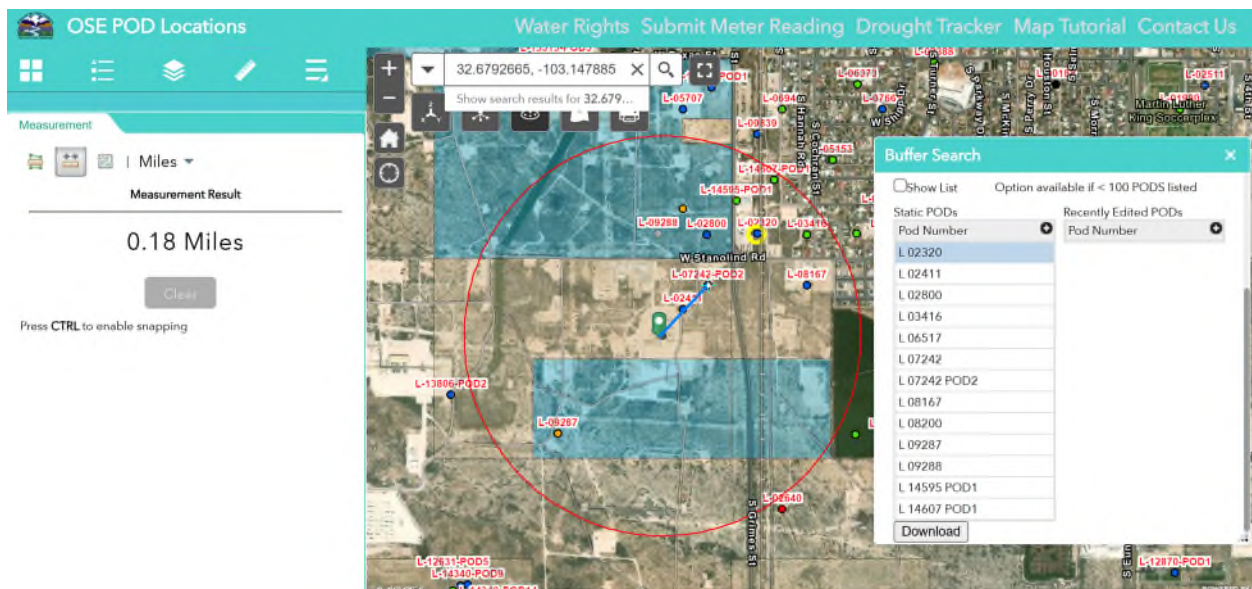
Any other fresh water well or spring: 0.18 miles (~950 feet)

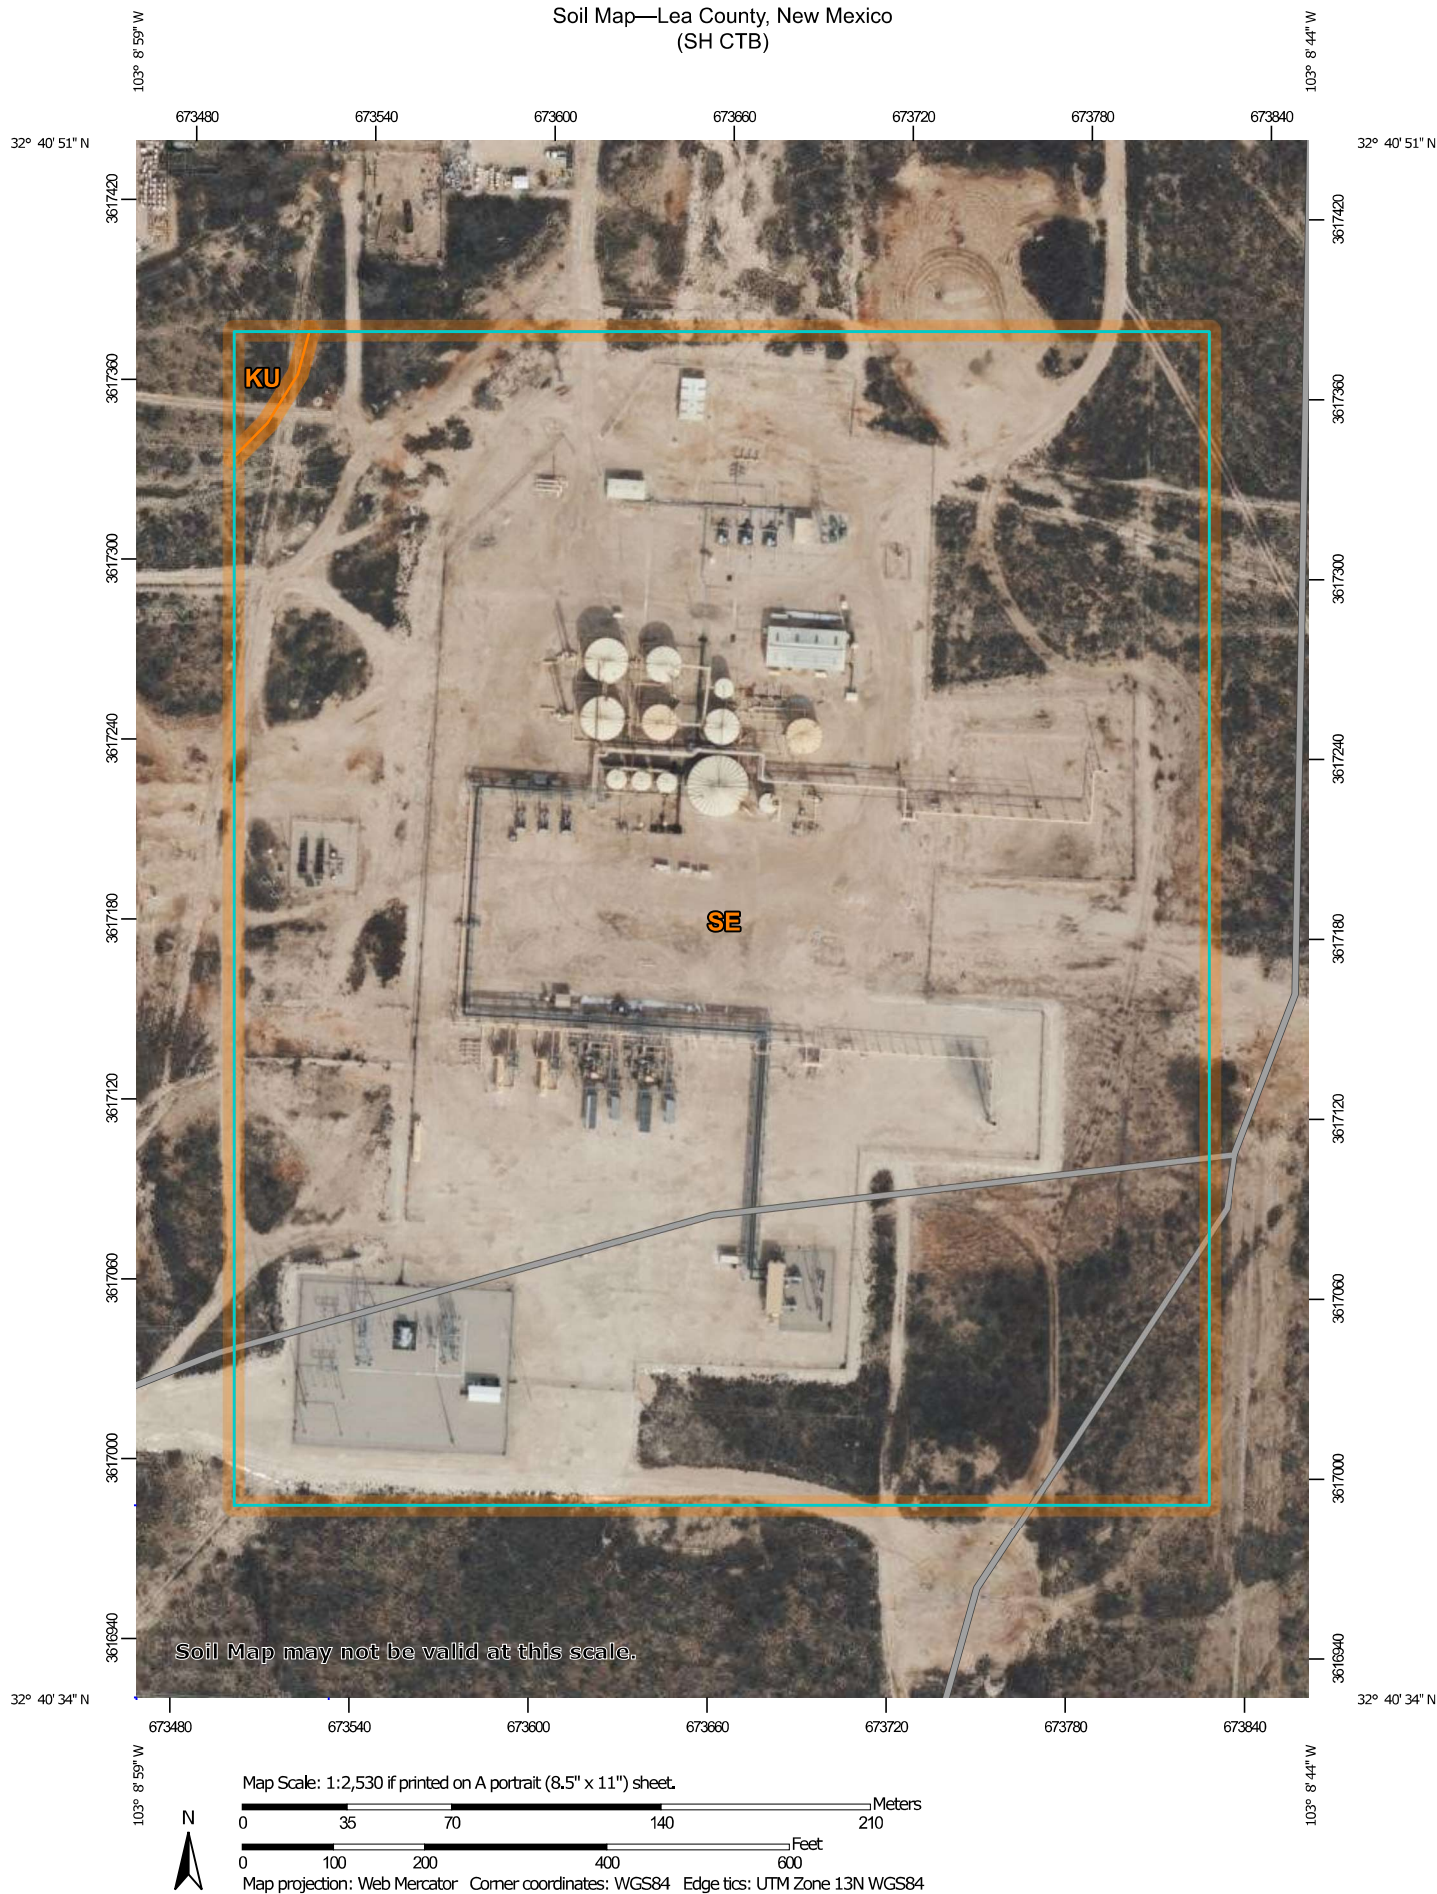
Soil Map—Lea County, New Mexico  
(SH CTB)

Map Unit Legend

| Map Unit Symbol | Map Unit Name | Acres in AOI | Percent of AOI |
| KU | Kimbrough-Lea complex, dry, 0 to 3 percent slopes | 0.2 | 0.5% |
| SE | Simona fine sandy loam, 0 to 3 percent slopes | 31.6 | 99.5% |
