**C-141 - CO2 GAS RELEASE ONLY (No Liquids)**  
**EVENT SUMMARY, VARIANCE REQUEST & CLOSURE REQUEST REPORT**

| <b>Facility Name:</b> | North Hobbs RCF | <b>Flare Date:</b> | 06/17/2025 |
| <b>Cause:</b> | Controlled gas release only, no liquids involved - Combusted in a flare to reduce emissions | | |

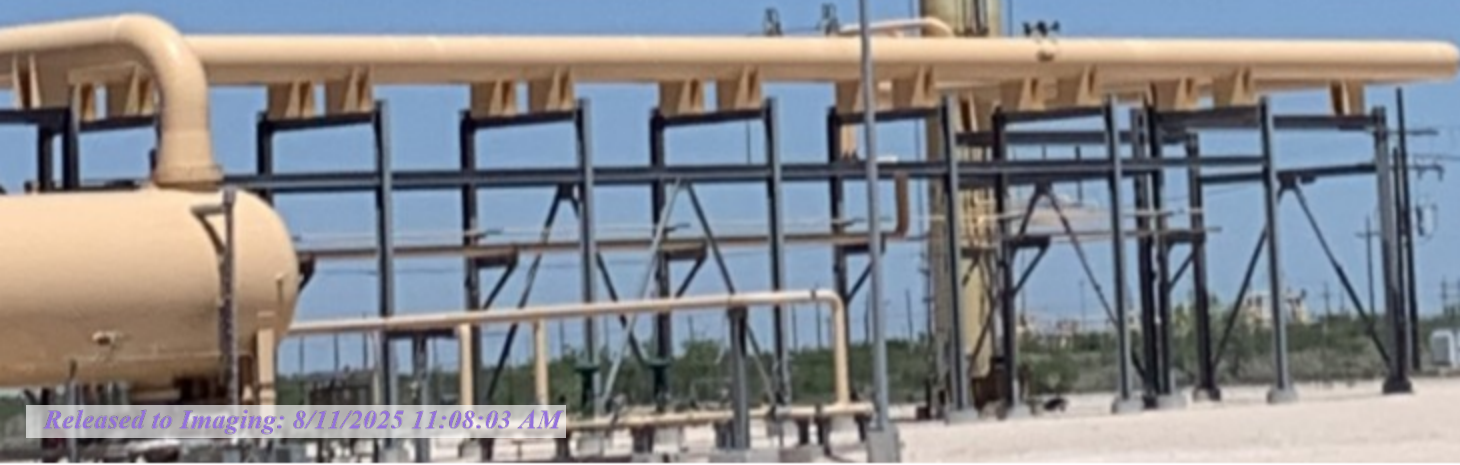
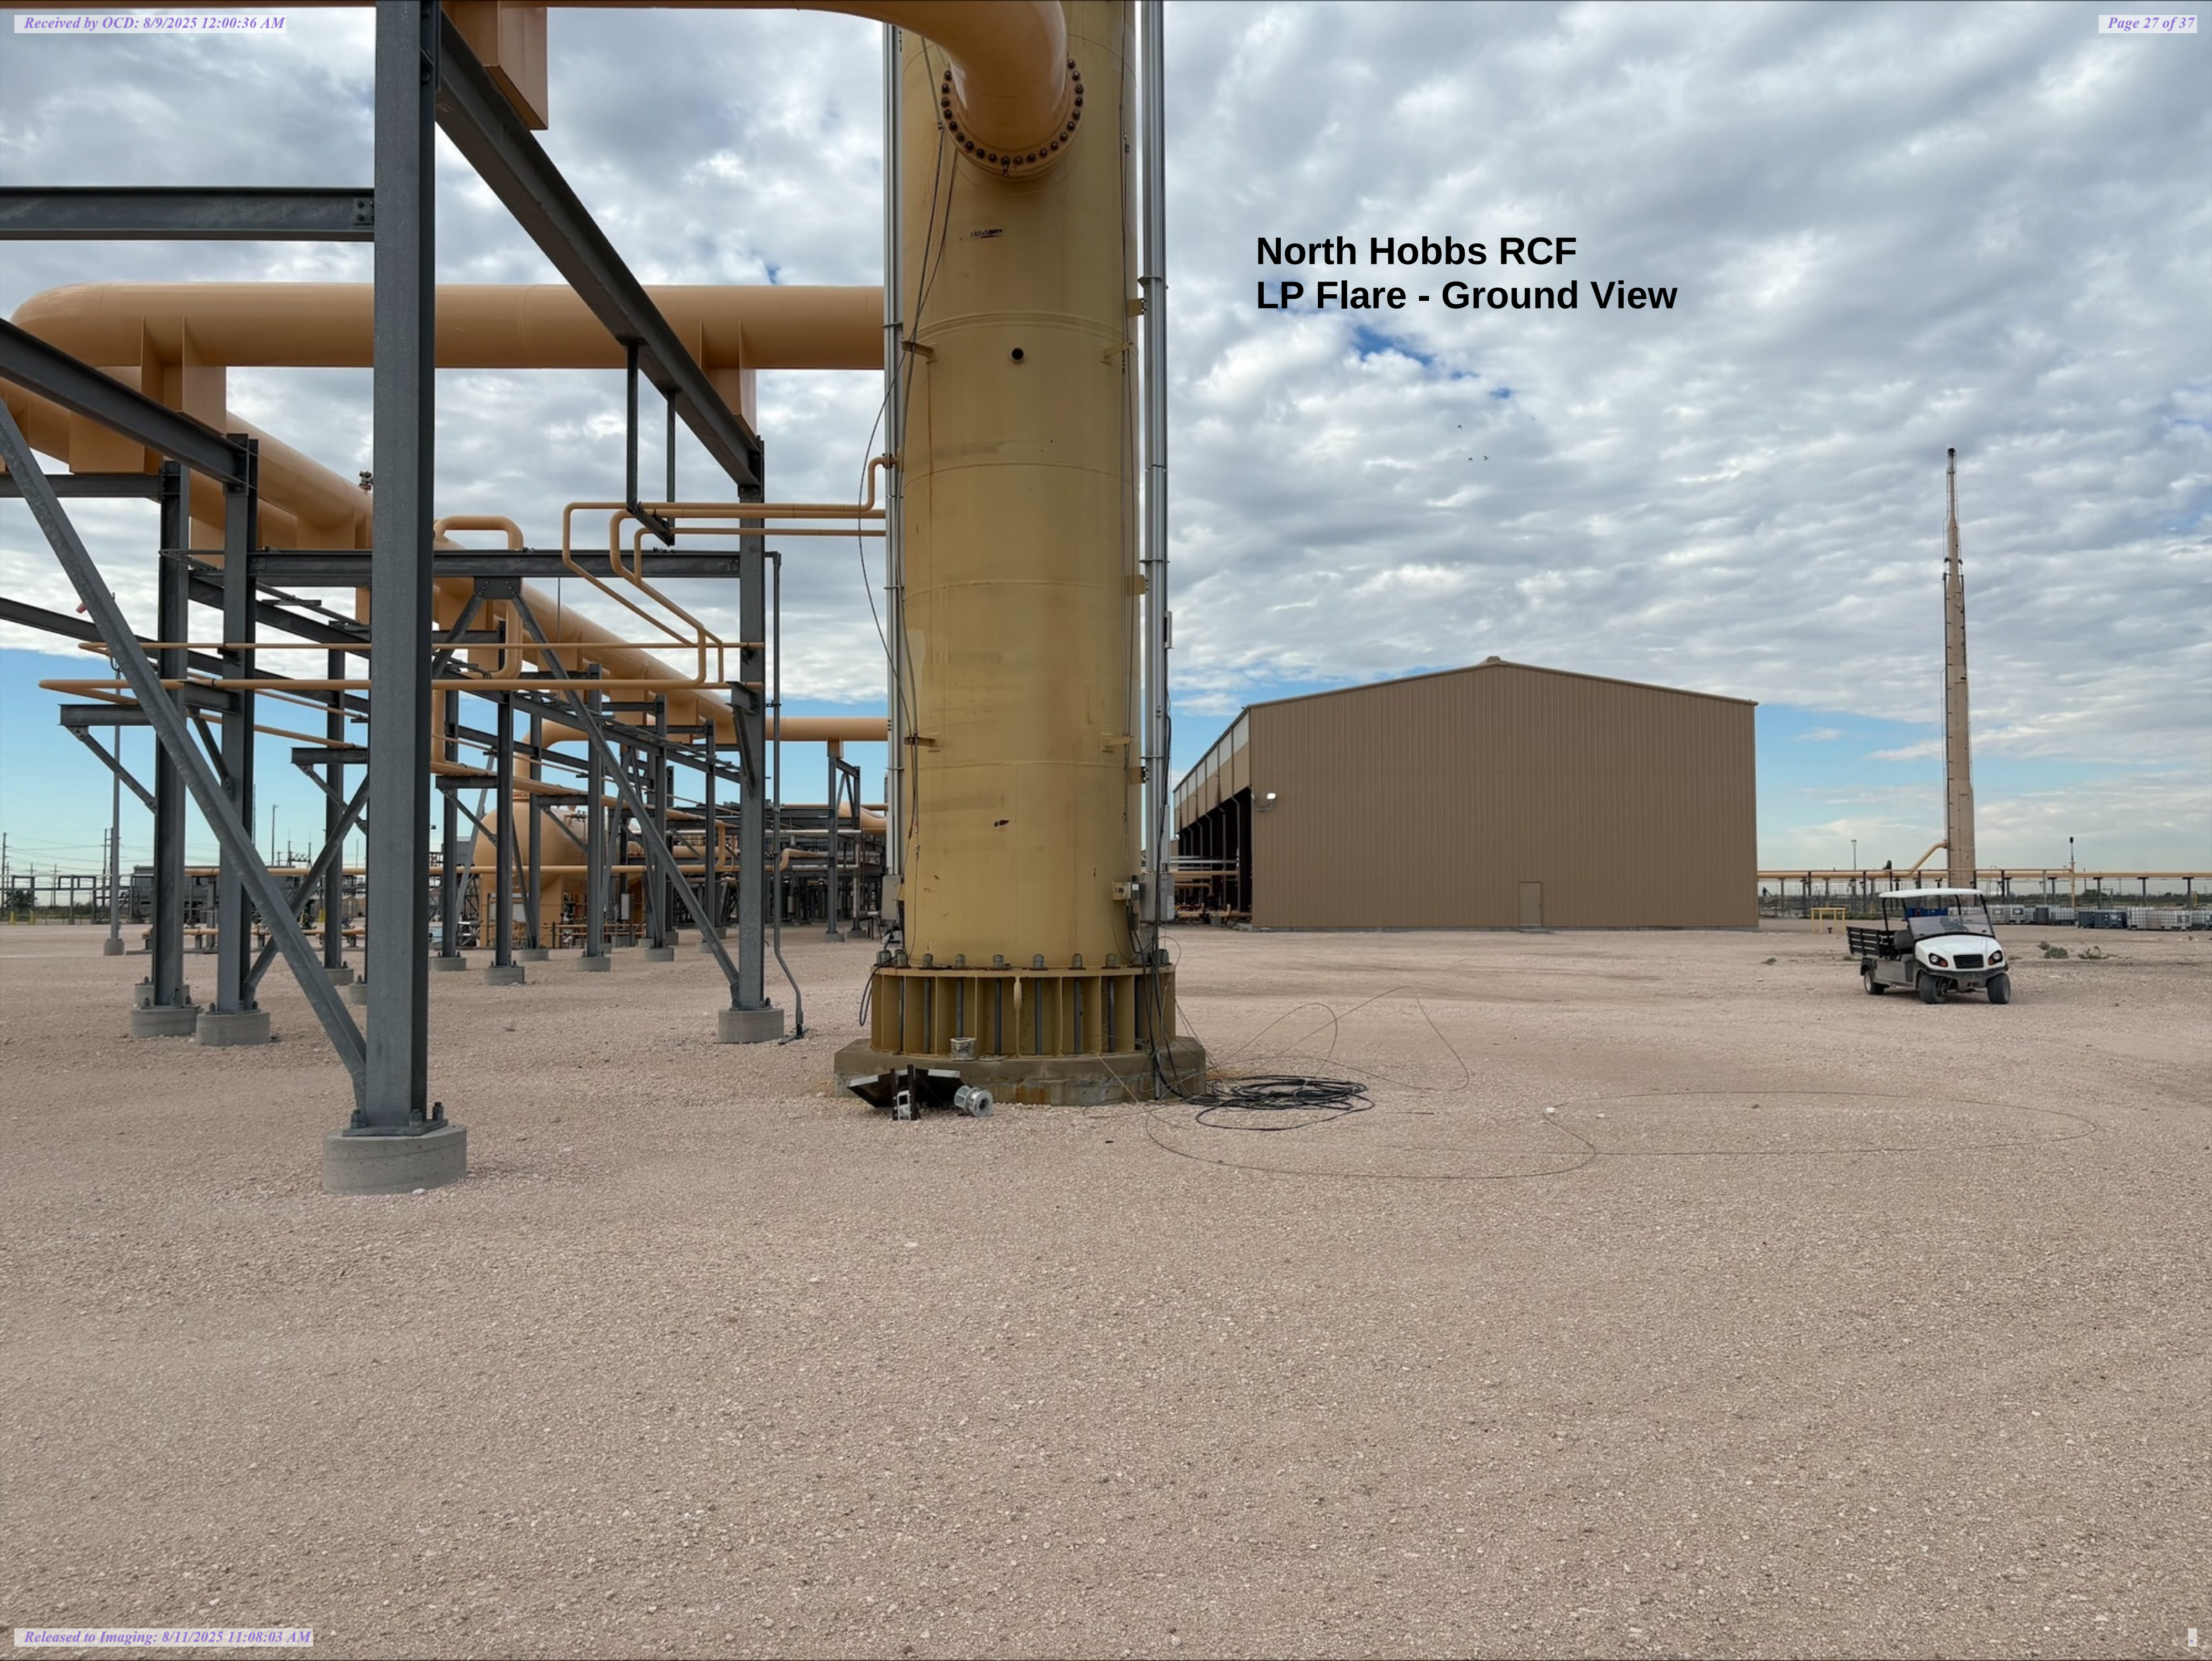
# North Hobbs RCF LP Flare

**North Hobbs RCF  
LP Flare - Ground View**
