**C-141 - CO2 GAS RELEASE ONLY (No Liquids)**  
**EVENT SUMMARY, VARIANCE REQUEST & CLOSURE REQUEST REPORT**

| <b>Facility ID:</b> | fJXXK1521644806 | <b>Incident #:</b> | nAPP2514150374 |
| <b>Facility Name:</b> | North Hobbs CTB | <b>Flare Date:</b> | 05/14/2025 |

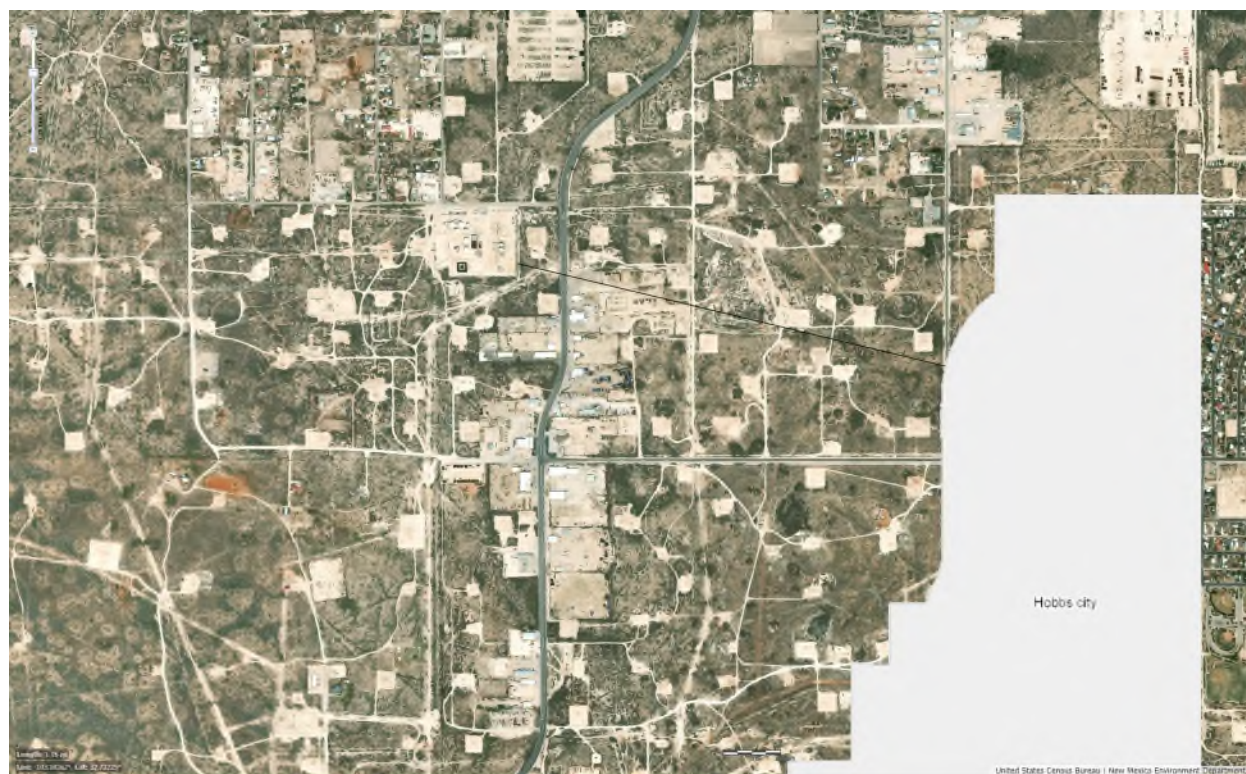
Municipal Boundaries: ~1.16 miles (~6124 feet)

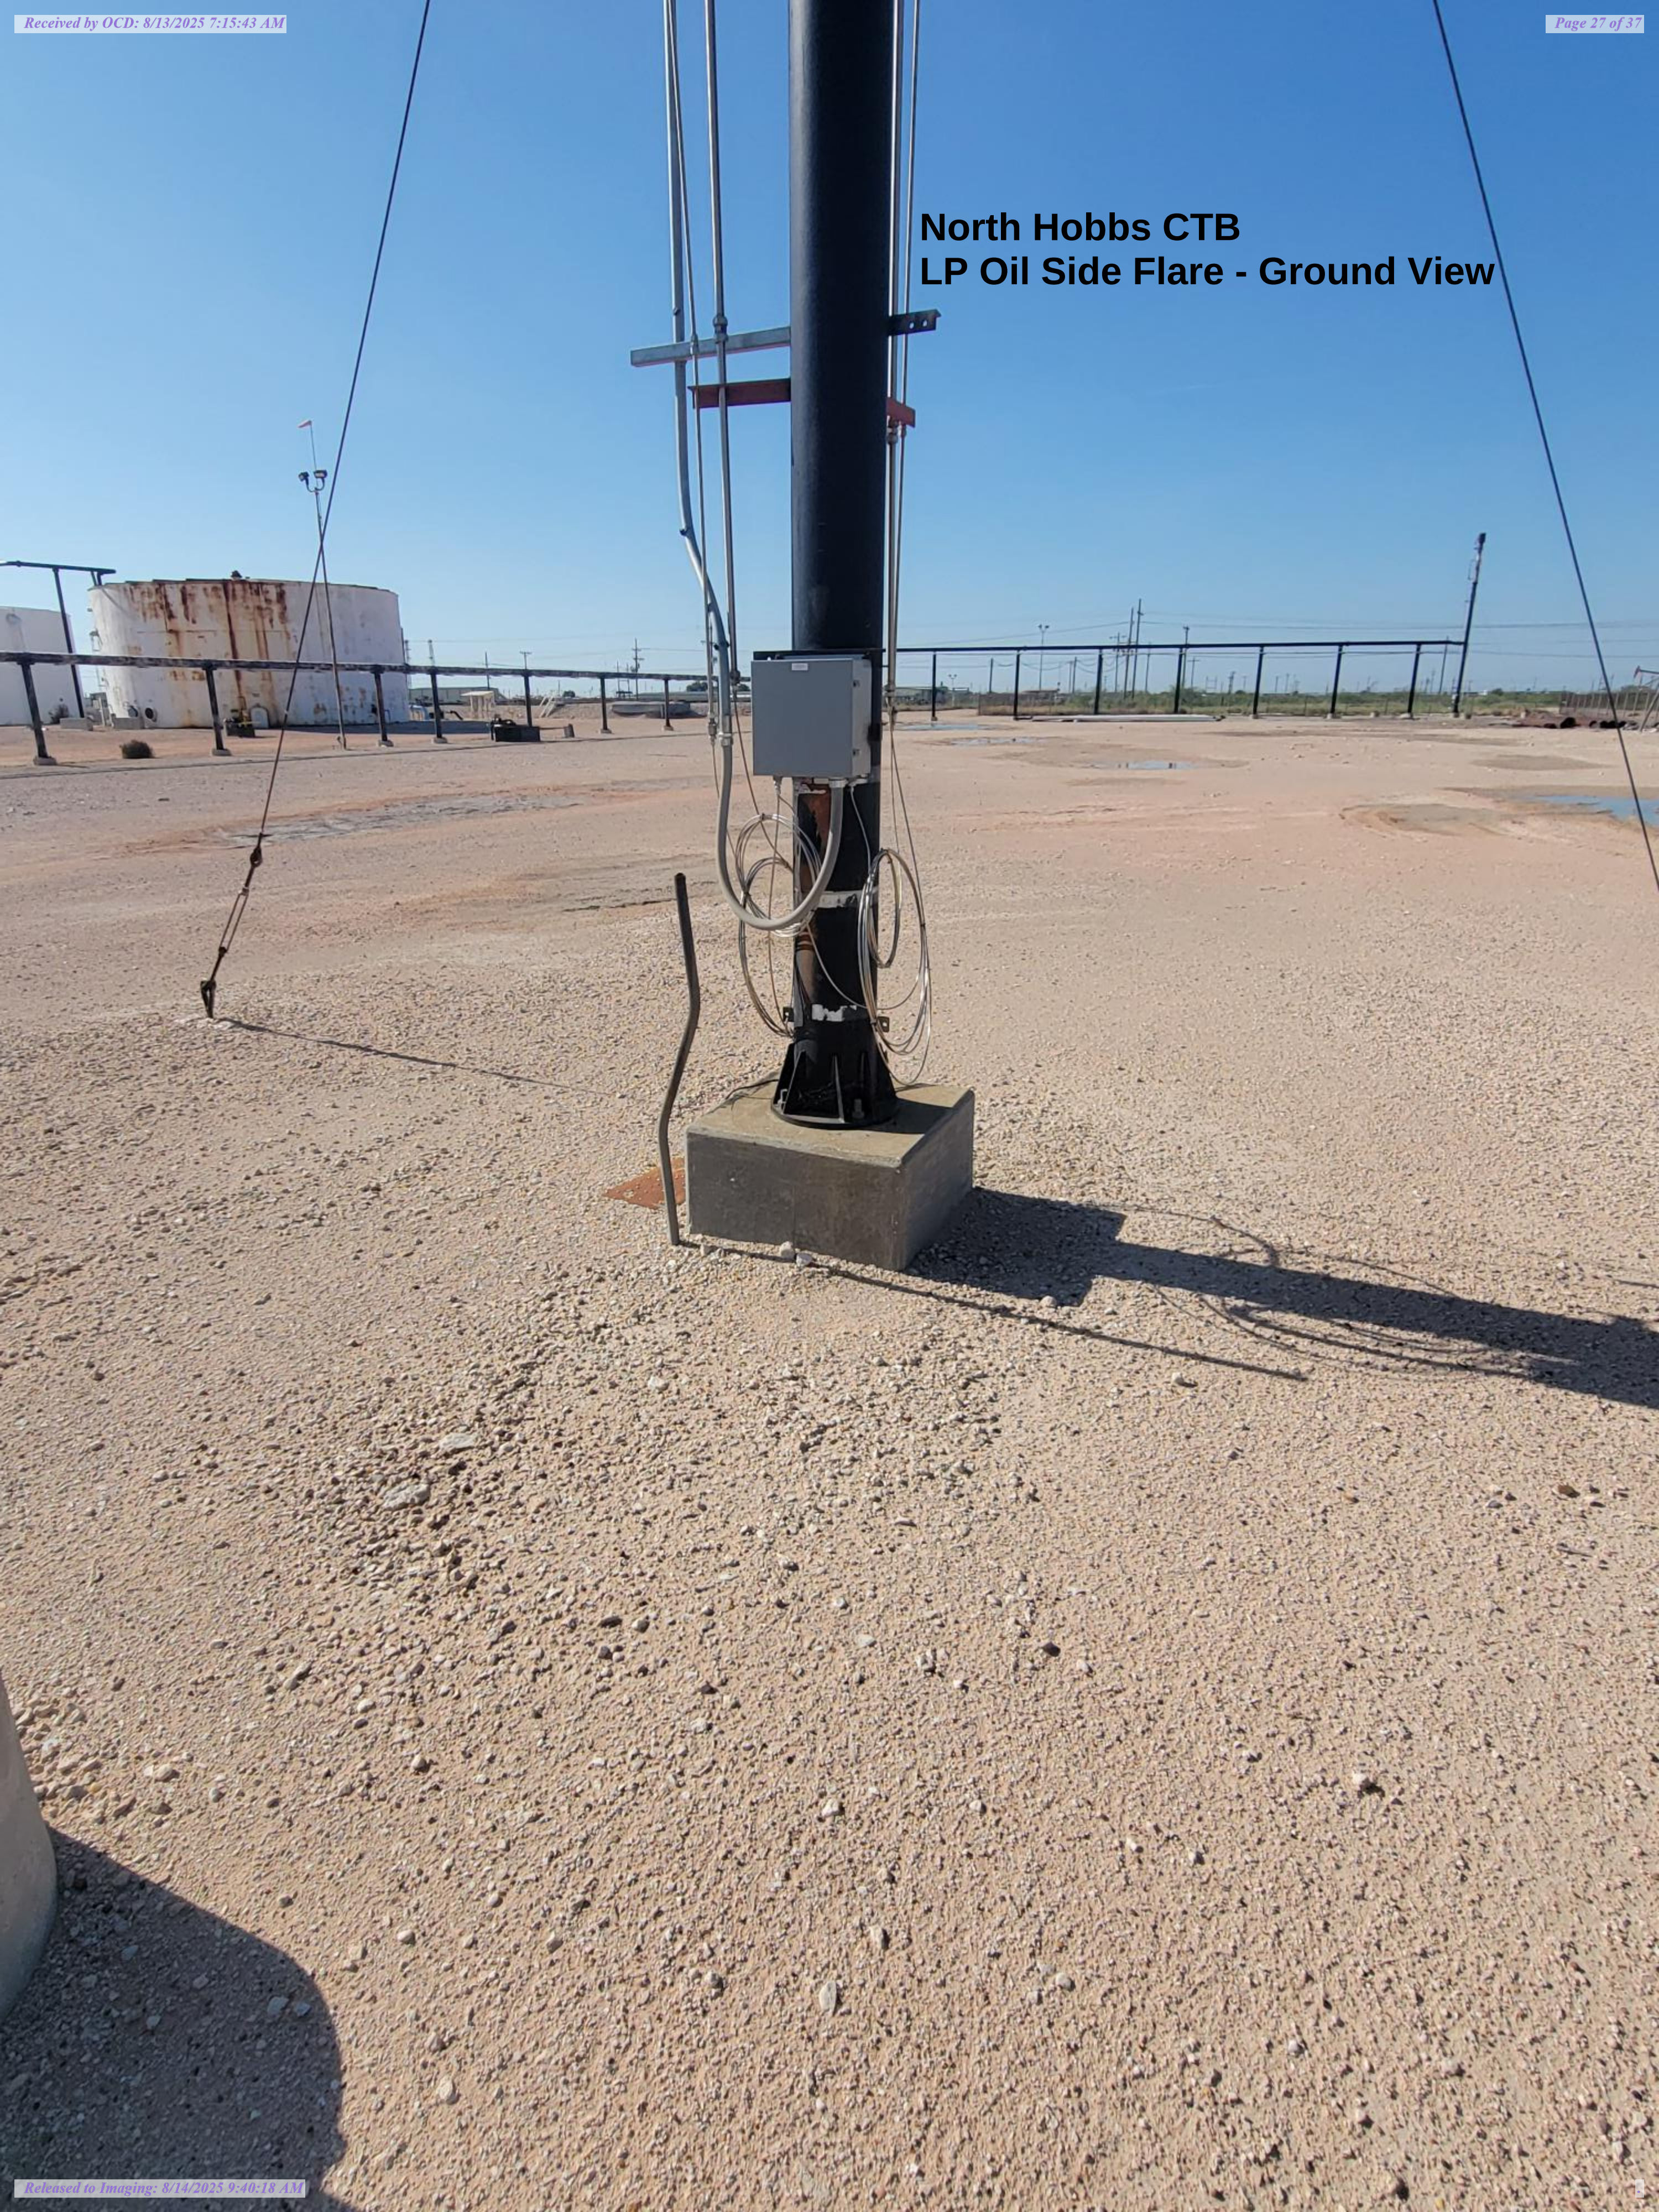
**North Hobbs CTB  
LP Oil Side Flare - Ground View**
