Remediation Summary and Site Closure Request

NMOCD Incident Number:
nAPP2412818139

TARGA Midstream Services LLC

TRC Environmental Corporation
10 Desta Drive, Suite 130E
Midland, TX 79705

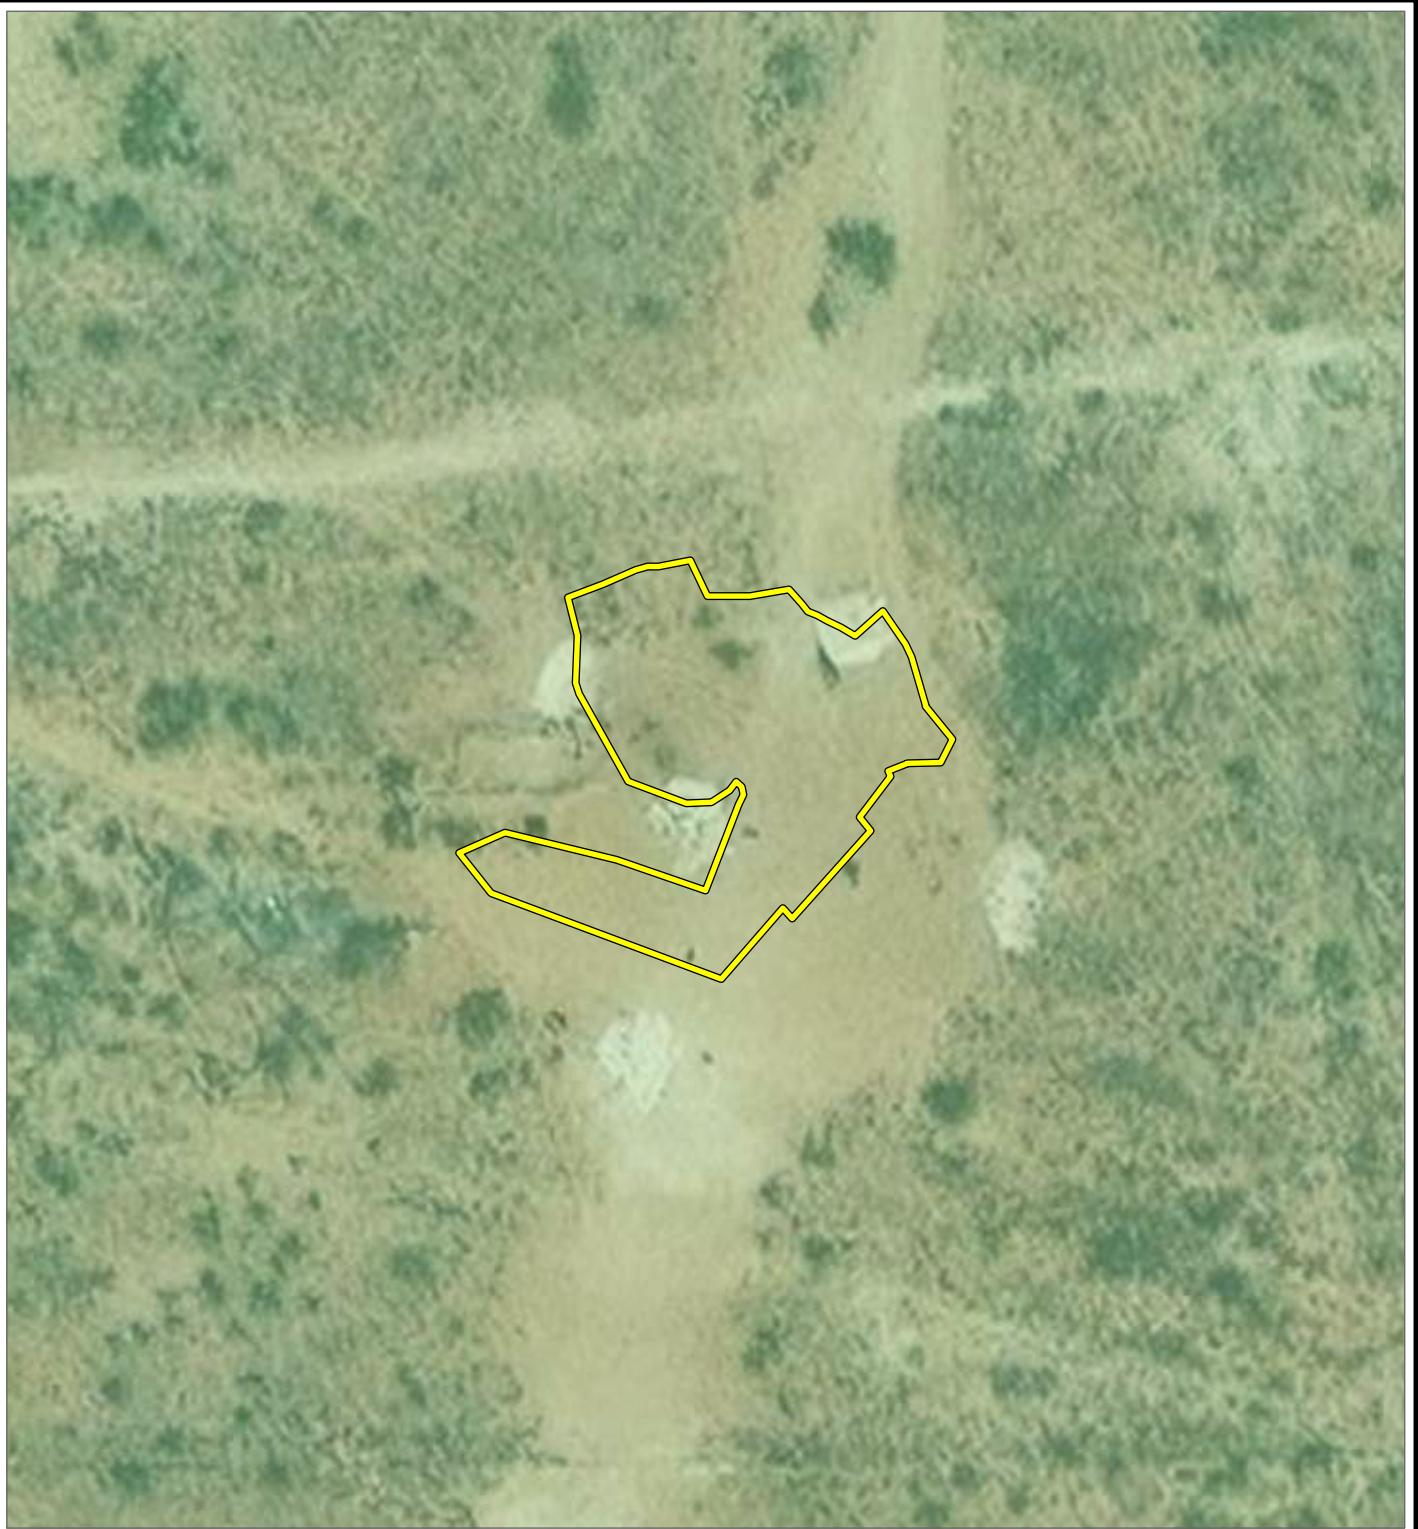
FIGURE 3

Based on the NMOCD Site Classification criteria, soil analytical data collected during the investigation of the Release Site were compared to Closure Criteria for depth to groundwater 51 to 100 feet bgs. The Leak #34 is not situated in a potential Karst area as outlined in Bureau of Land Management (BLM) publicly available Karst Potential Map. The Karst Potential Map is provided as **Figure 3**. Further research of the Federal Flood Site (FEMA) indicates that this site is not located in a 100-year floodplain- the map is provided as **Figure 6**. The NMOCD closure criteria based on the lack of sensitive receptors and deeper groundwater is:

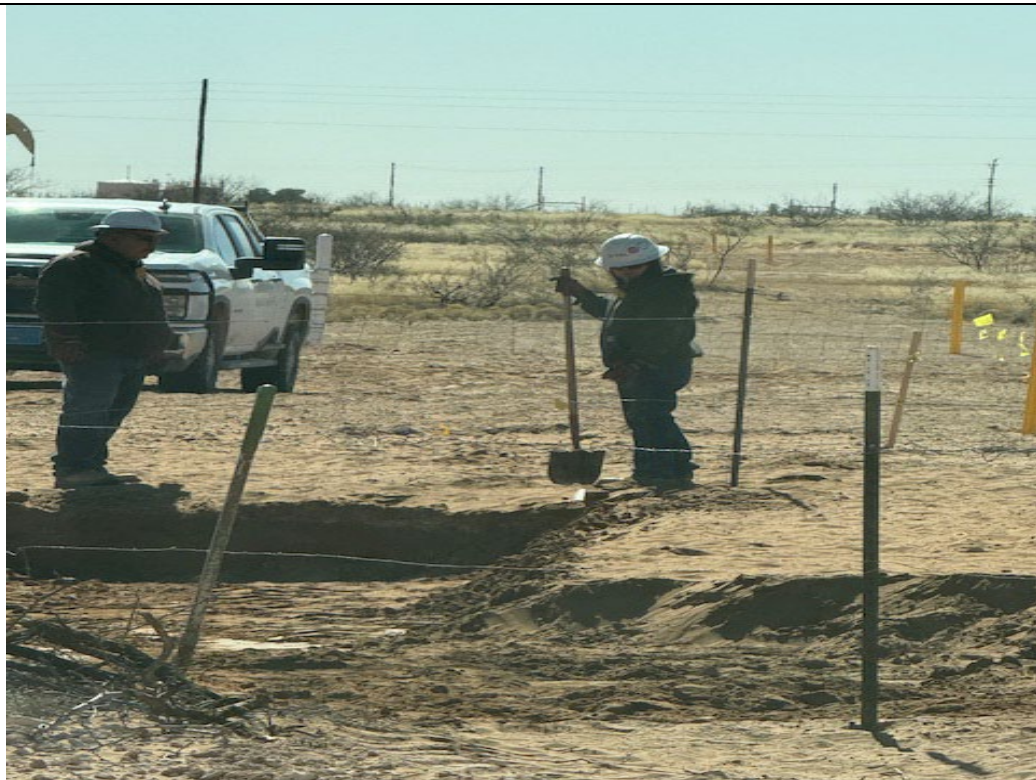
Direction:
Looking South

Description:
Hand Excavating
Lines

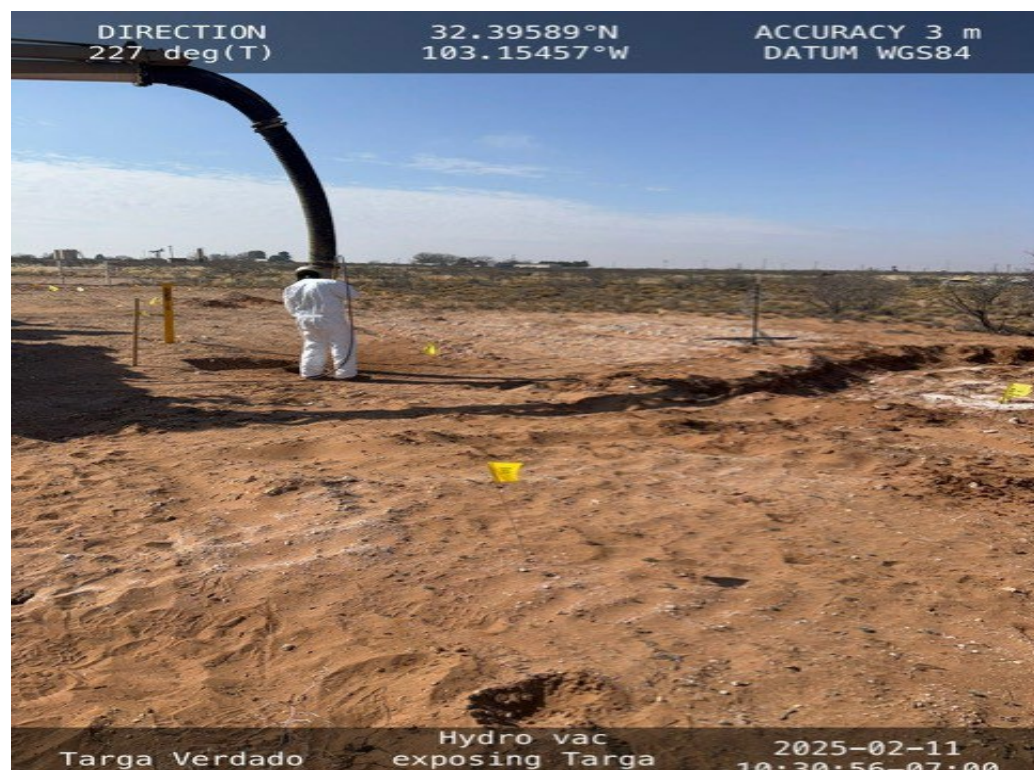
Photograph No. 4

Direction:
Looking South

Description:
Hydro Vac Lines
