**Closure Report  
Lea Unit #044H & #045H  
Lea County, New Mexico  
Unit M Sec 01 T20S R34E  
32.596628°, -103.520177°**

**Incident ID: NRM2024760291  
Crude Oil Release  
Point of Release: Stuffing box failed  
Release Date: 08.17.2020  
Volume Released: 15 Barrels of Crude Oil  
Volume Recovered: 0 Barrels of Crude Oil**

**Incident ID: NCH1903249514  
Crude Oil Release  
Point of Release: Stuffing box blowout  
Release Date: 12.05.2018  
Volume Released: 42 Barrels of Crude Oil  
Volume Recovered: 30 Barrels of Crude Oil**

**Re: Closure Report**  
**Lea Unit 44H & 45H**  
**Incident ID: NRM2024760291 & NCH1903249514**  
**Coterra Energy Operating Co.**  
**Site Location: Unit M, S01, T20S, R34E**  
**(Lat 32.596628°, Long -103.520177°)**  
**Lea County, New Mexico**

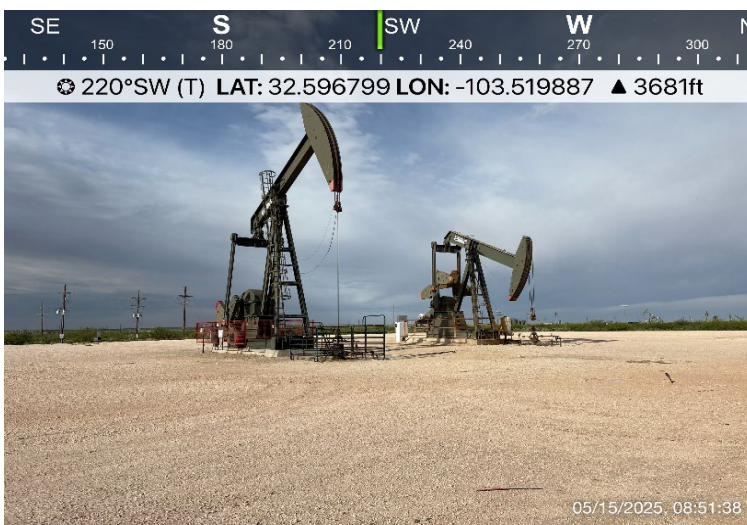
## Photograph No. 3

View Southwest, area of S-1 through S-5.

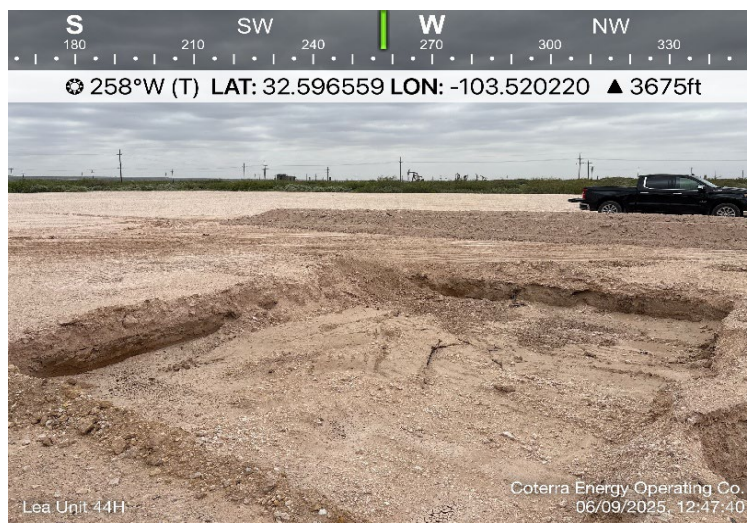
View West, area of CS-1 and CS-2.

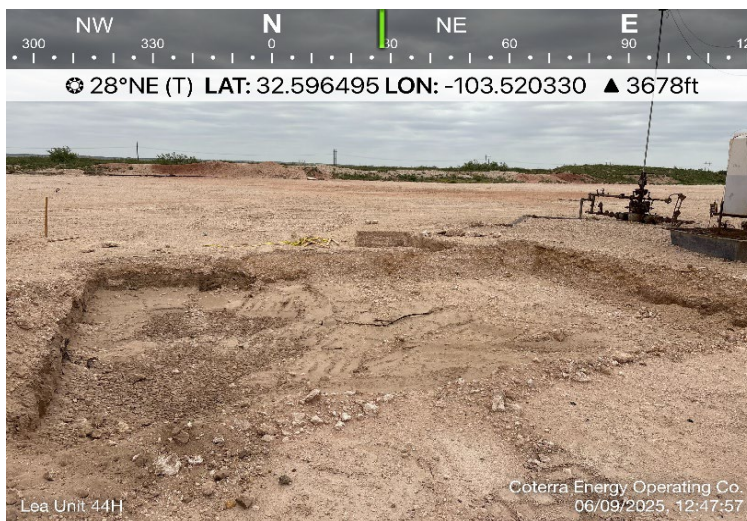
View Northeast, area of CS-1 and CS-2.

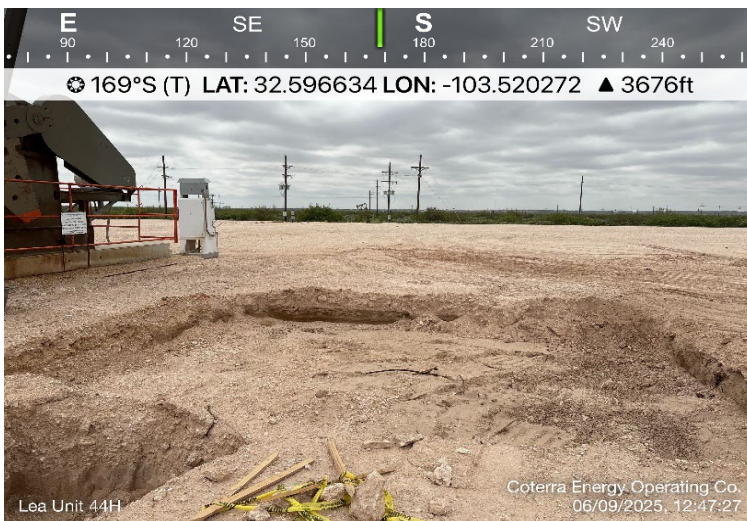
View South, area of CS-1 and CS-2.

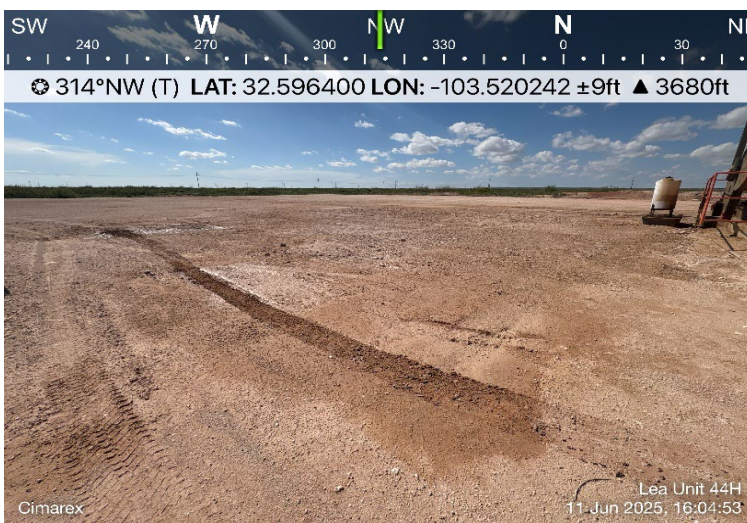
## Photograph No. 9

View Northwest, area of CS-1 and CS-2 backfilled. Soil was damp from recent rains.

Before the excavation was backfilled, a composite sample of the backfill material was collected on June 9, 2025, to ensure the material was clean per NMOCD standards. The backfill material was sourced from a nearby stockpile located at 32.597024°, -103.519570°. Refer to Table 2. Once the remediation activities were completed, the excavated areas were backfilled with clean material to surface grade.
