Re: NMOCD #nAPP2522863810  
Thistle Compressor Station  
32.212977, -103.593194  
U/L O, Section 17, Township 24 South, Range 33 East

## Section 1: Event Details

NMOCD Incident #nAPP2522863810 pertains to a fire that occurred at Targa's Thistle Compressor Station. Third-party personnel were onsite when lightning struck a chemical tank near the pipeline auto launcher to the east of the Facility. The lightning strike caused the chemical tank to ignite. There was no gas released into the atmosphere and no liquids released to surface, as this tank was located in containment.

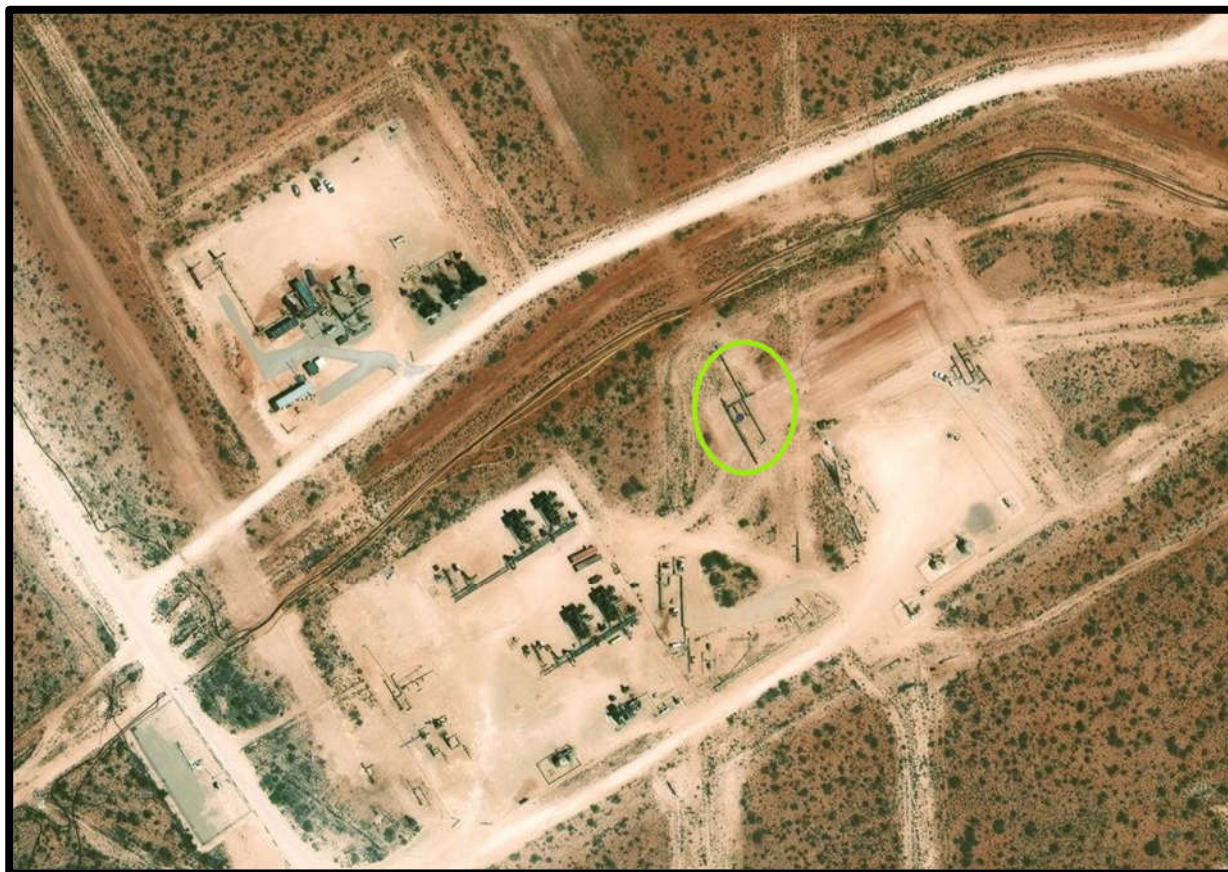
**Figure 7**

**Green Circle Indicates Referenced Targa Chemical Tank**

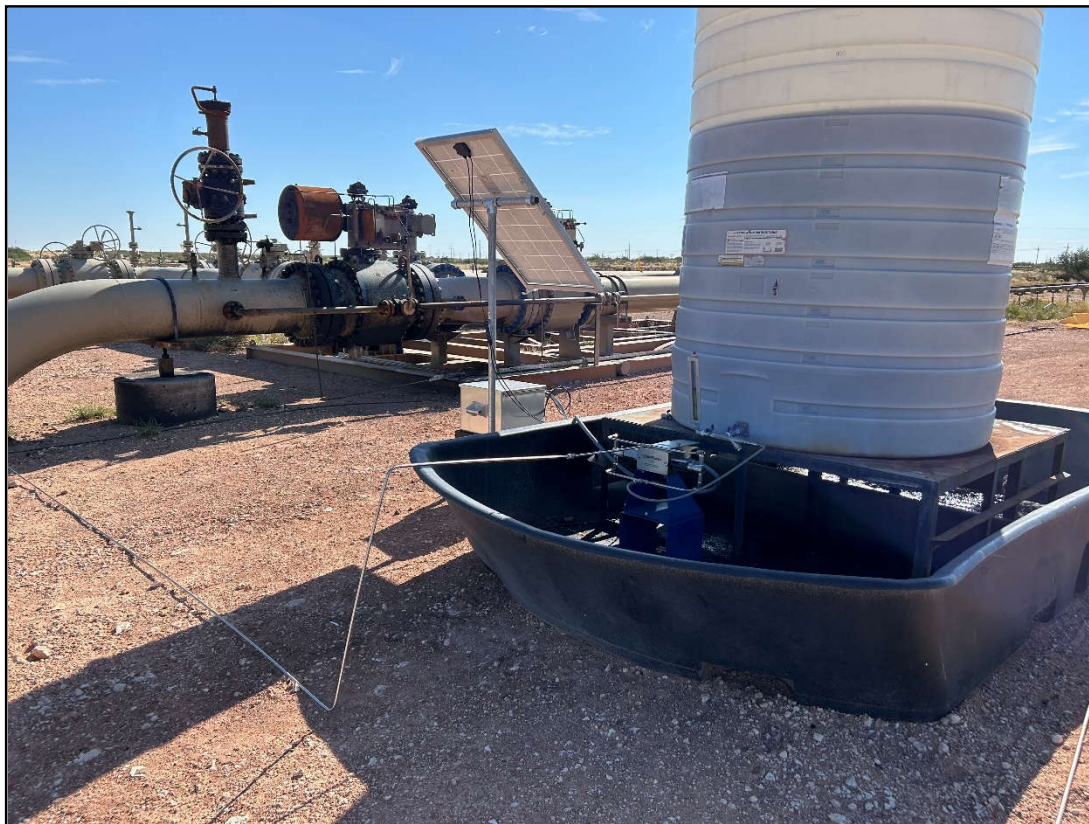
Photo of Chemical Tank and Auto Launcher facing south

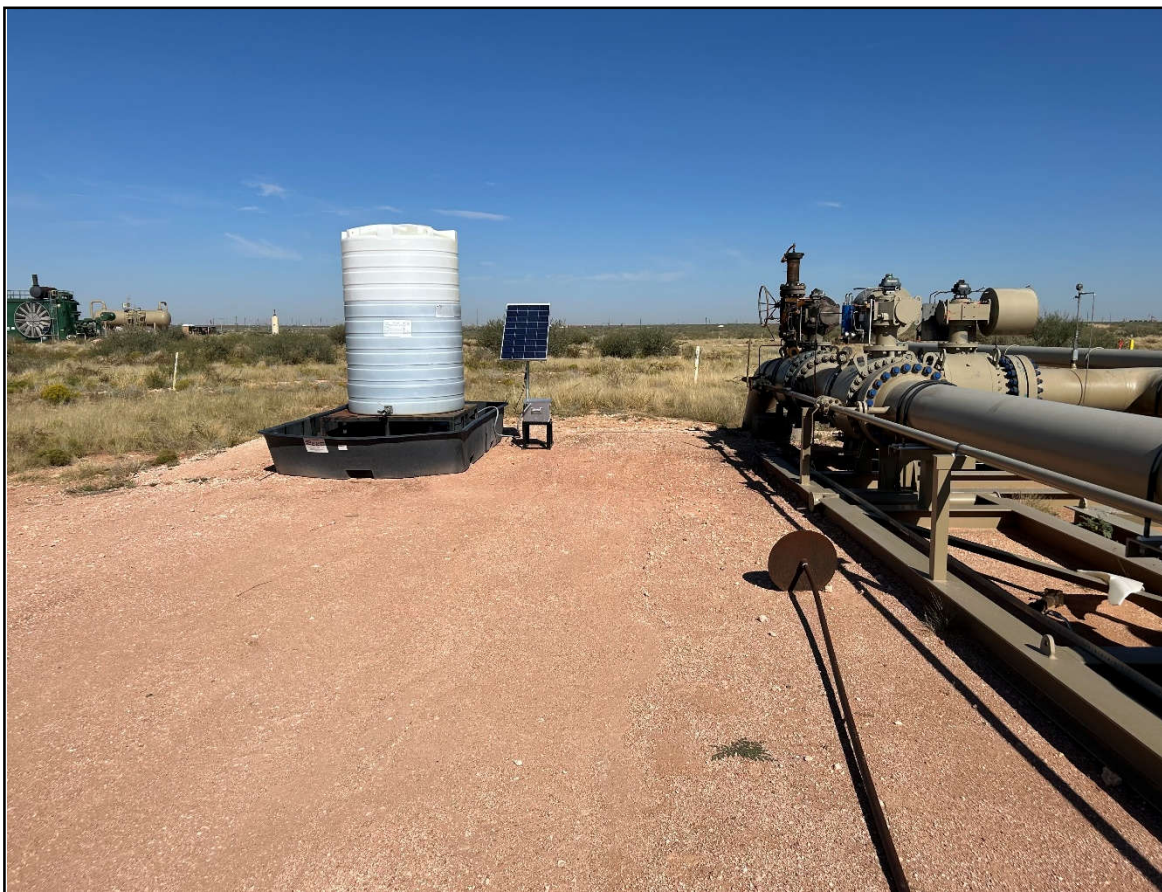
This was an above ground fire event with no gas released to atmosphere and no liquids released to surface, photographs are shown in Appendix C illustrating no staining to soil. Targa is respectfully requesting a variance to NMAC Part 29 sampling requirements due to the absence of liquids or gas released. Photographs indicating no soil impact, and the tank in containment, are shown in Appendix C.

**Photo indicating no soil was impacted during this fire event.**

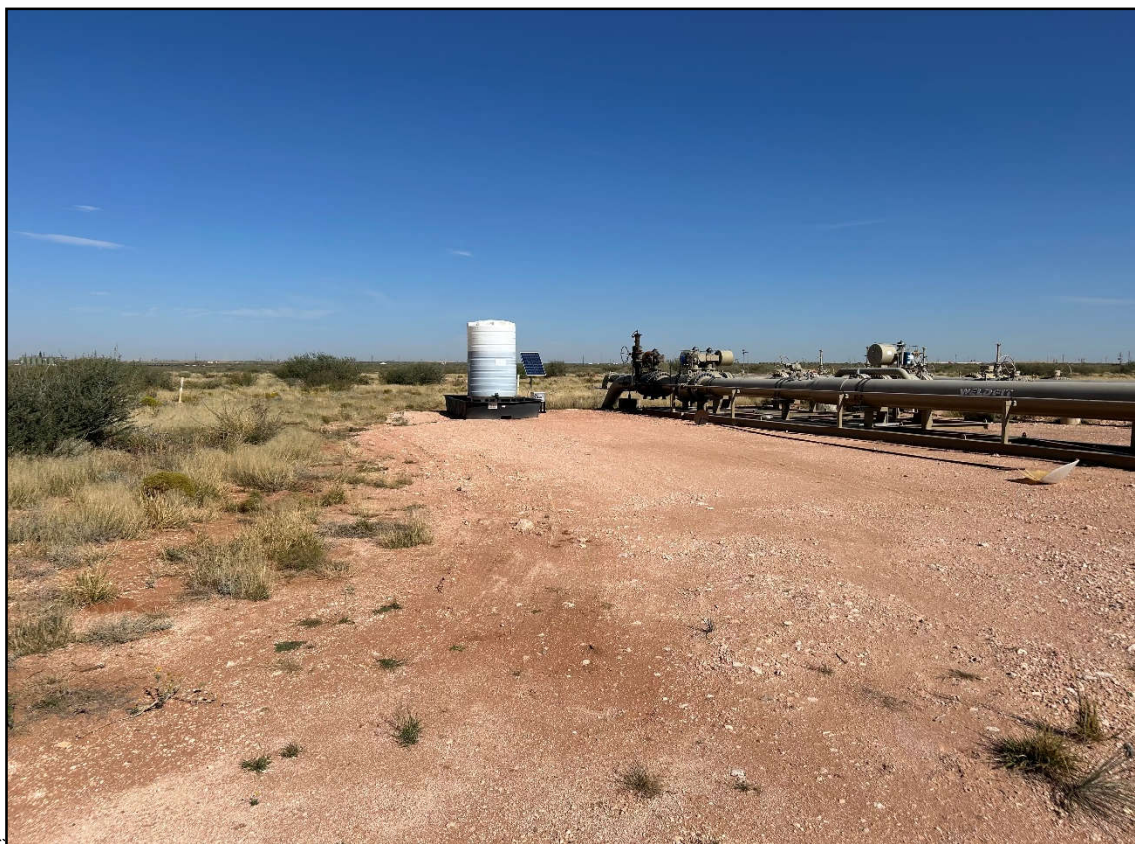
**Photo indication no soil was impacted during this fire event.**
