C-141 - CO2 GAS RELEASE ONLY (No Liquids)
EVENT SUMMARY, VARIANCE REQUEST & CLOSURE REQUEST REPORT

Facility Name: South Hobbs CTB

Flare Date: 11/27/2025

Cause: controlled release of gas only, no liquids involved - combusted in a flare to reduce emissions;

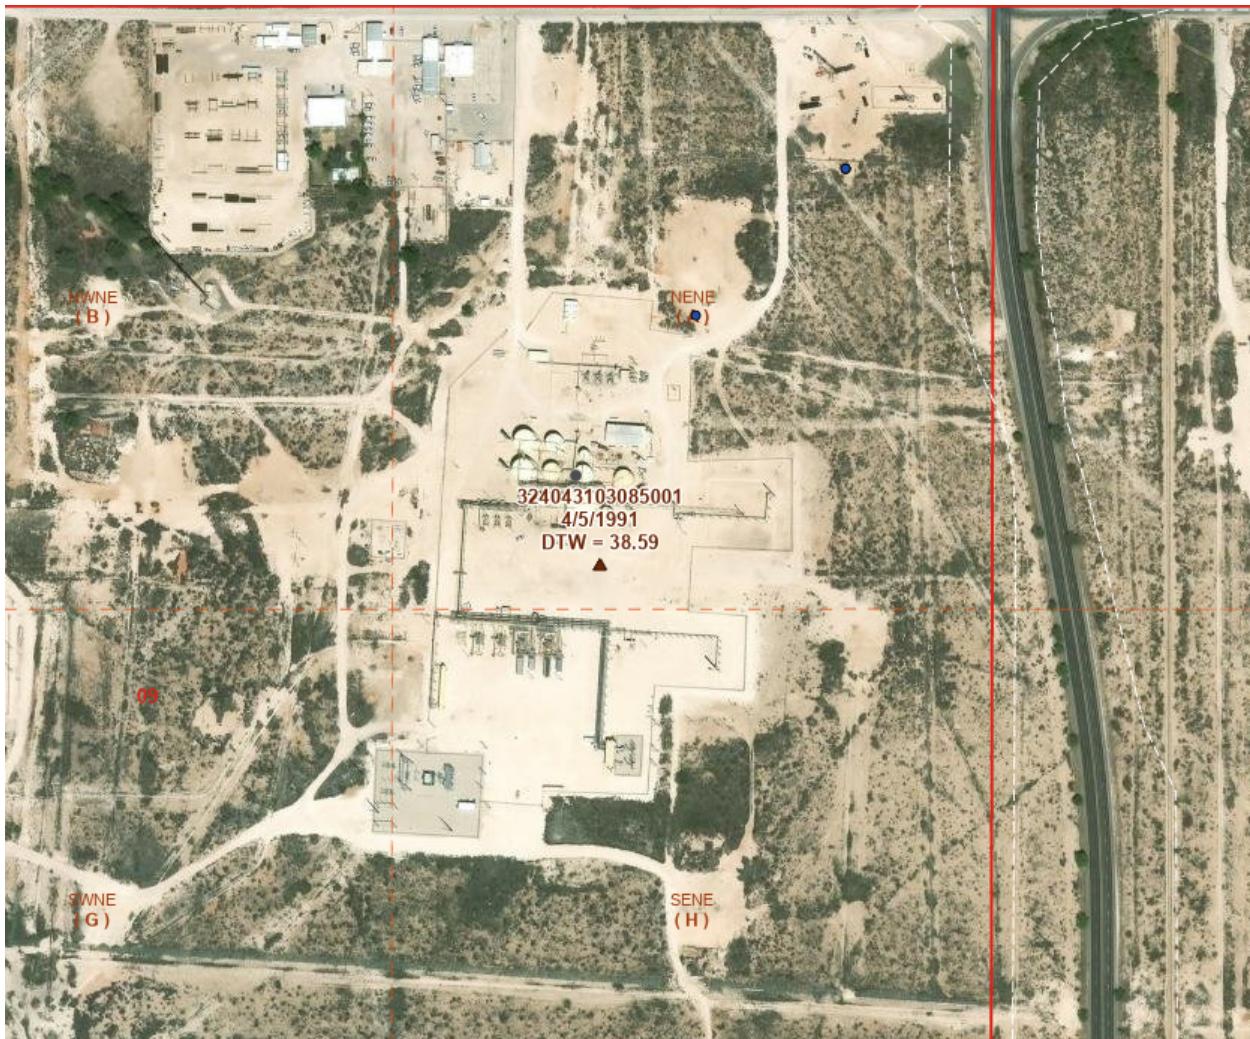
Depth to Water: 26 to 50 feet, determined by USGS
