SUBJECT: Liner Inspection and Closure Report for North Thistle 3 CTB 1– January 9, 2026 Site Visit

Incident ID: nAPP2528041022/nAPP2532836691/nAPP2533532699  
Facility ID (Name): fAPP2130622273 (NORTH THISTLE 3 CTB 1)  
Facility Location: Unit P of Section 3, Township 23 South, Range 33 East, New Mexico  
Facility GPS Coordinates: 32.329904, -103.553590  
Lea County, New Mexico

# Environmental Liner Inspection Field Notes & Photolog Report

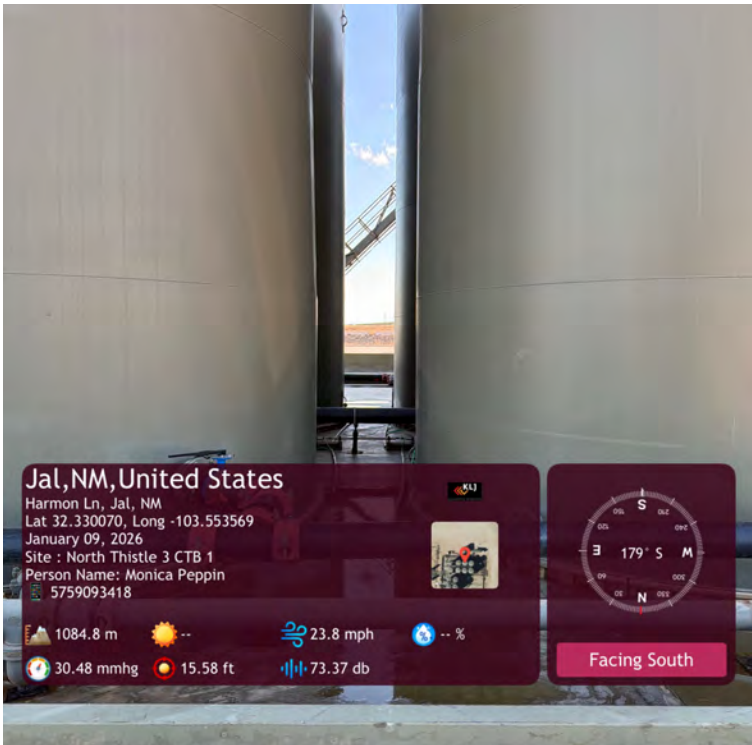
- 1:51 PM – Arrived on Site. Conducted a site safety assessment, reviewed potential hazards, and completed required safety documentation.
- 2:05 PM – Walked the lined secondary containment to visually assess overall conditions and confirm liner integrity.
- 2:04 PM – Initiated inspection activities within the lined secondary containment area. Visual observations focused on liner surface conditions, piping, and tank bases.
- 2:21 PM – No visible tears, punctures, or defects in the liner material were observed.

- Liner meets standards to be in compliance.
- No further action for site.
- Draft and finalize closure report for all three incidents.
- Send report for closure request to regulatory agencies.

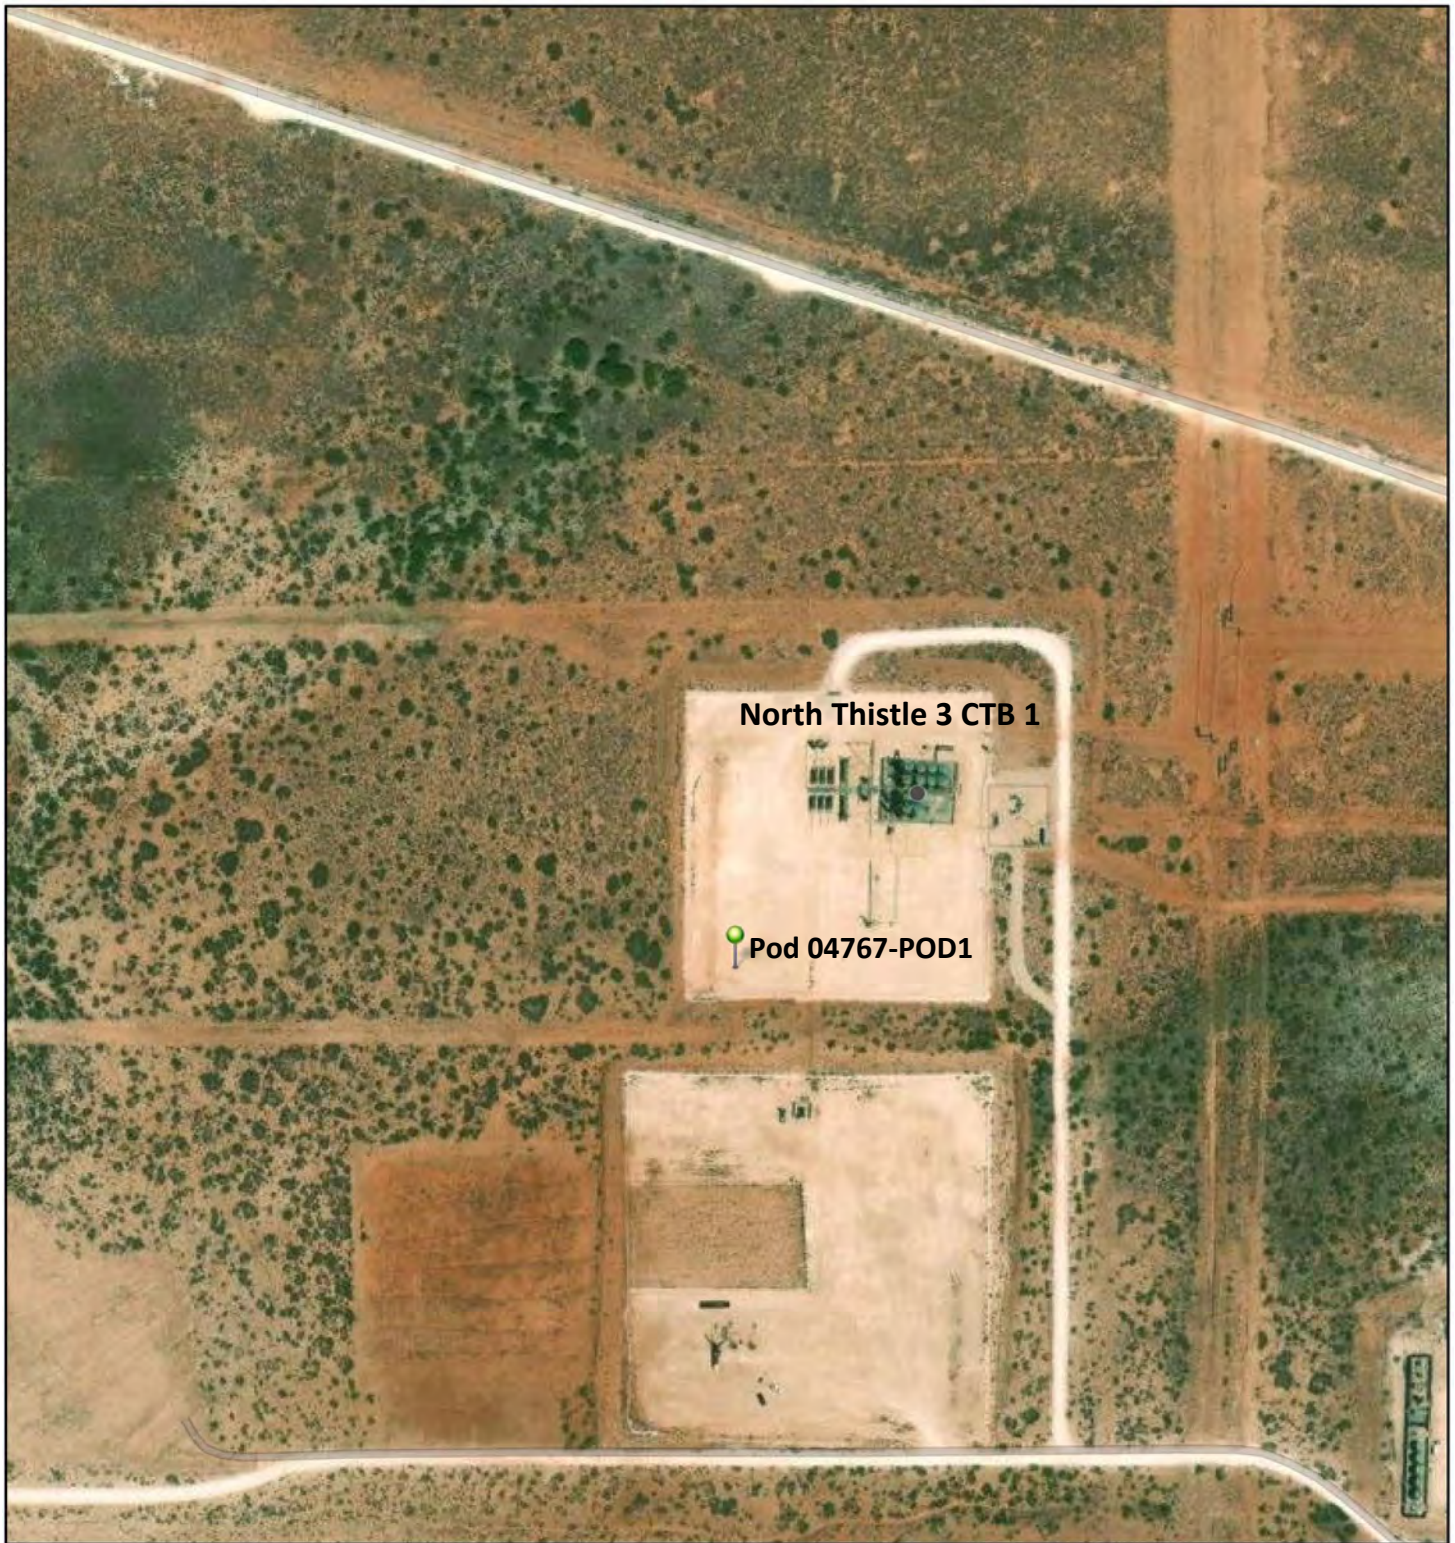
# North Thistle 3 CTB 1 - Nearest Pod for DTGW Determination

**North Thistle 3 CTB 1**  
**Nearest POD**  
04767-POD  
**POD Use**  
Monitor Well/Temp. BH for  
DTGW determination  
**Depth of Well**  
55 ft bgs
