## Release Notification

Site Name: Vacuum Glorietta West Unit #27	Site Type: Injection
Date Release Discovered: <del>08/06/2020</del> 7/29/2020	API# (if applicable): 30-025-31869

External corrosion of 2" buried steel injection line failure resulting in leak to ground.

On 08/17/2020, Chevron reported a release at the Vacuum Glorietta West Unit #27. The release was caused by external corrosion of a 2" buried steel injection line failure. Approximately 16,744 sqft. of the Pad and Pasture was found to be damp upon initial inspection.

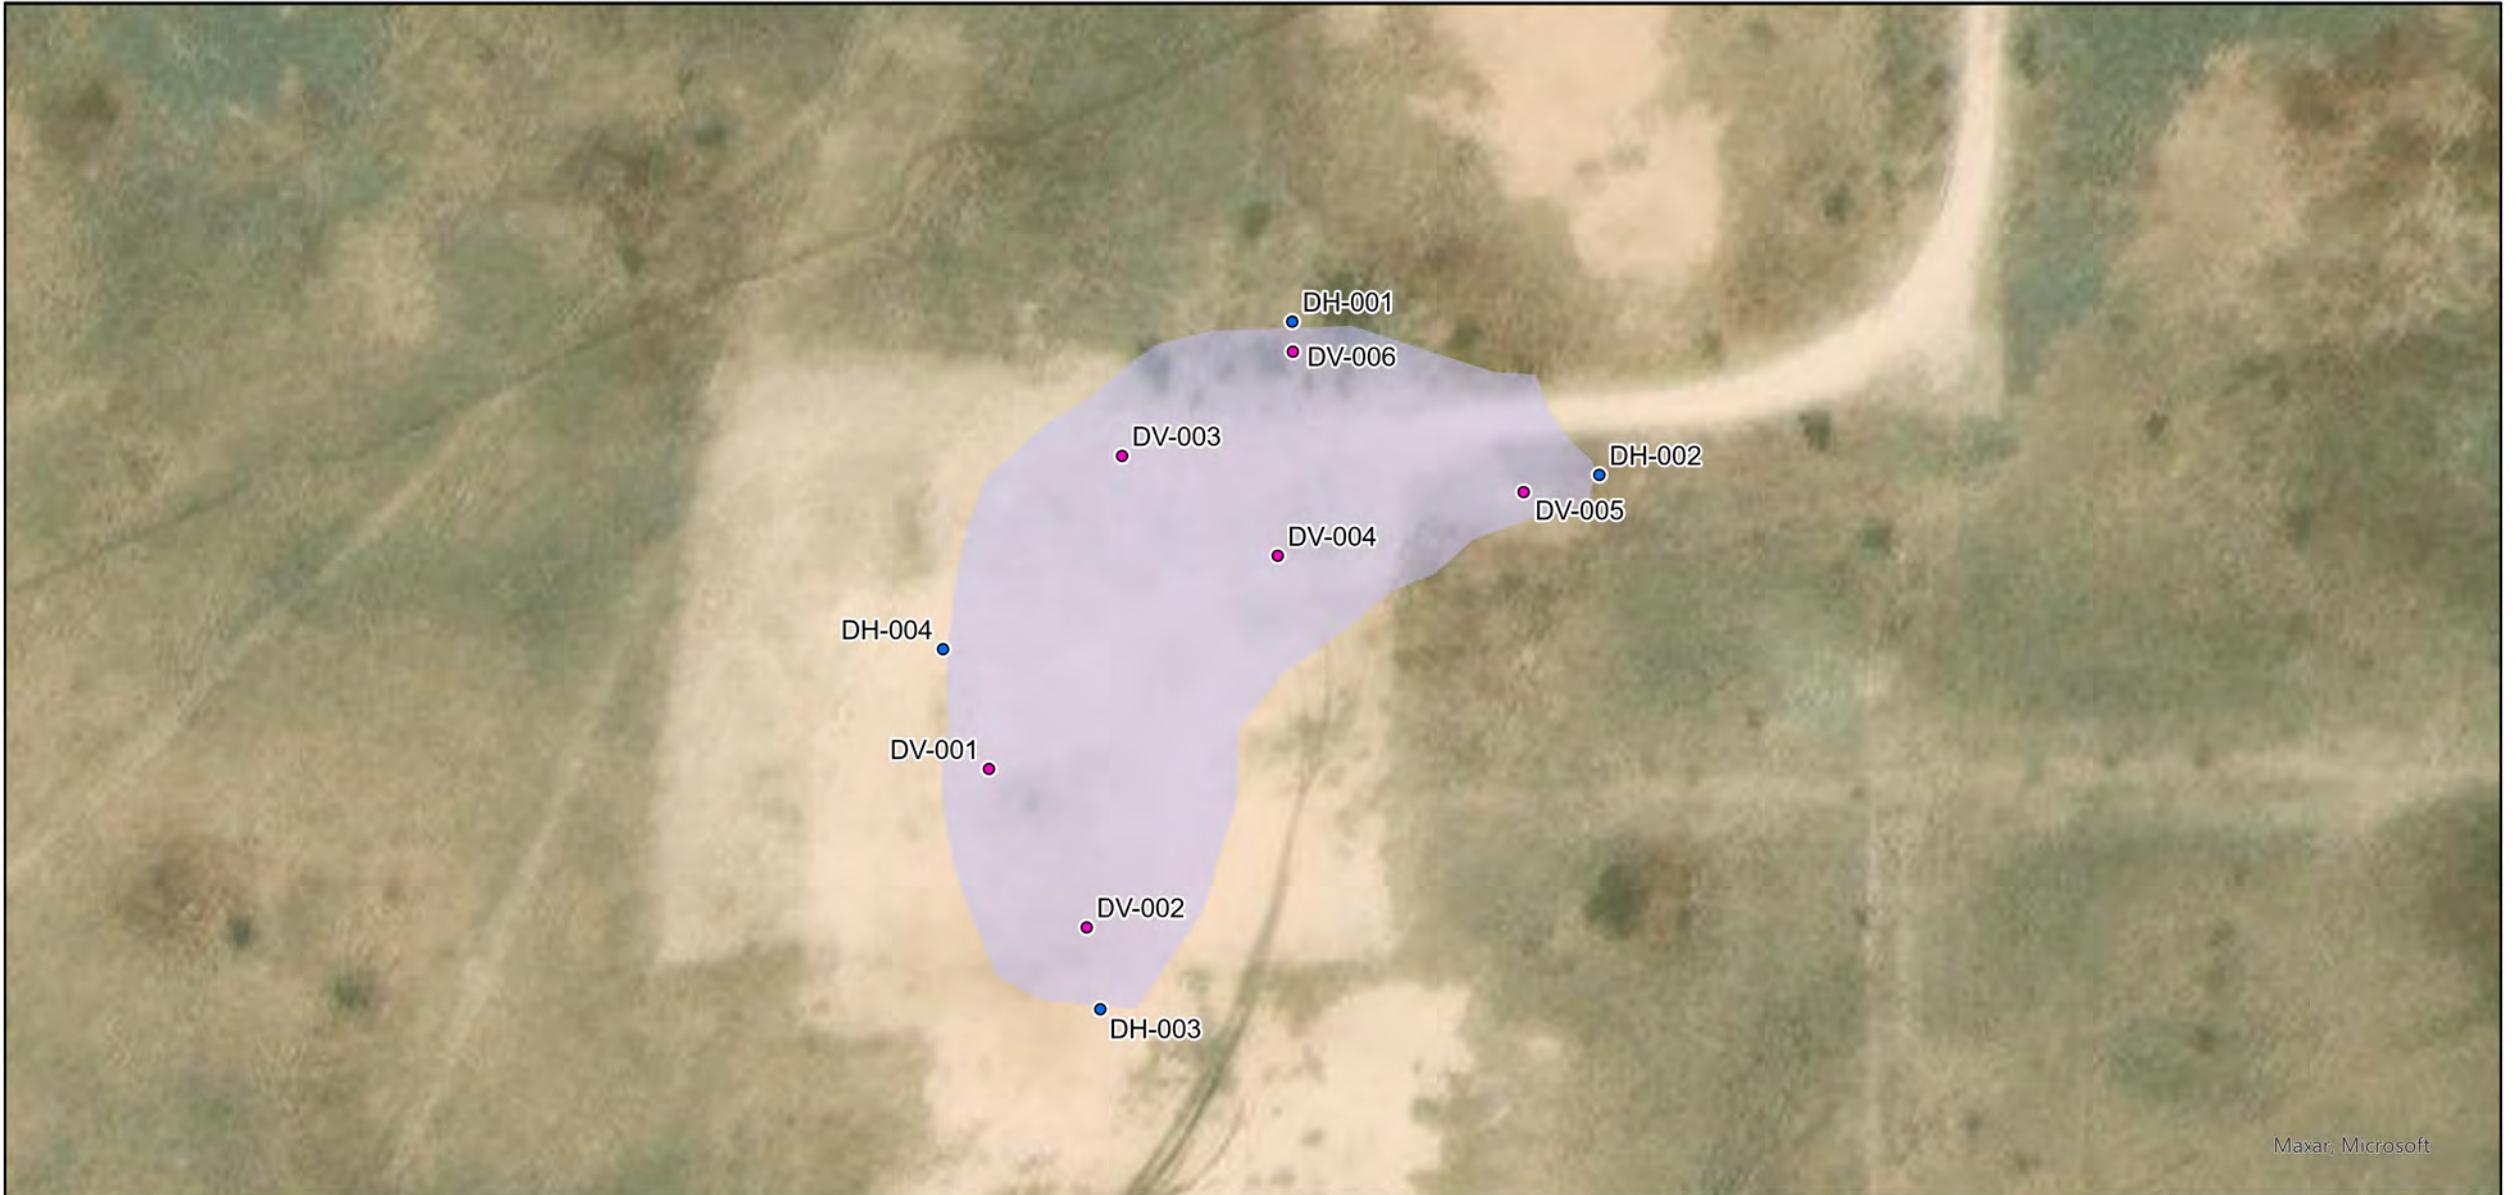
**Delineation Map**  
**MorningStar Operating LLC**  
**Vacuum Glorietta West Unit #27**  
**Lea County, New Mexico**  
**32.8052254, -103.5228958**  
**NMOCD Reference # NRM2023058280**

- Vertical Delineation
- Horizontal Delineation
- Release Area

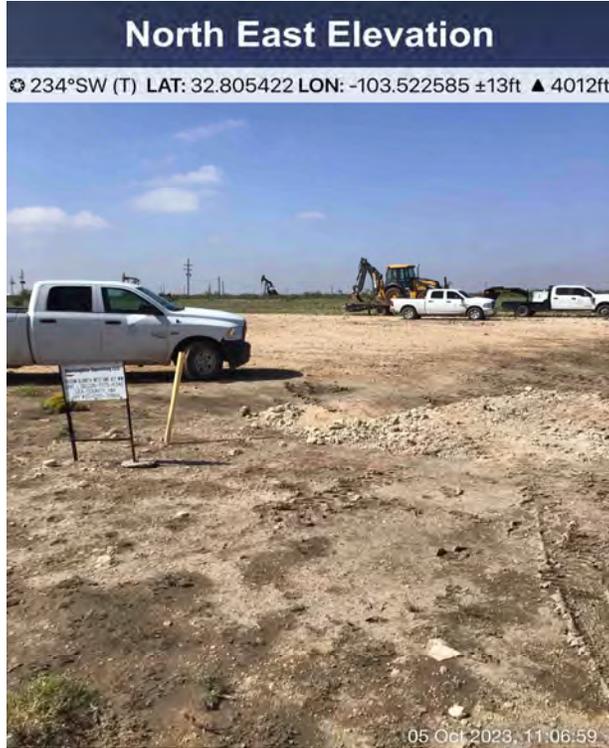
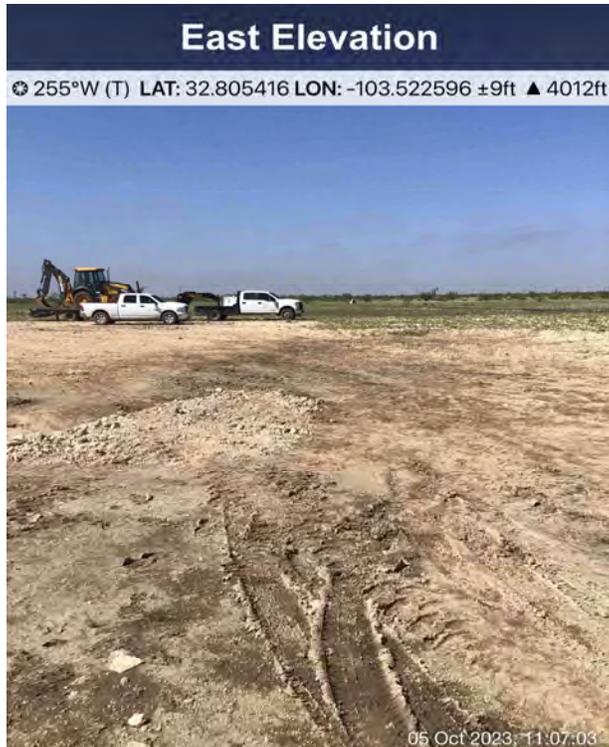
**Initial Release**

**Pad:**

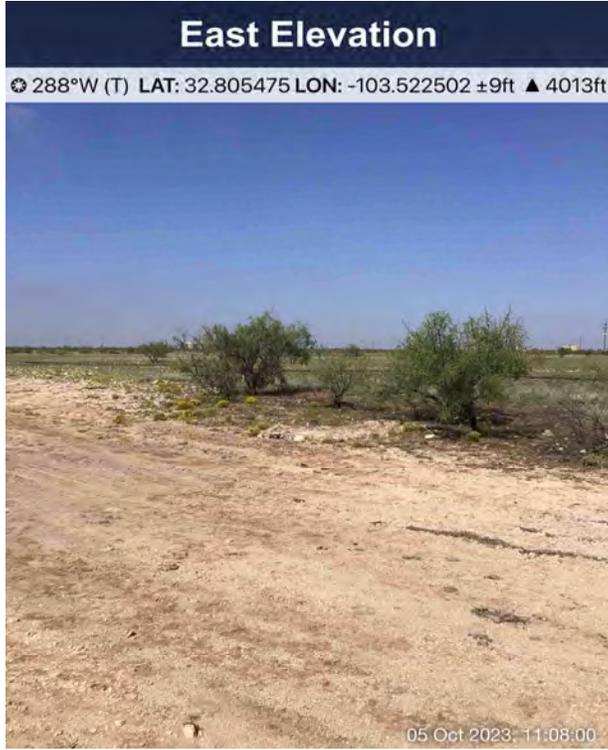
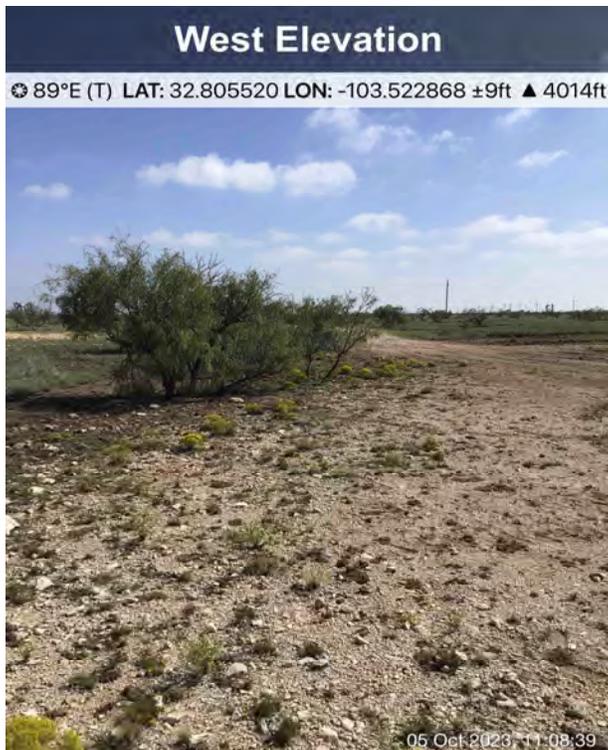
**Initial Release**

**Pasture:**

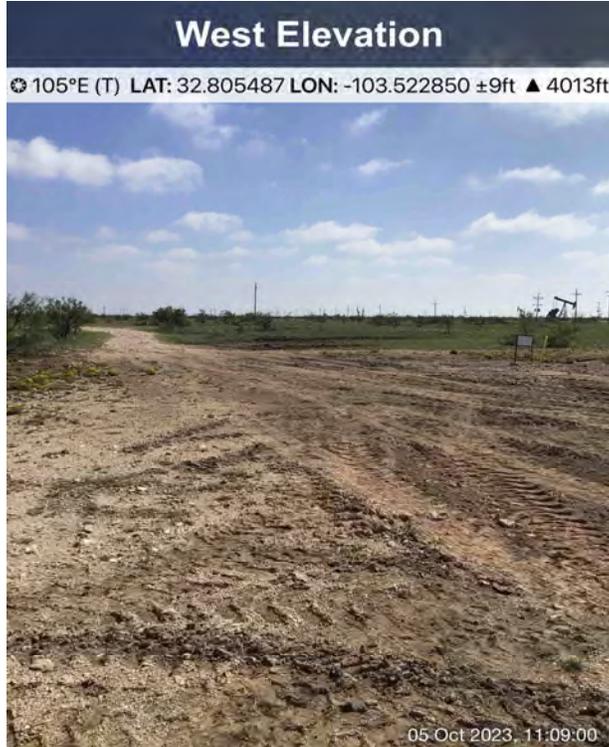
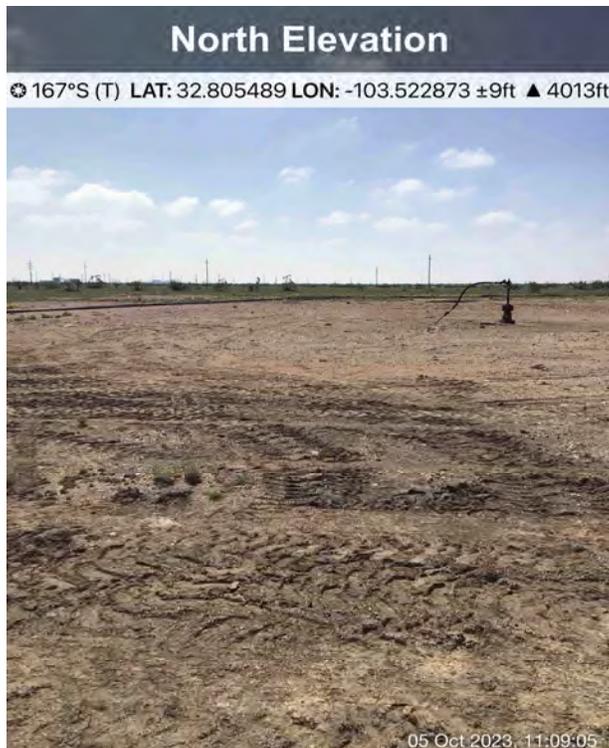
**Initial Release**

**Pad:**

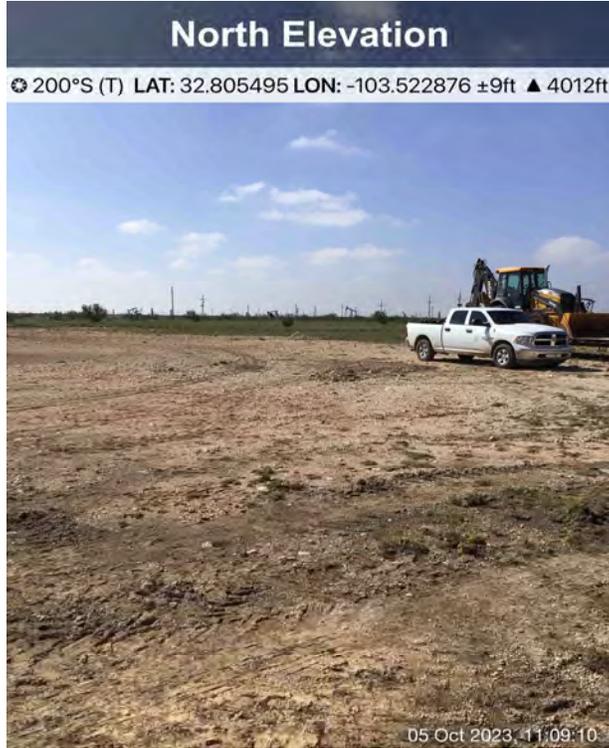
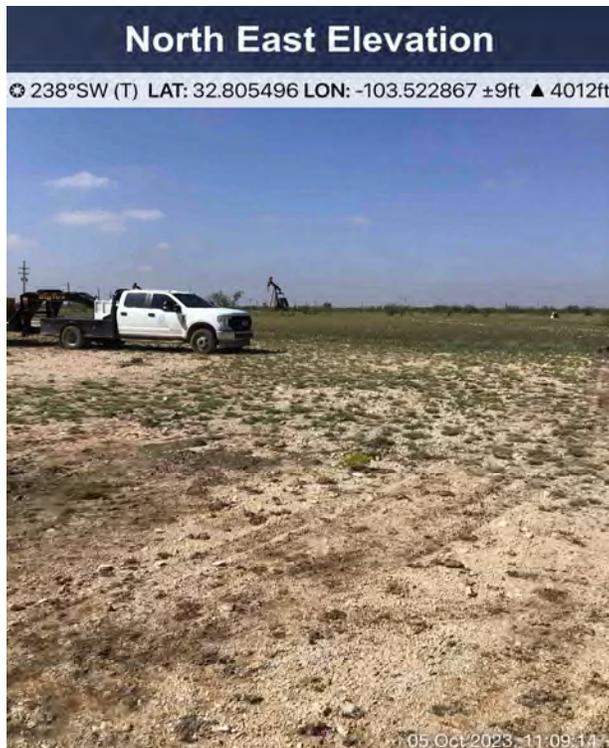
**Initial Release**

**Pad:**

**Pasture:**

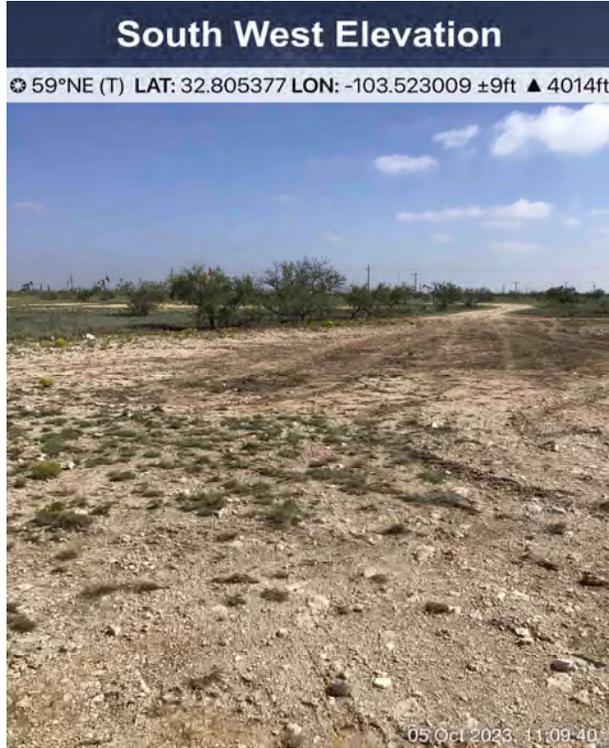
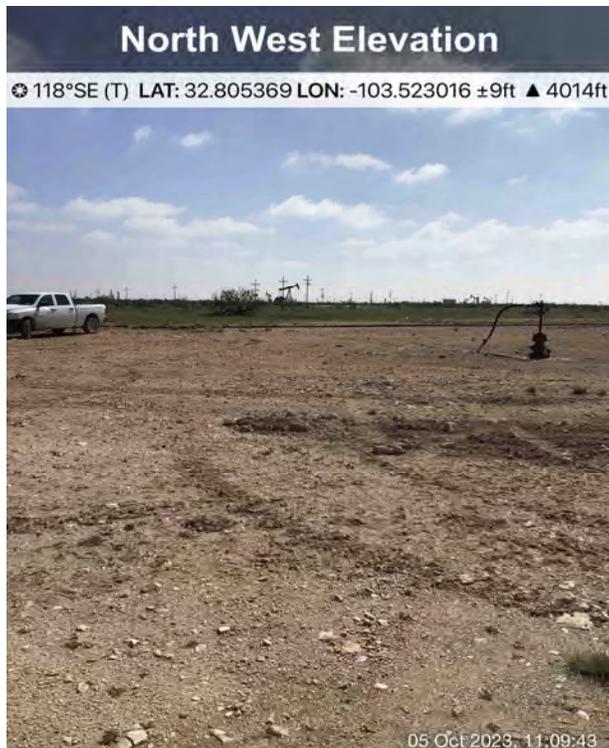
**Initial Release**

**Pad:**

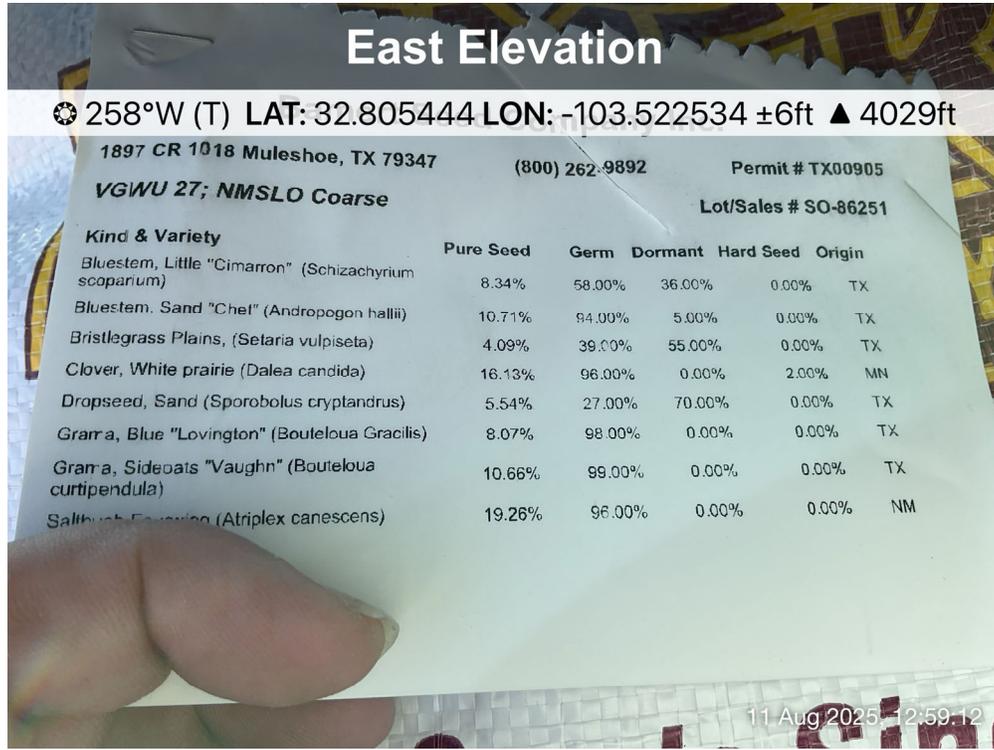
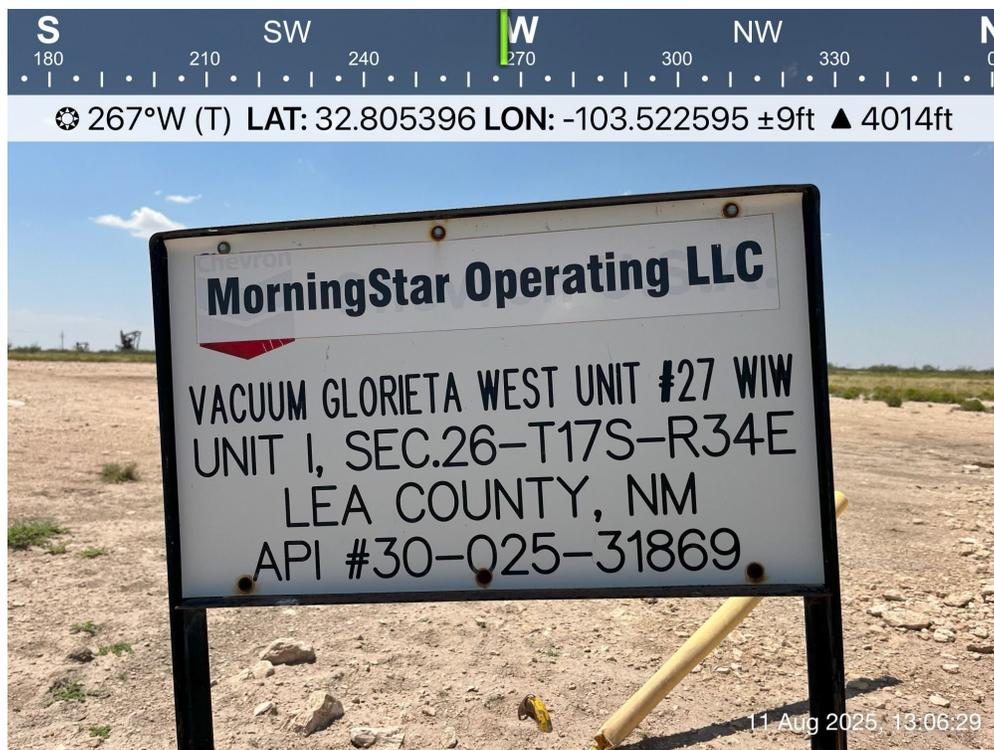
### Seeding Area

#### Seed Tag:

#### Pasture:

Areas affected by the release are being restored to a condition that existed before the release to the extent practicable. On 08/11/2025, the site was hand seeded with the prescribed NMSLO seed mixture (SLO Seed Mix Version 1-200808 for Coarse (CS) Sites). Following distribution, the seed was incorporated into the soil surface by raking to promote proper seed-to-soil contact.
