**C-141 - CO2 GAS RELEASE ONLY (No Liquids)**  
**EVENT SUMMARY, VARIANCE REQUEST & CLOSURE REQUEST REPORT**

**Facility ID:** fjXK1530631838

**Facility Name:** South Hobbs RCF**Flare Date:** 1/26/2026**Duration of Event:** 0hours and 15mins**MCF Flared:** 378 MCF**Start Time:** 12:00 AM**End Time:** 12:15 AM**Cause:** controlled release of gas only, no liquids involved - combusted in a flare to reduce emissions;

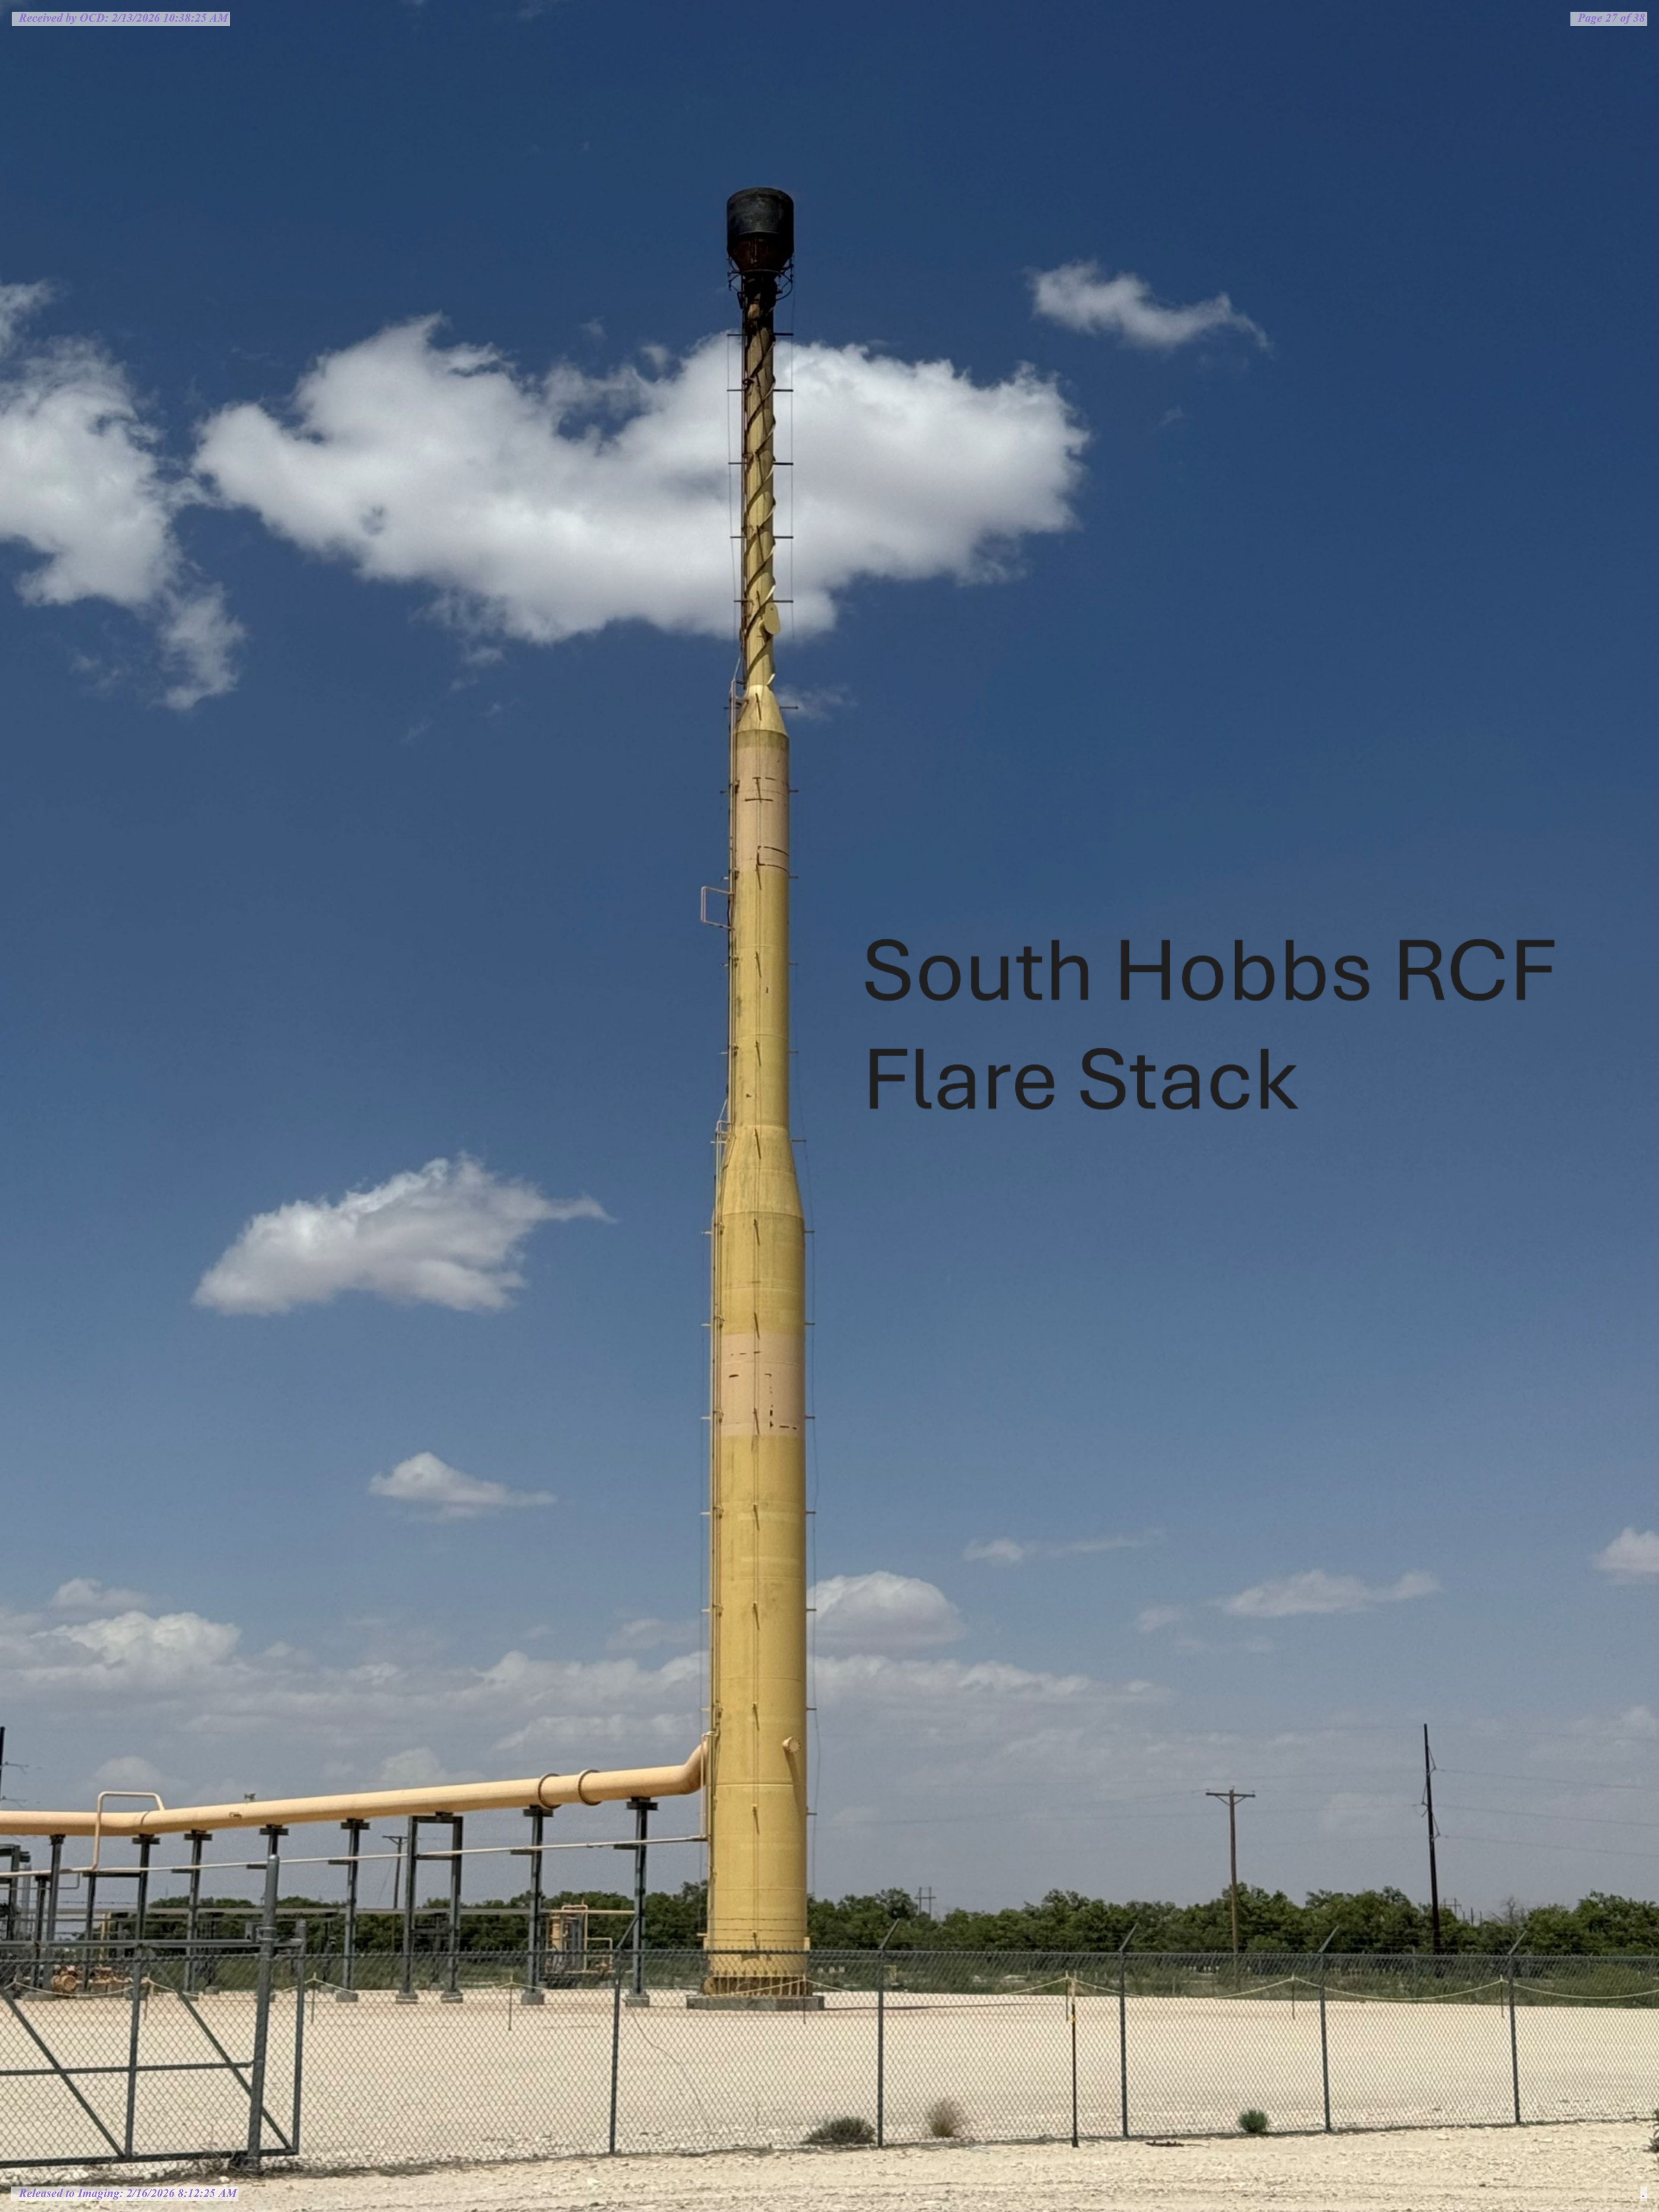
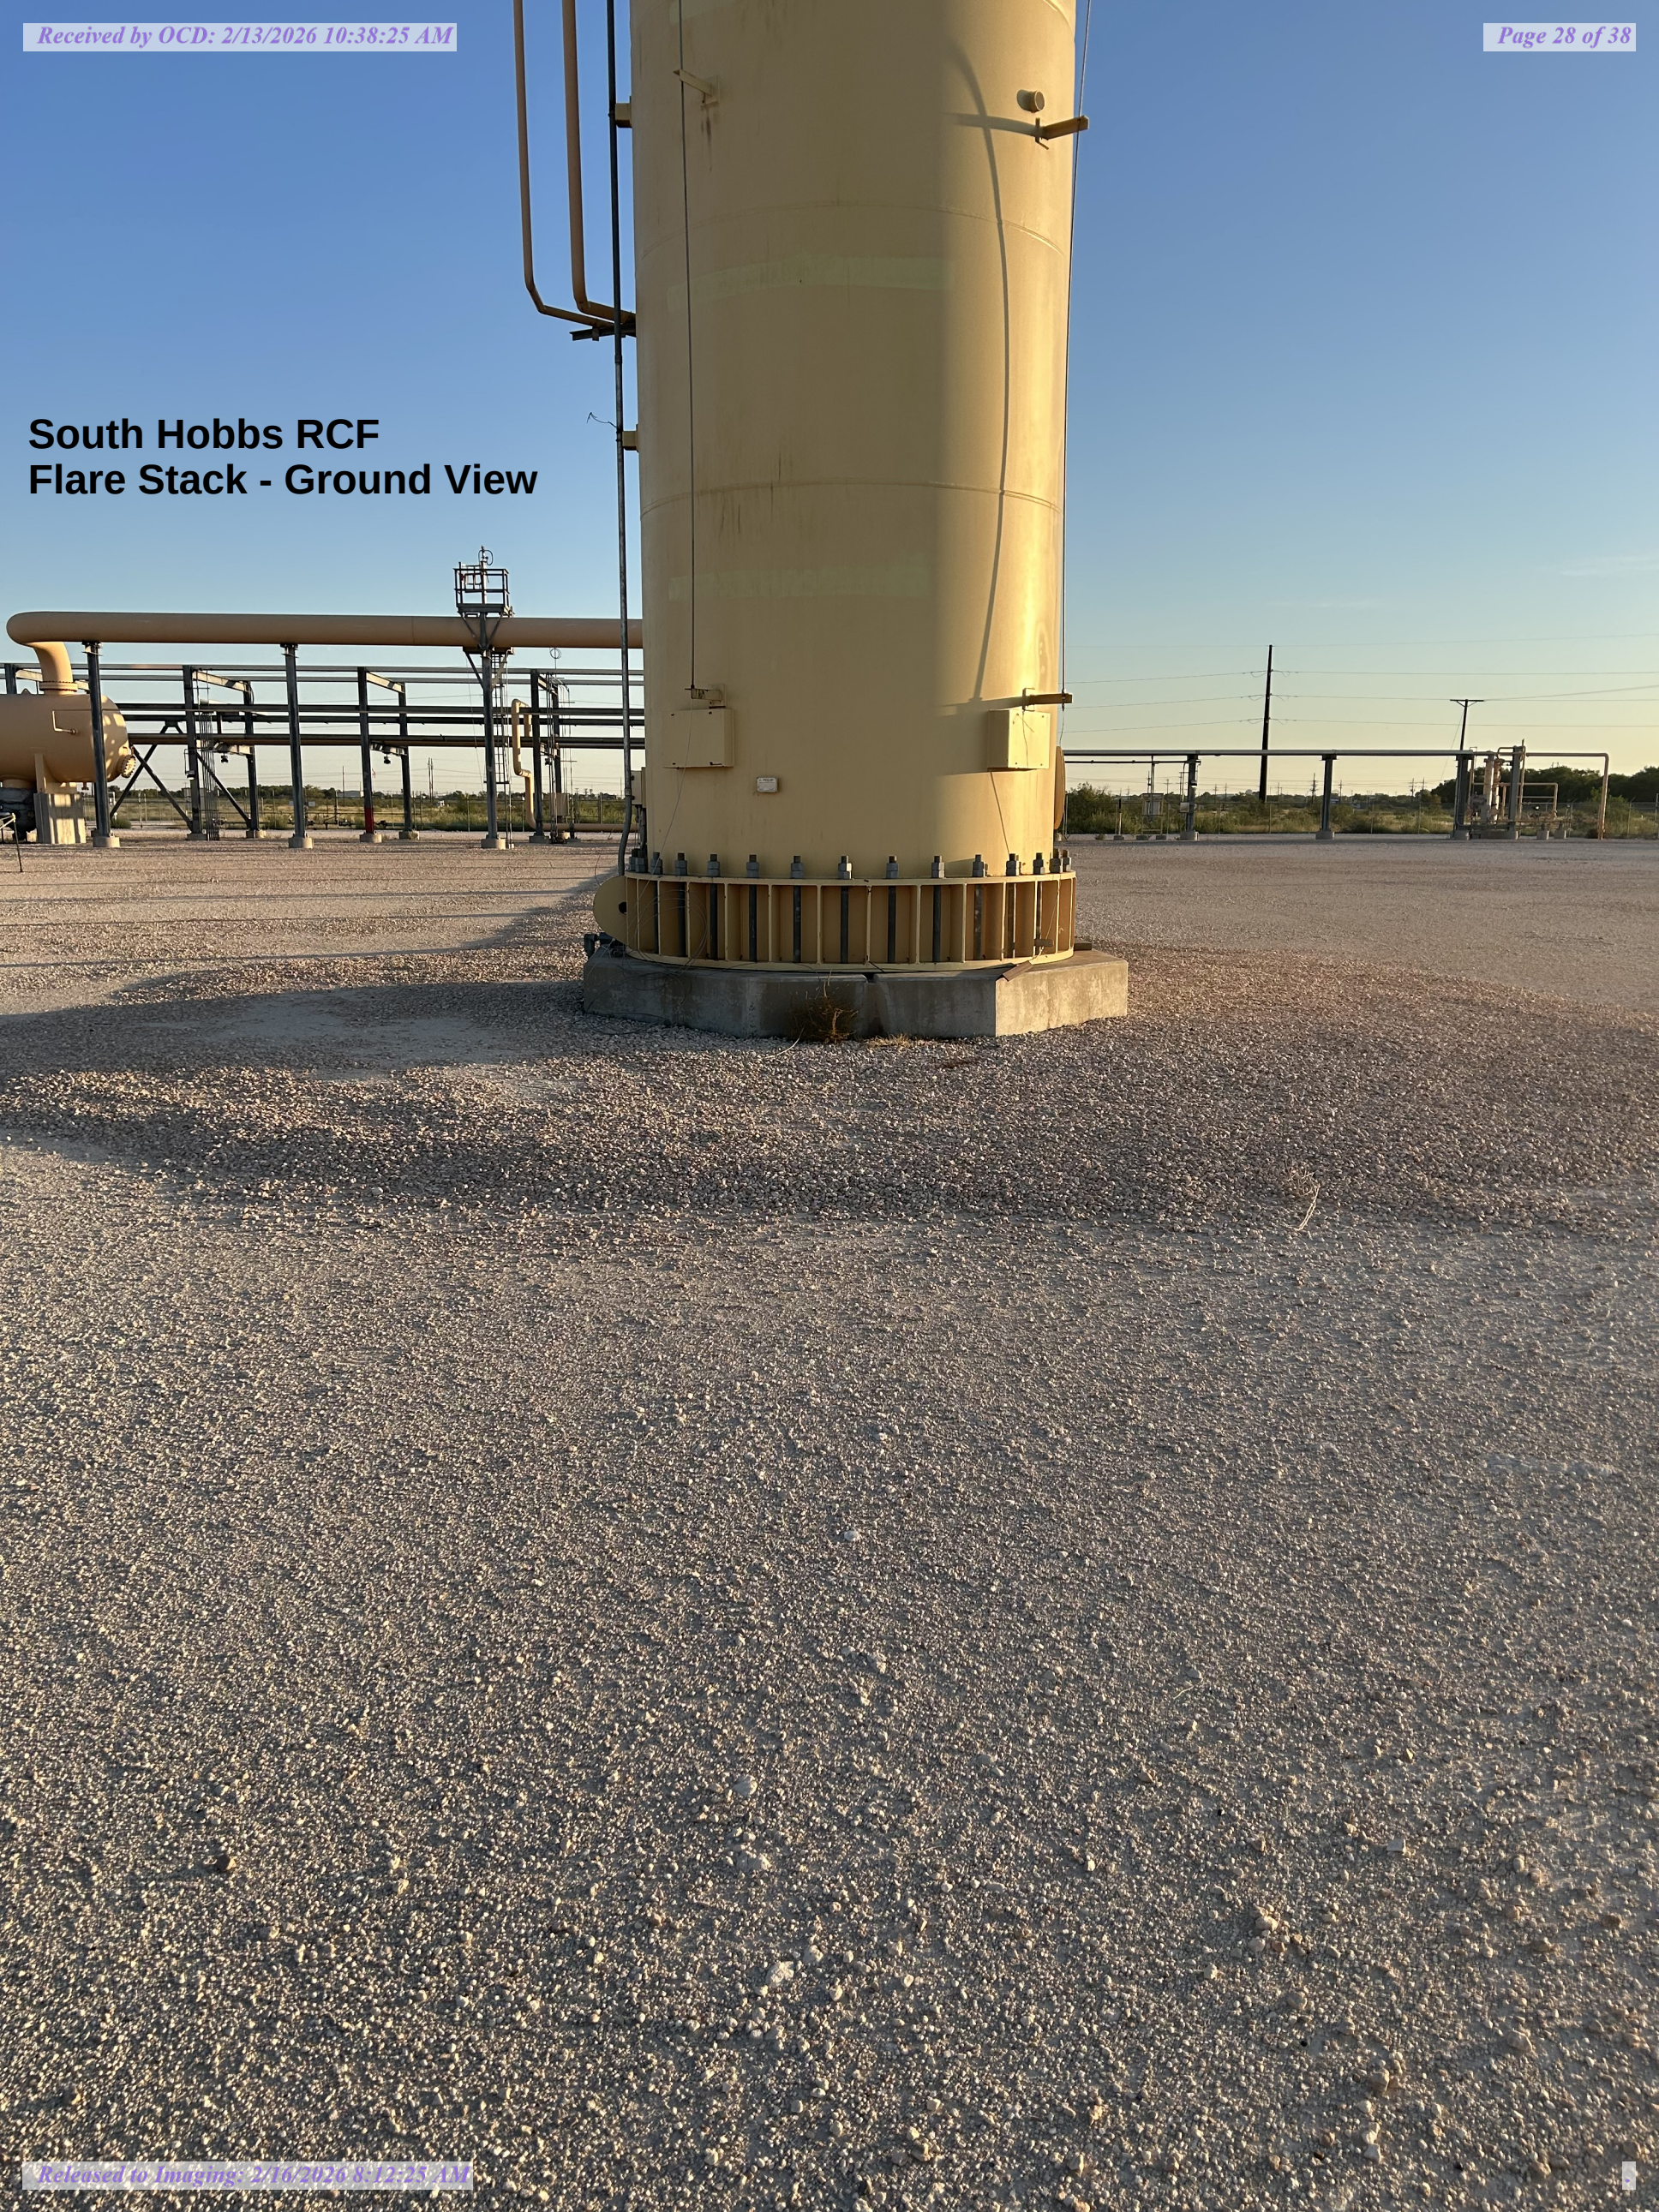
# South Hobbs RCF Flare Stack

**South Hobbs RCF  
Flare Stack - Ground View**
