**RE: Florance Gas Com J #016  
2025 Annual Monitoring Report**

Cottonwood Consulting LLC (Cottonwood) is pleased to provide Simcoe LLC (Simcoe) with the results of the soil vapor extraction (SVE) monitoring conducted at the Florance Gas Com J #016 well site (API 30-045-09800). Details regarding the methodology and associated results are summarized below.

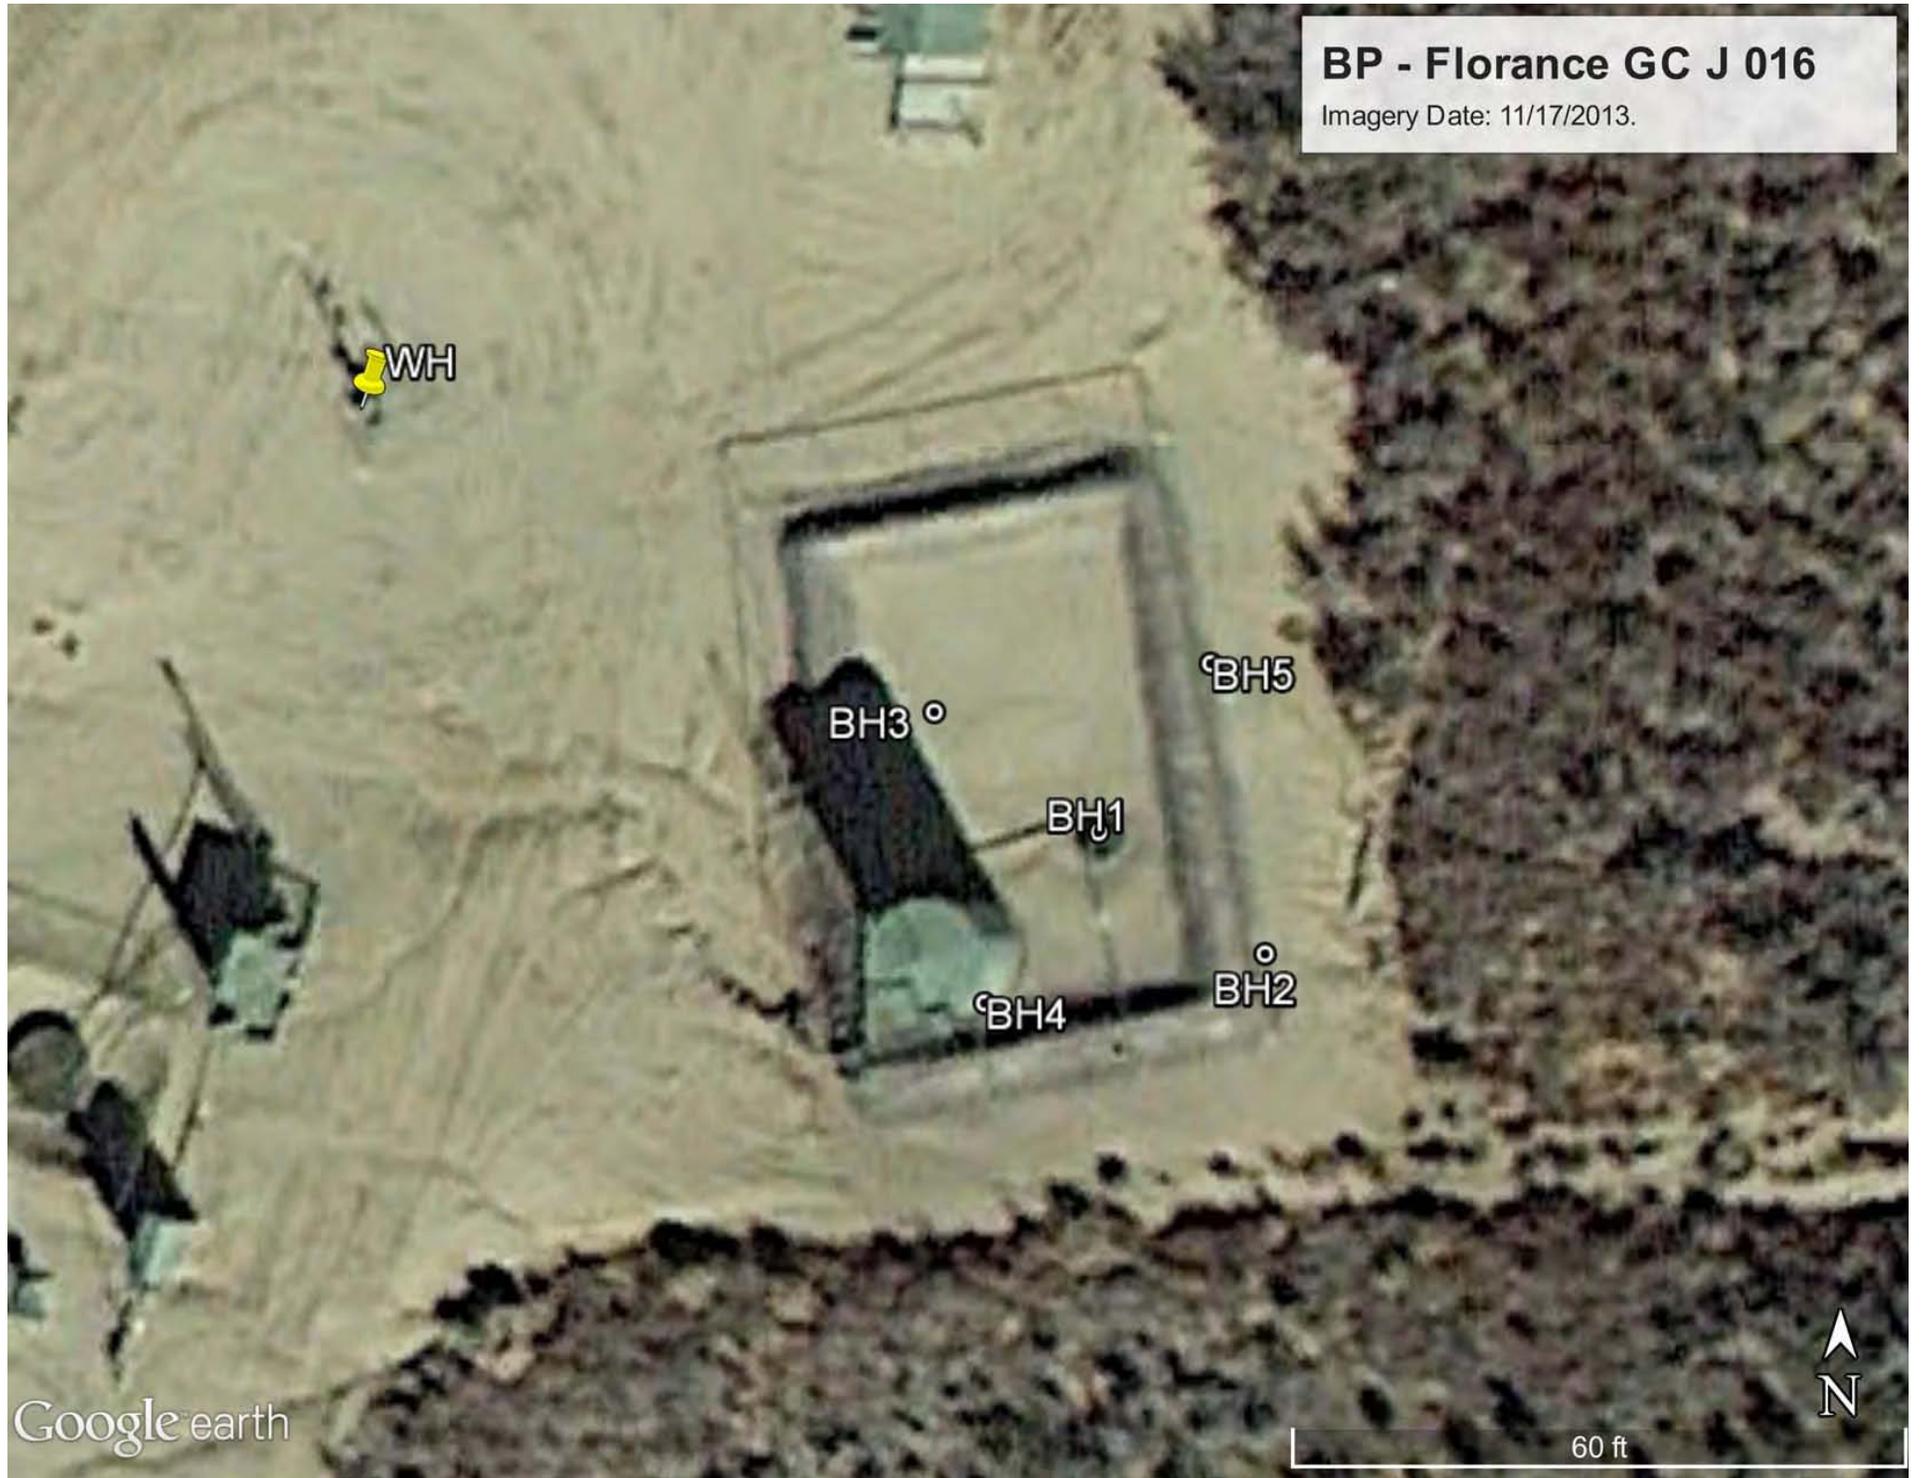
**FIGURE 1**

In March 2014, impacted soils were discovered during the closure of a below-grade tank (BGT) at the Florance Gas Com J #016 well site. Soil boring results indicated that the area below the former BGT was impacted. The SVE system was installed to perform in-situ remediation of these soils. The SVE system was installed in February 2016 (Figure 1).

**BP - Florance GC J 016**

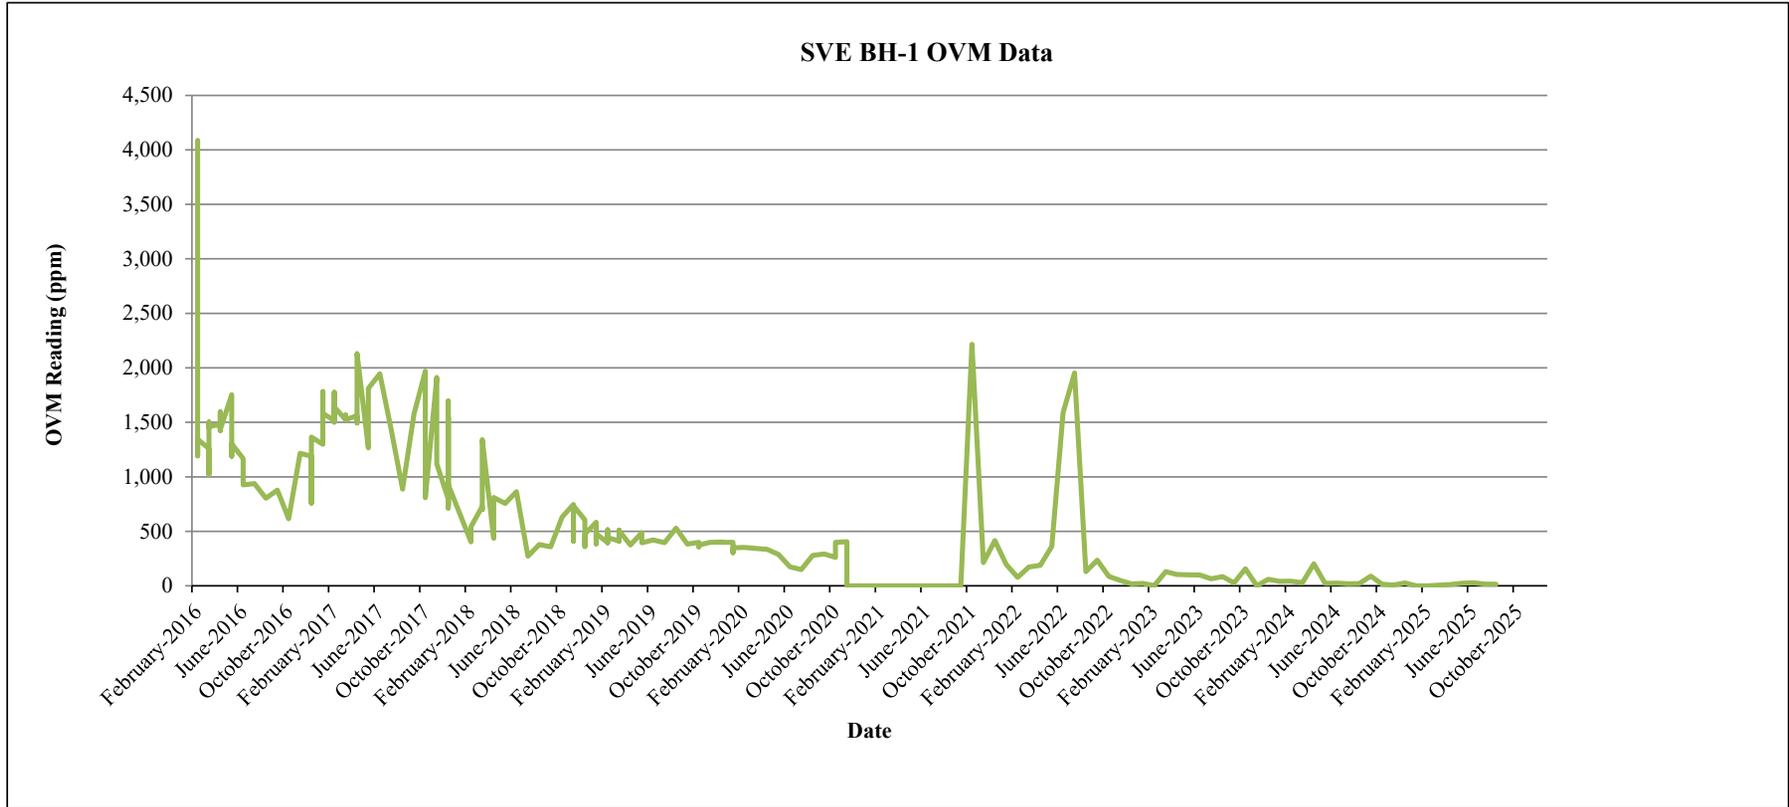
**FIGURE 2**

It appears that the SVE system has reduced OVM readings in SVE point BH-1. OVM readings have been on a general downward trend since the system began extraction, with the exception of readings collected in October 2021 and June and July 2022. See Figure 2 for OVM reading results in BH-1 and Attachment 1 for a summary of the SVE System Monitoring Data.

**Florance Gas Com J #016  
OVM Reading Results  
Simcoe LLC**

OVM readings have trended downward since the system began extraction. Simcoe will continue to conduct regular monitoring at the Florance Gas Com J #016 SVE system. In the future, Simcoe may advance subsurface soil borings to verify closure standards are met.
