SUBJECT: Liner Inspection and Closure Report for North Thistle 3 CTB 1– January 9, 2026 Site Visit

Incident ID: nAPP2528041022/nAPP2532836691/nAPP2533532699  
Facility ID (Name): fAPP2130622273 (NORTH THISTLE 3 CTB 1)  
Facility Location: Unit P of Section 3, Township 23 South, Range 33 East, New Mexico  
Facility GPS Coordinates: 32.329904, -103.553590  
Lea County, New Mexico

# LINER INSPECTION FIELD NOTES & PHOTOLOG REPORT

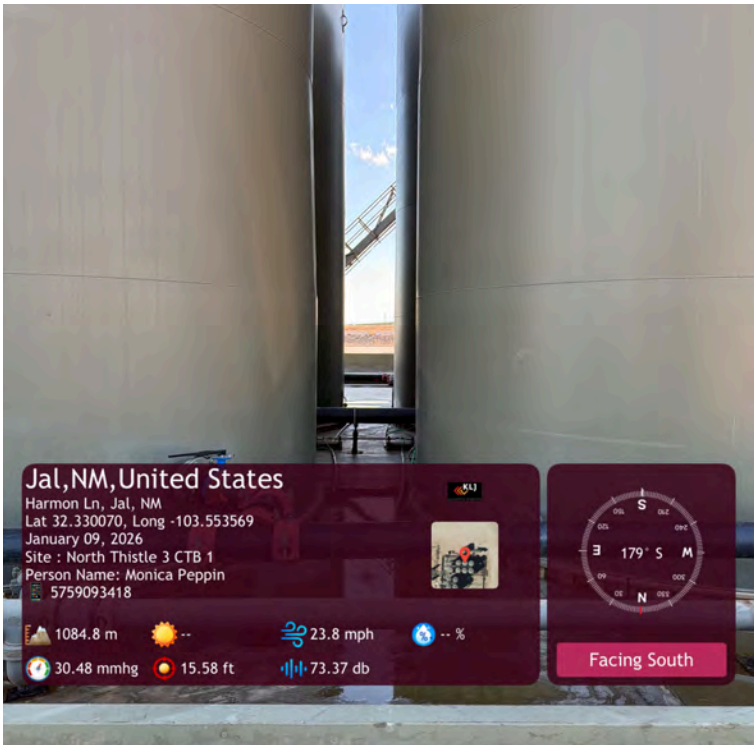
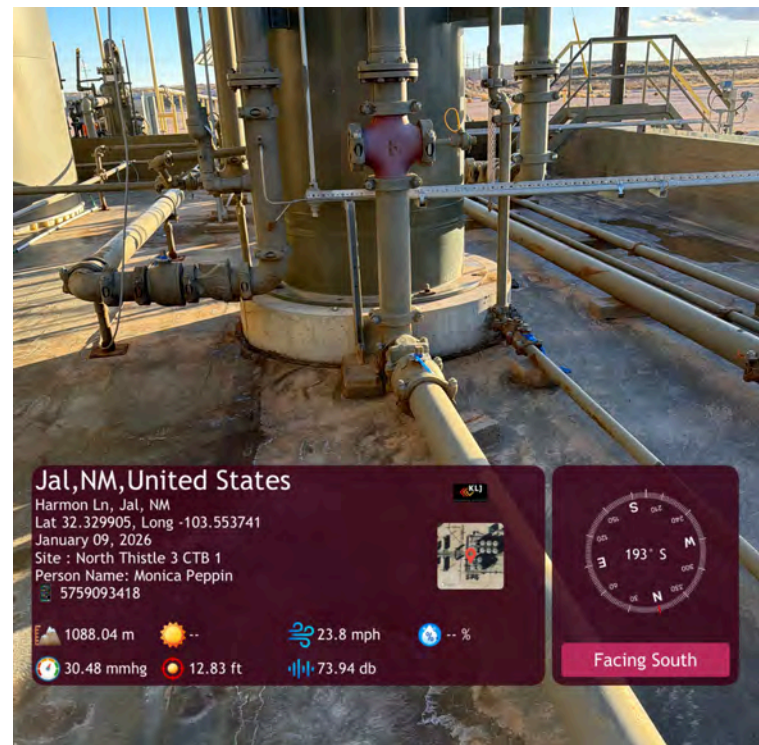
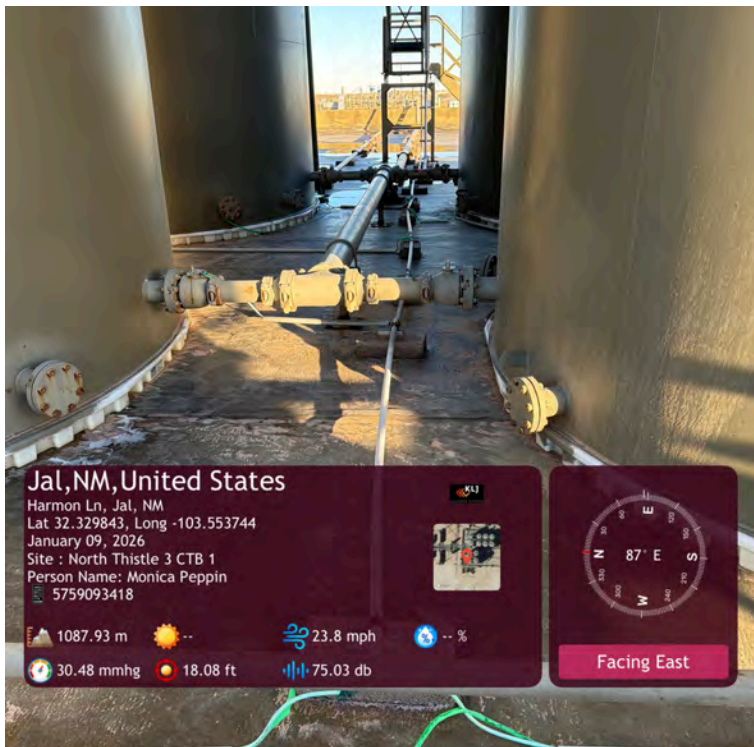
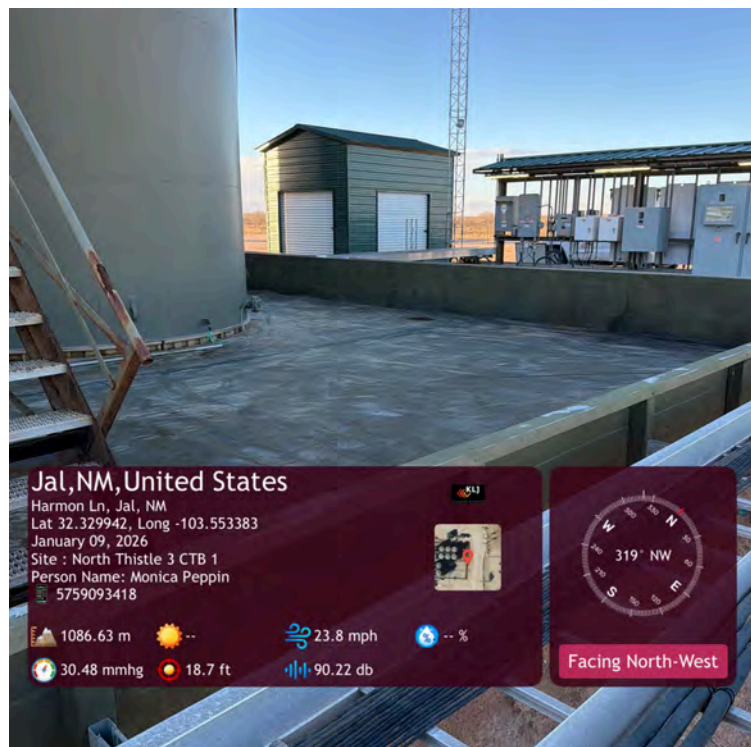
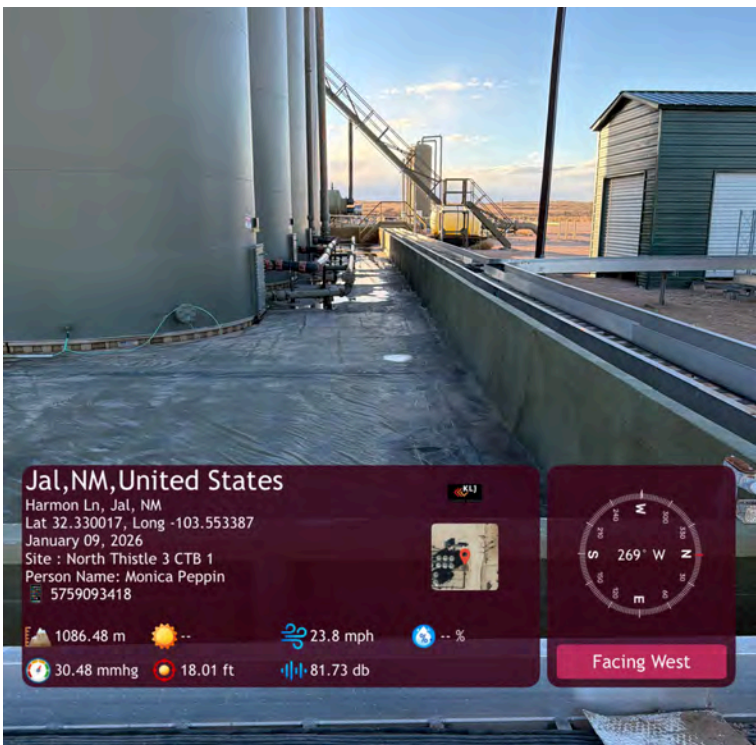
# Photolog

- 1:51 PM – Arrived on Site. Conducted a site safety assessment, reviewed potential hazards, and completed required safety documentation.
- 2:05 PM – Walked the lined secondary containment to visually assess overall conditions and confirm liner integrity.
- 2:04 PM – Initiated inspection activities within the lined secondary containment area. Visual observations focused on liner surface conditions, piping, and tank bases.
- 2:21 PM – No visible tears, punctures, or defects in the liner material were observed.

- Liner meets standards to be in compliance.
- No further action for site.
- Draft and finalize closure report for all three incidents.
- Send report for closure request to regulatory agencies.
