**Re: First Quarter 2026 – SVE System Update**

San Juan 28-6 #31  
Rio Arriba County, New Mexico  
Hilcorp Energy Company  
NMOCD Incident Number: NVF1816655680

Ensolum, LLC (Ensolum), on behalf of Hilcorp Energy Company (Hilcorp), presents this *First Quarter 2026 – SVE System Update* report summarizing the soil vapor extraction (SVE) system performance at the San Juan 28-6 #31 natural gas production well (Site) located in Unit M, Section 28, Township 28 North, Range 6 West in Rio Arriba County, New Mexico (Figure 1). Specifically, this report summarizes Site activities performed in January, February, and March of 2026 to the New Mexico Oil Conservation Division (NMOCD).

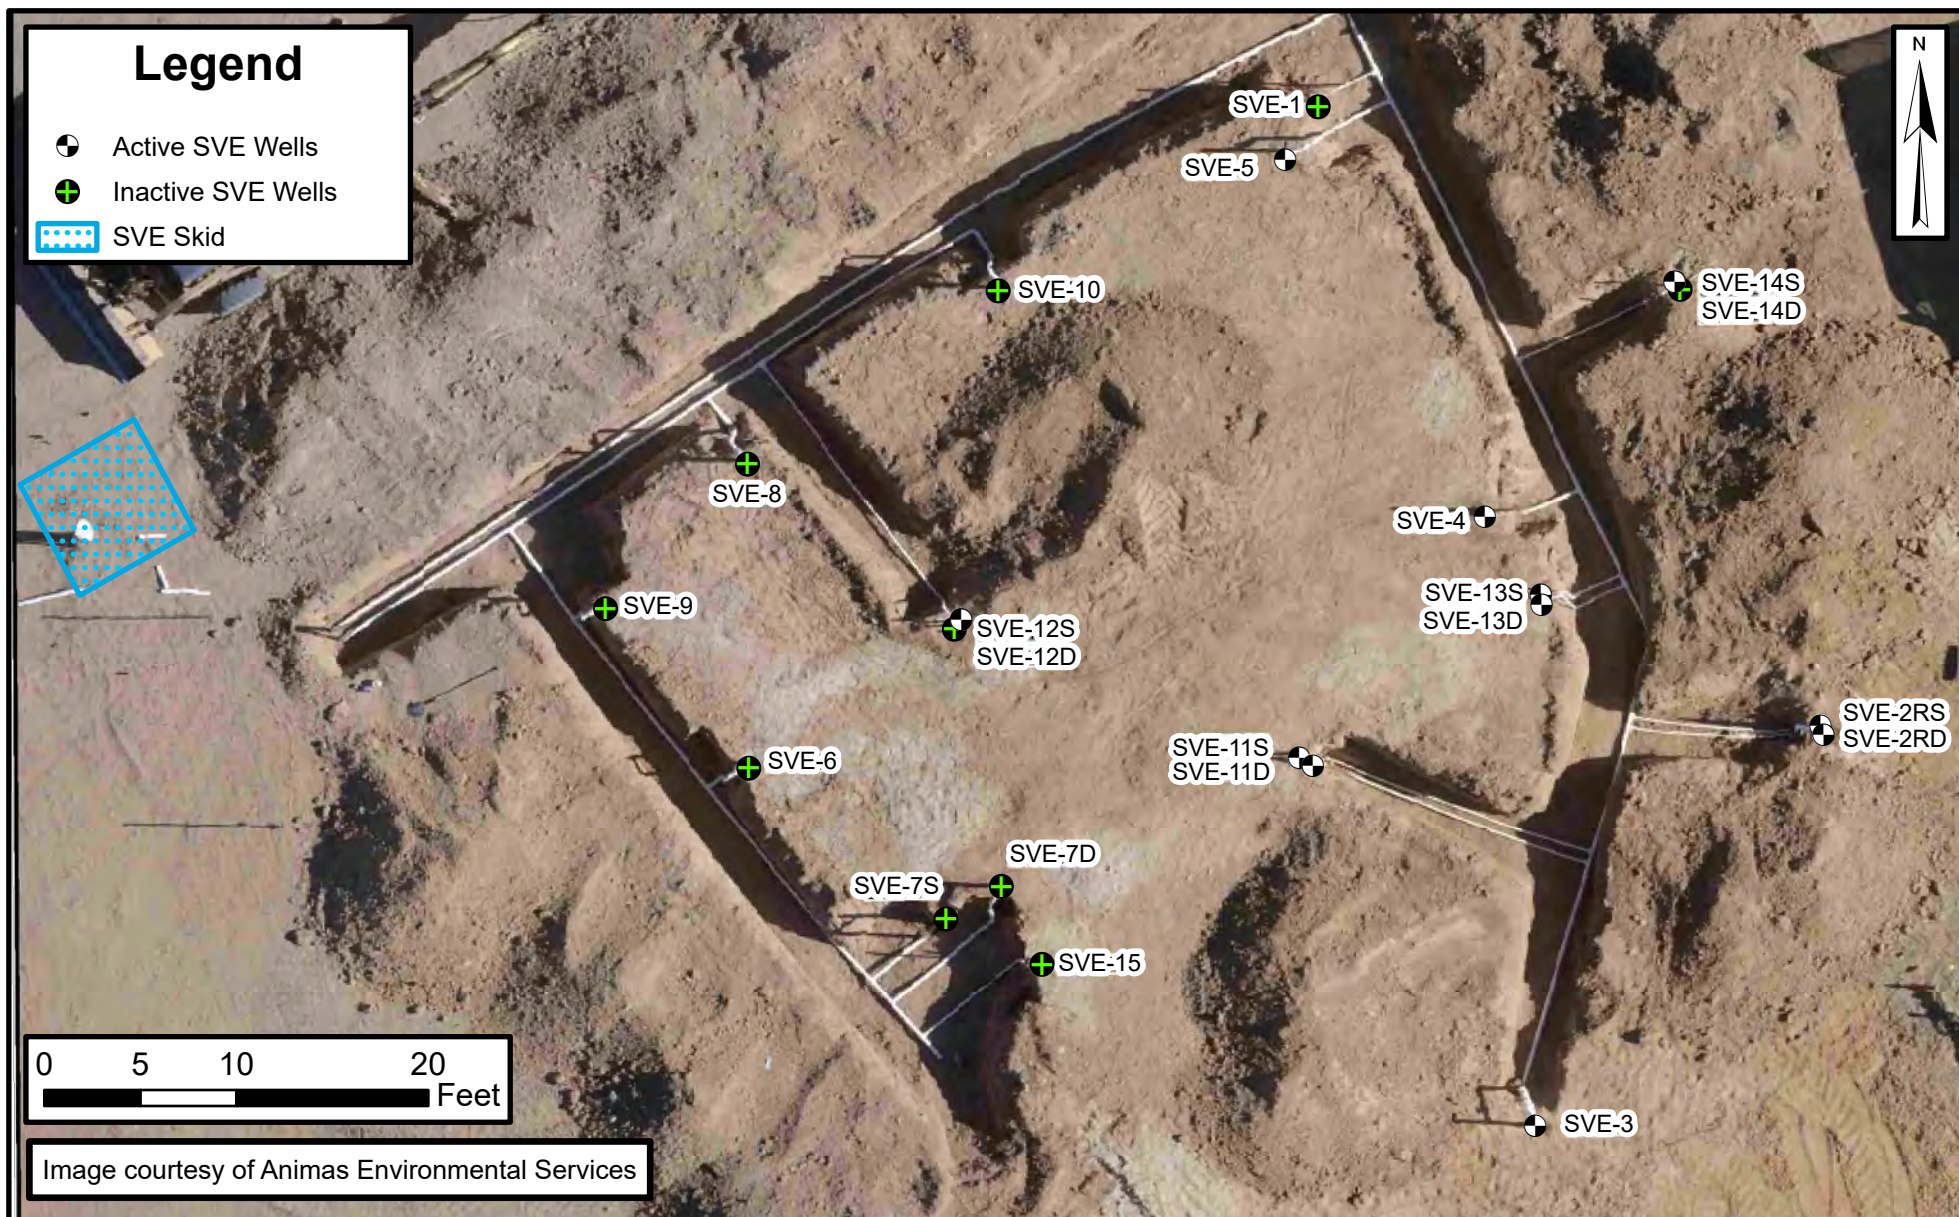
FIGURE  
**2**

# SVE System Configuration

The current SVE system consists of a three-phase, 3 horsepower (HP) Ametek Rotron Model EN656 regenerative blower capable of producing 100 standard cubic feet per minute (scfm) of flow and 50 inches of water column (IWC). In total, 19 SVE wells (SVE-1, SVE-2RS, SVE-2RD, SVE-3, SVE-4, SVE-5, SVE-6, SVE-7S, SVE-7D, SVE-8, SVE-9, SVE-10, SVE-11S, SVE-11D, SVE-12S, SVE-13S, SVE-13D, SVE-14S, and SVE-15) are installed at the Site at varying depth intervals in order to induce air flow through the impacted zones in the subsurface. Two additional deep zone SVE wells (SVE-12D and SVE-14D) were previously installed but are not currently connected to the SVE system. SVE well locations are presented on Figure 2. Additionally, the power for the SVE system was converted from generator to a permanent power drop on April 20, 2022. Specifically, the voltage capacity of the power drop at the Site was increased in order to run the SVE system and negate the need for a generator to power the system. This was determined to be necessary based on reliability issues with the generators used at the Site.
