Closure Report
Amazing Riser (01.04.26)
Lea County, New Mexico
Incident ID: nAPP2600644999
Unit A Sec 15 T23S R32E
32.309365°, -103.656672°

Produced Water Release
Point of Release: Equipment Failure on Pump
Release Date: 01/04/2026
Volume Released: 10 Barrels of Produced Water
Volume Recovered: 5 Barrels of Produced Water

**Re: Closure Report
Amazing Riser (01.04.26)
EOG Resources, Inc
Incident ID: nAPP2600644999
Site Location: Unit A, S15, T23S, R32E
(Lat 32.309365°, Long -103.656672°)
Lea County, New Mexico**

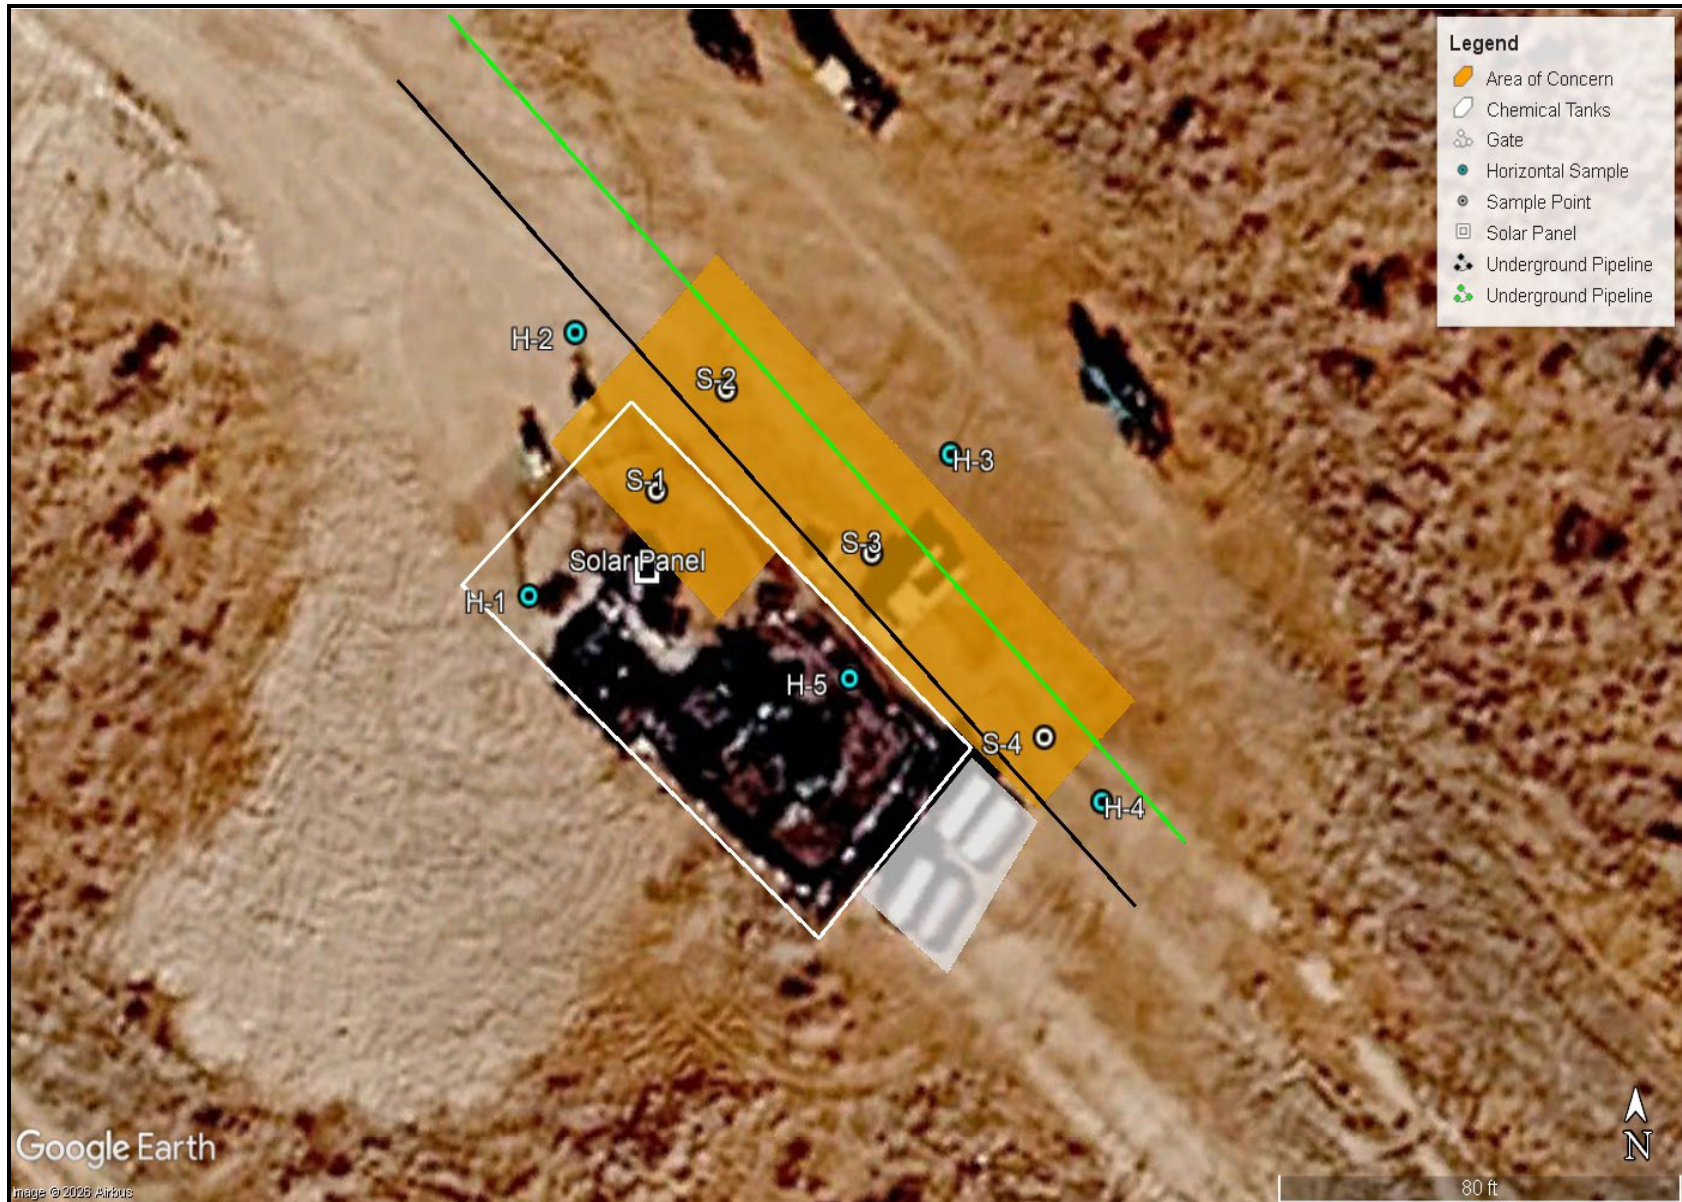
FIGURE 3

SAMPLE LOCATION MAP
EOG RESOURCES
AMAZING RISER (01.04.26)
LEA COUNTY, NEW MEXICO
32.309365°, -103.656672°

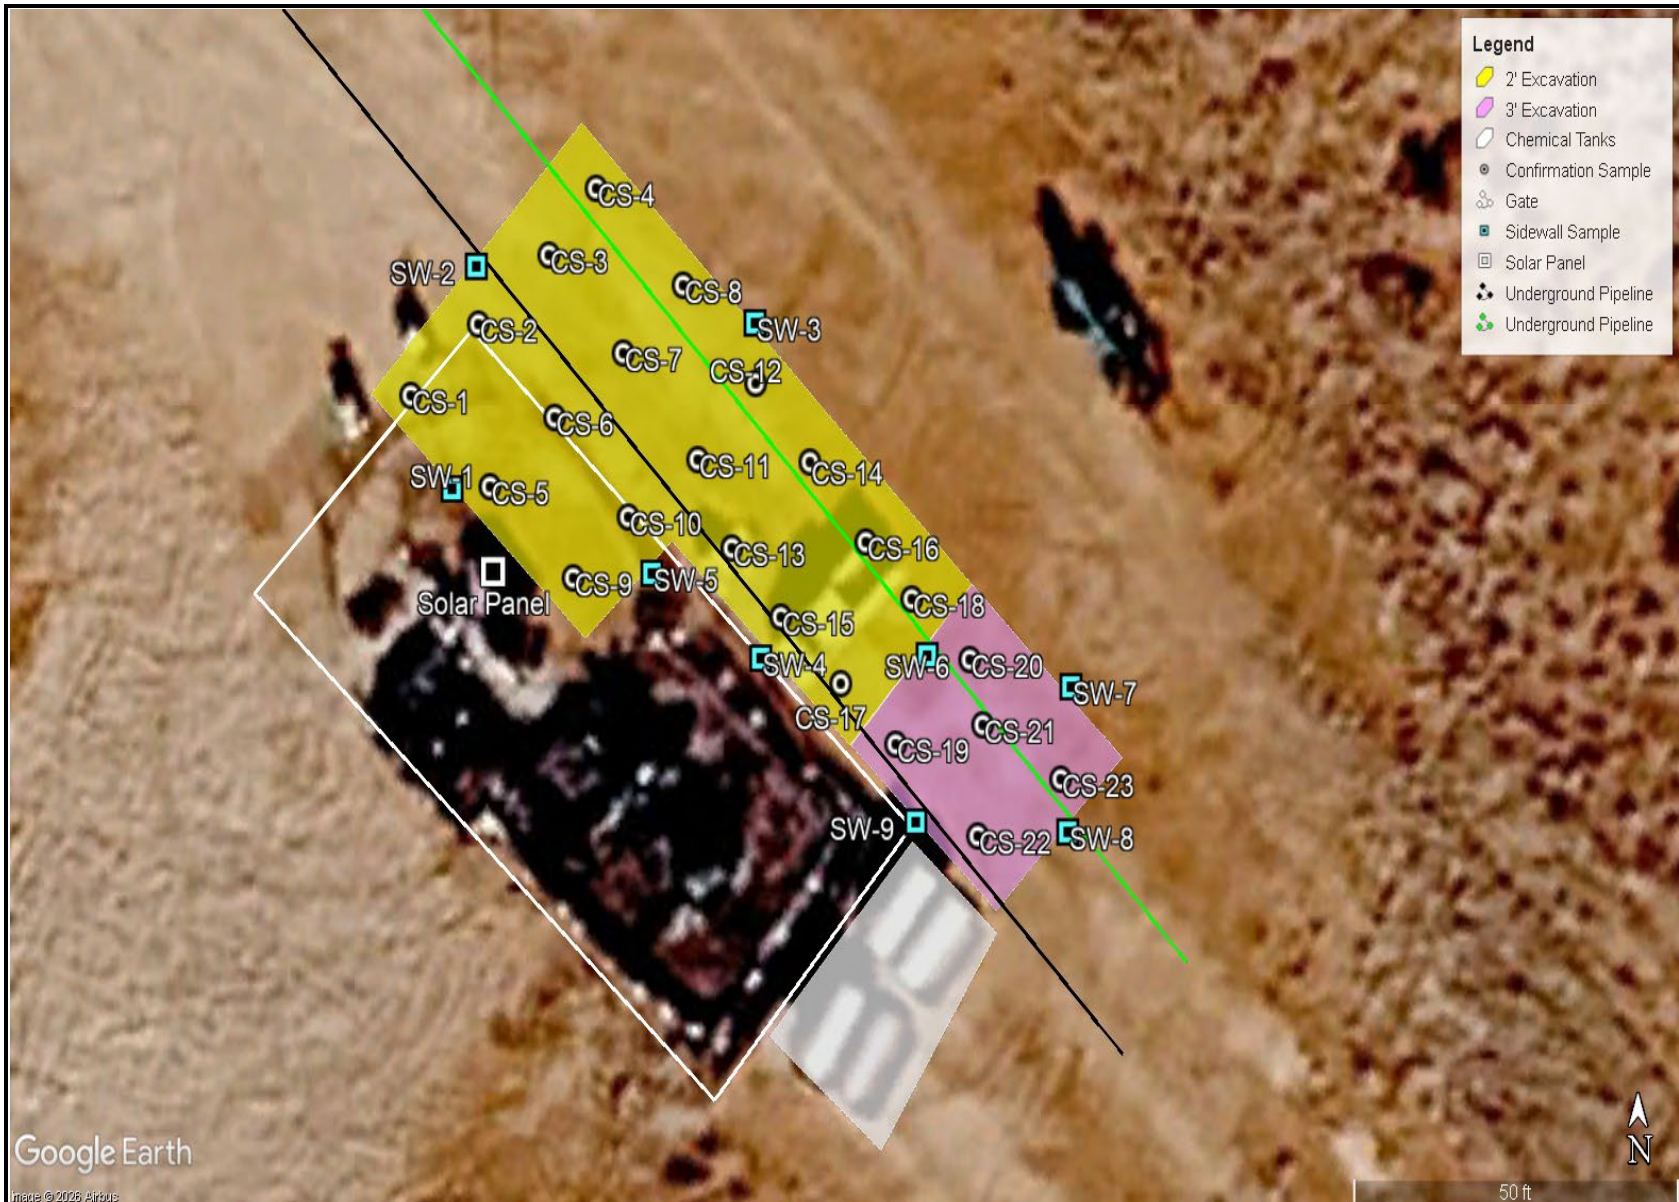
</p>	<p>FIGURE 4</p>
--	--	-----------------

<p>EXCAVATION MAP EOG RESOURCES AMAZING RISER (01.04.26) LEA COUNTY, NEW MEXICO 32.309365°, -103.656672°</p>	<p>CARMONA RESOURCES

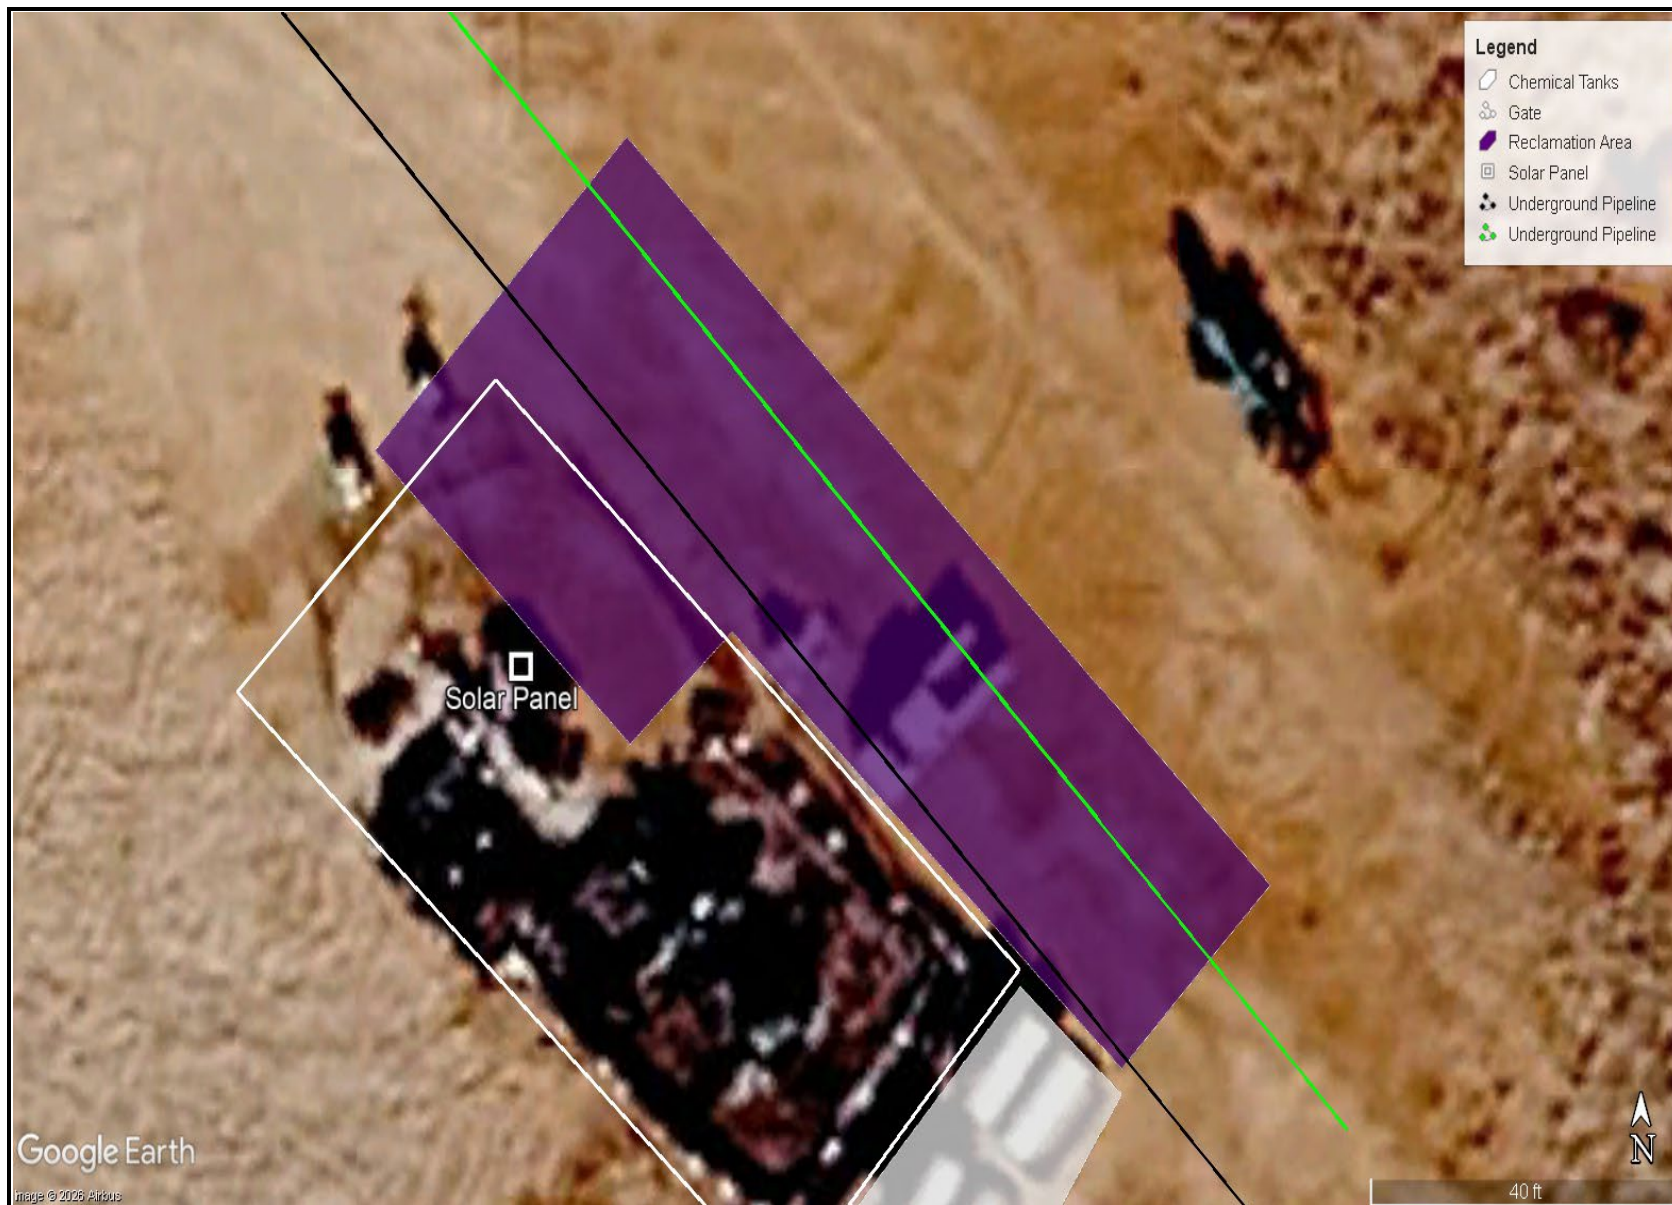
<p>RECLAMATION MAP EOG RESOURCES AMAZING RISER (01.04.26) LEA COUNTY, NEW MEXICO 32.309365°, -103.656672°</p>	<p>CARMONA RESOURCES

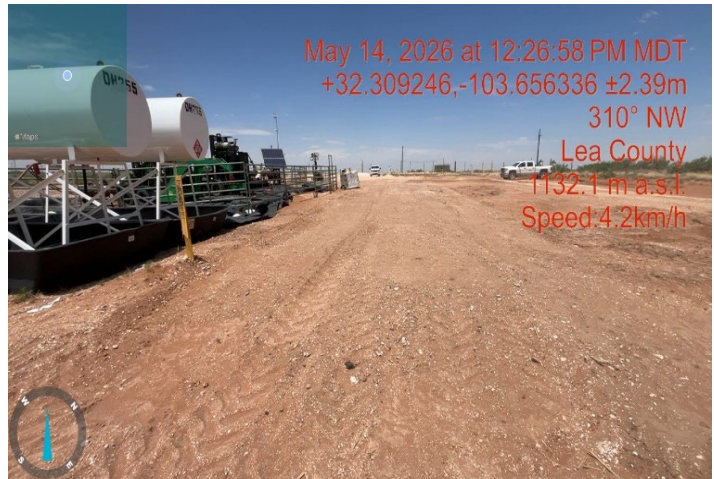
Description:
View Northwest of backfilled area.

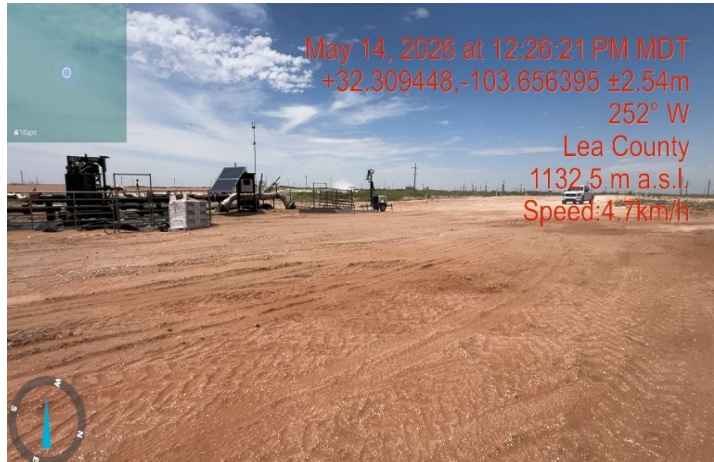
Photograph No. 5

Description:
View West of backfilled area.

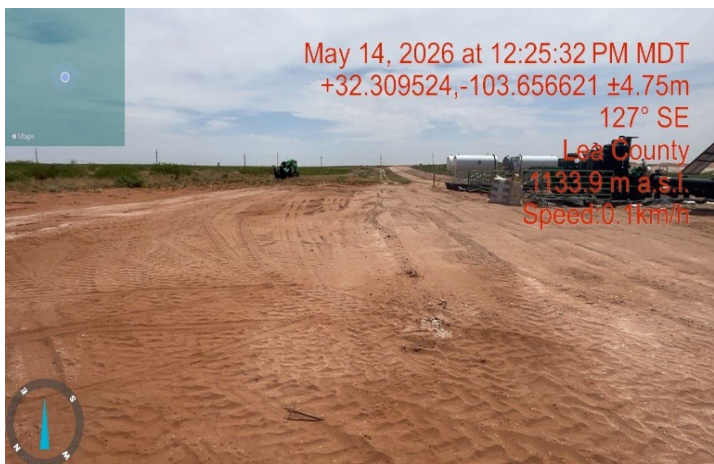
Photograph No. 6

Description:
View Southeast of backfilled area.

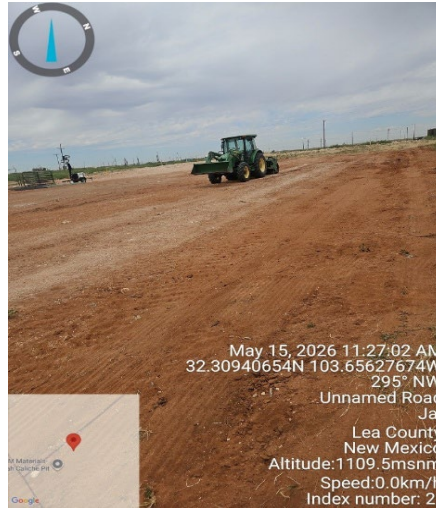
View Northwest of reclamation area.

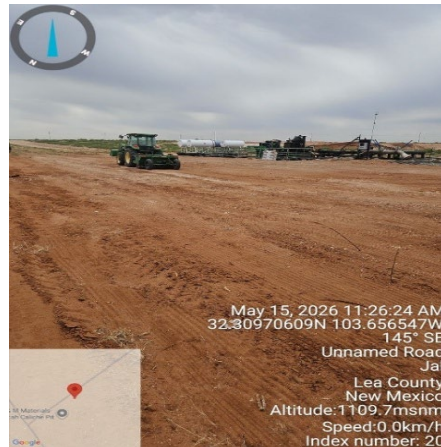
Photograph No. 8

View Southeast of reclamation area.
