Closure Report
Magnum Pronto State Com 5H
Incident ID: nAPP2601652797
Lea County, New Mexico
Unit O Sec 32 T19S R32E
32.610417°, -103.787367°

Crude Oil Release
Point of Release: Tank Release
Release Date: 12/31/2025
Volume Released: 16 Barrels of Crude Oil
Volume Recovered: 16 Barrels of Crude Oil

**Re: Closure Report
Magnum Pronto State Com 5H
COG Operating, LLC
Incident Number: nAPP2601652797
Site Location: Unit O, S32, T19S, R32E
(Lat 32.610417°, Long -103.787367°)
Lea County, New Mexico**

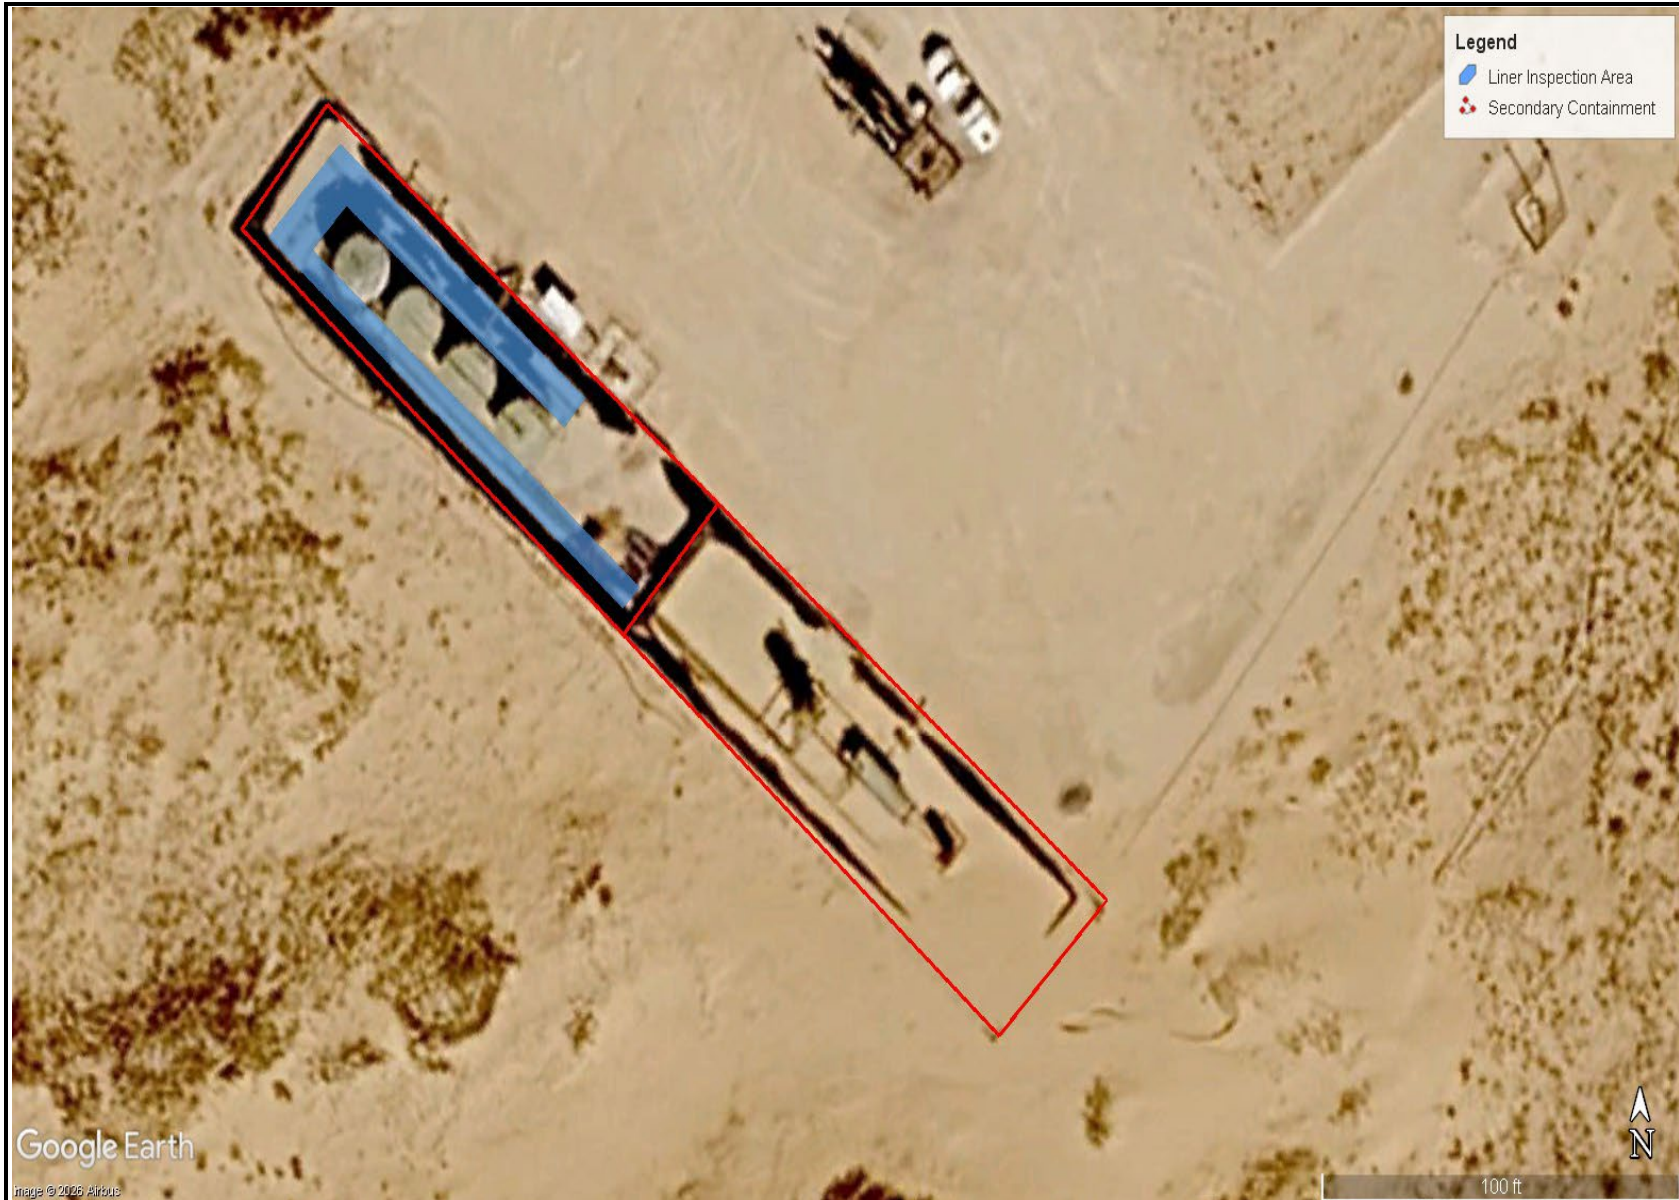
FIGURE 3

Based on the information obtained from the NMOCD, the release was discovered on December 31, 2025, due to a tank release. It resulted in approximately sixteen (16) barrels of crude oil being released, and sixteen (16) barrels of crude oil being recovered. See Figure 3.

SECONDARY CONTAINMENT MAP
COG OPERATING, LLC
LUSK DEEP UNIT A 32 (12.01.25)
LEA COUNTY, NEW MEXICO
32.644128, -103.795626

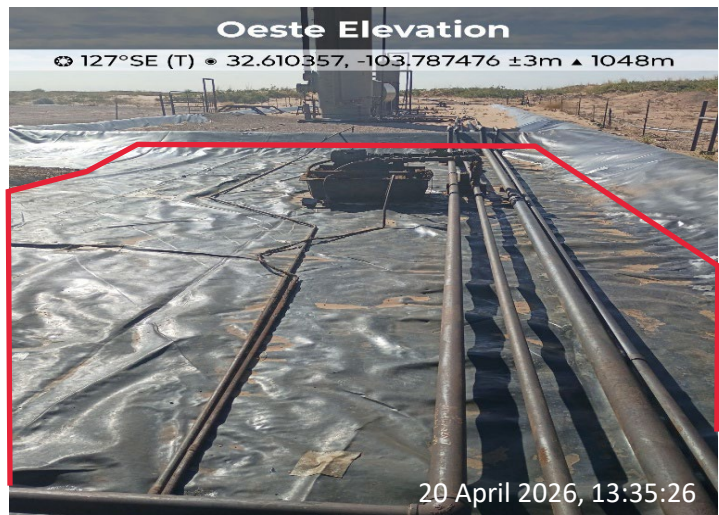
Photograph No. 2

Description:
View East of cleaned liner. Red outline is the area of the liner inspection.

Before conducting the liner inspection, the NMOCD was notified via the portal on April 15, 2026. A crew previously arrived on site to remove all freestanding fluids and the affected pea gravel was removed. After the plastic liner was thoroughly cleaned, Carmona Resources personnel inspected the liner to assess its structural integrity. On April 20, 2026, Carmona Resources, LLC conducted a liner inspection and confirmed that the liner was intact, with no integrity issues. Refer to the Photolog for details.

Based on the liner inspection throughout the facility, no further actions are required at the site. If you have any questions regarding this report or need additional information, don't hesitate to contact us at 432-813-6823.

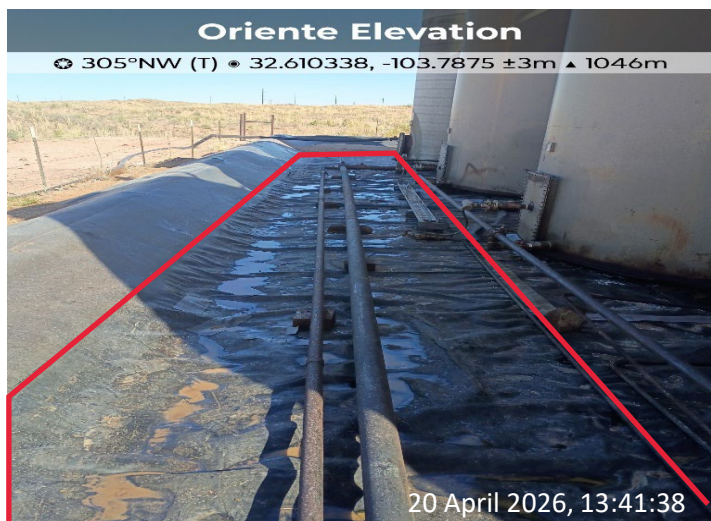
Photograph No. 3

Description:
View Northwest of cleaned liner. Red outline is the area of the liner inspection.
