**Closure Report  
Hades CTB  
Eddy County, New Mexico  
Unit L, S02, T23S, R28E  
32.340477°, -104.053425°**

**Prepared for:  
BTA Oil Producers, LLC  
104 S Pecos St.  
Midland, Texas 79701**

**Prepared by:  
Carmona Resources, LLC  
310 West Wall Street  
Suite 500  
Midland, Texas 79701**

**Incident ID: nAPP2612240824  
Produced Water Release  
Point of Release: The tops of three (3) produced water tanks caught on fire  
Release Date: 05.02.2026  
Volume Released: 0 Barrels of Produced Water  
Volume Recovered: 0 Barrels of Produced Water**

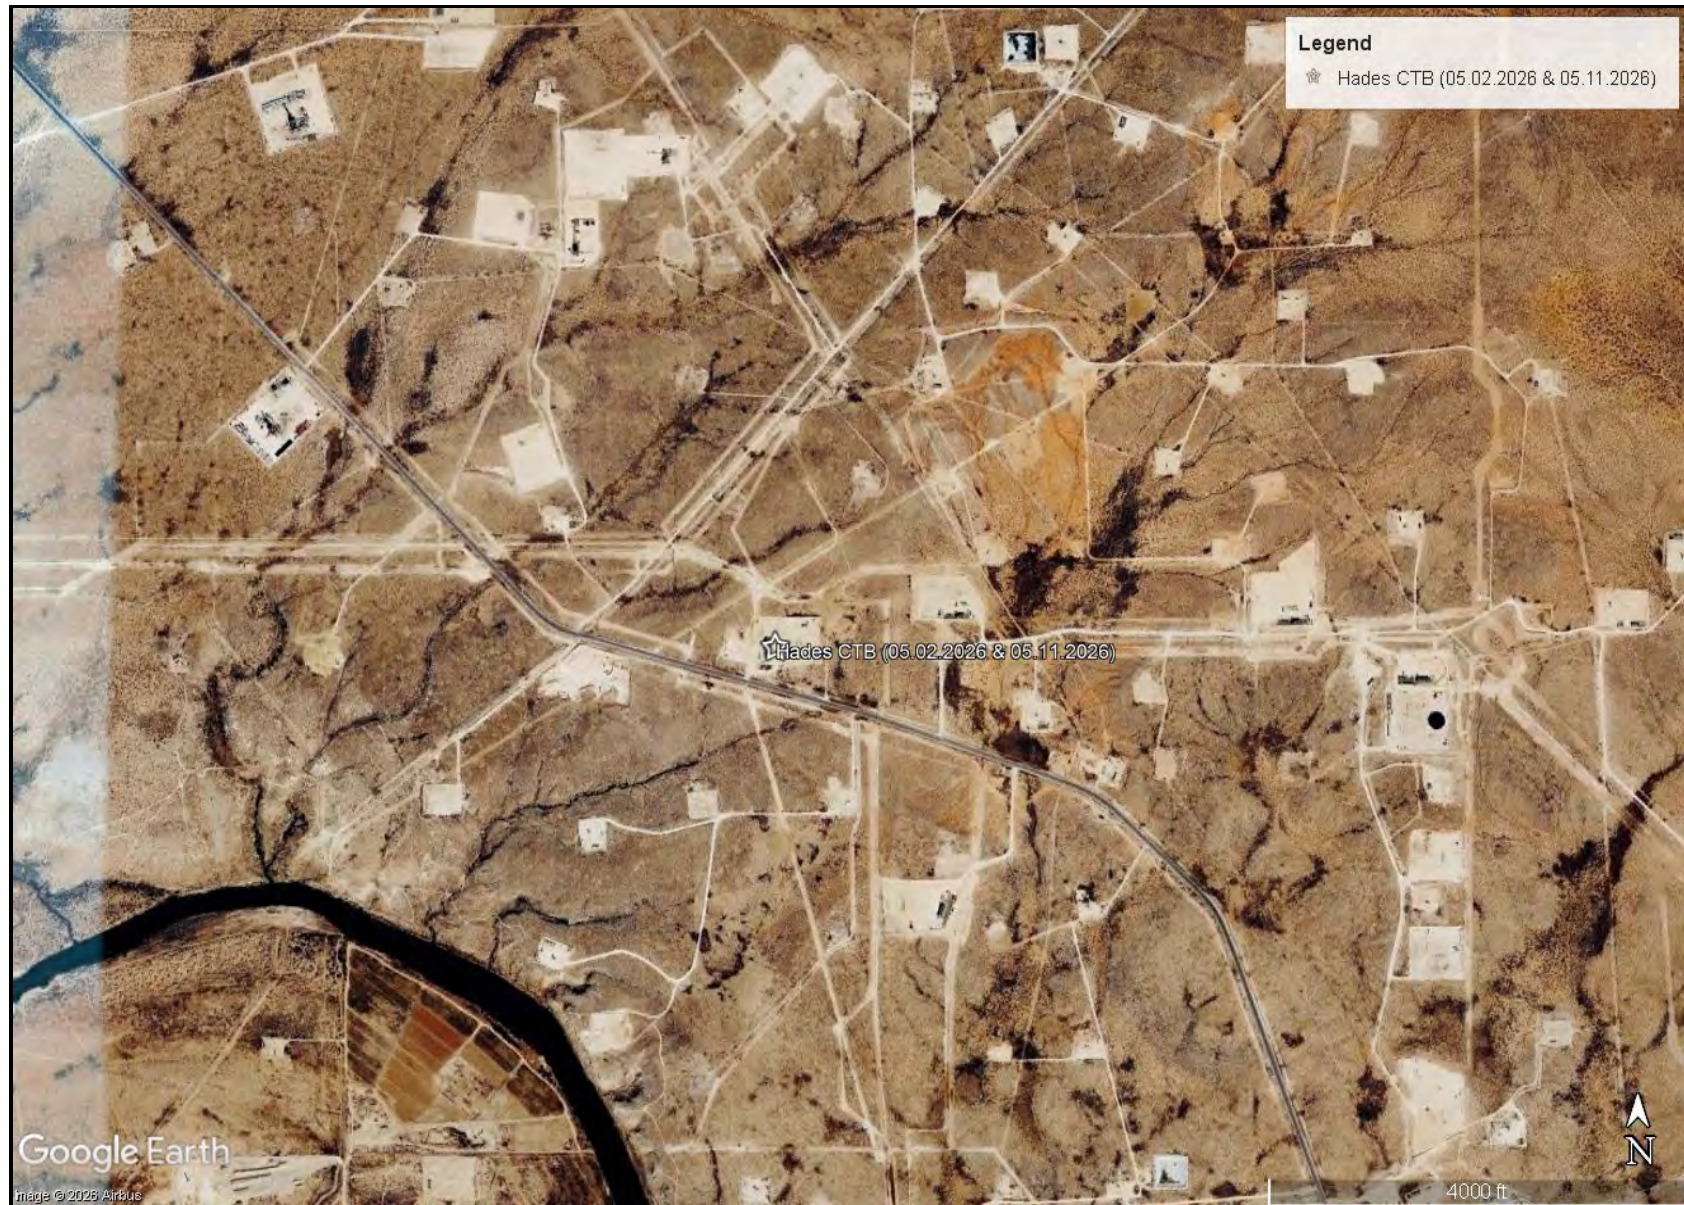
FIGURE 1

OVERVIEW MAP  
 BTA OIL PRODUCERS, LLC  
 HADES CTB (05.02.2026 & 05.11.2026)  
 EDDY COUNTY, NEW MEXICO  
 32.340477°, -104.053425°

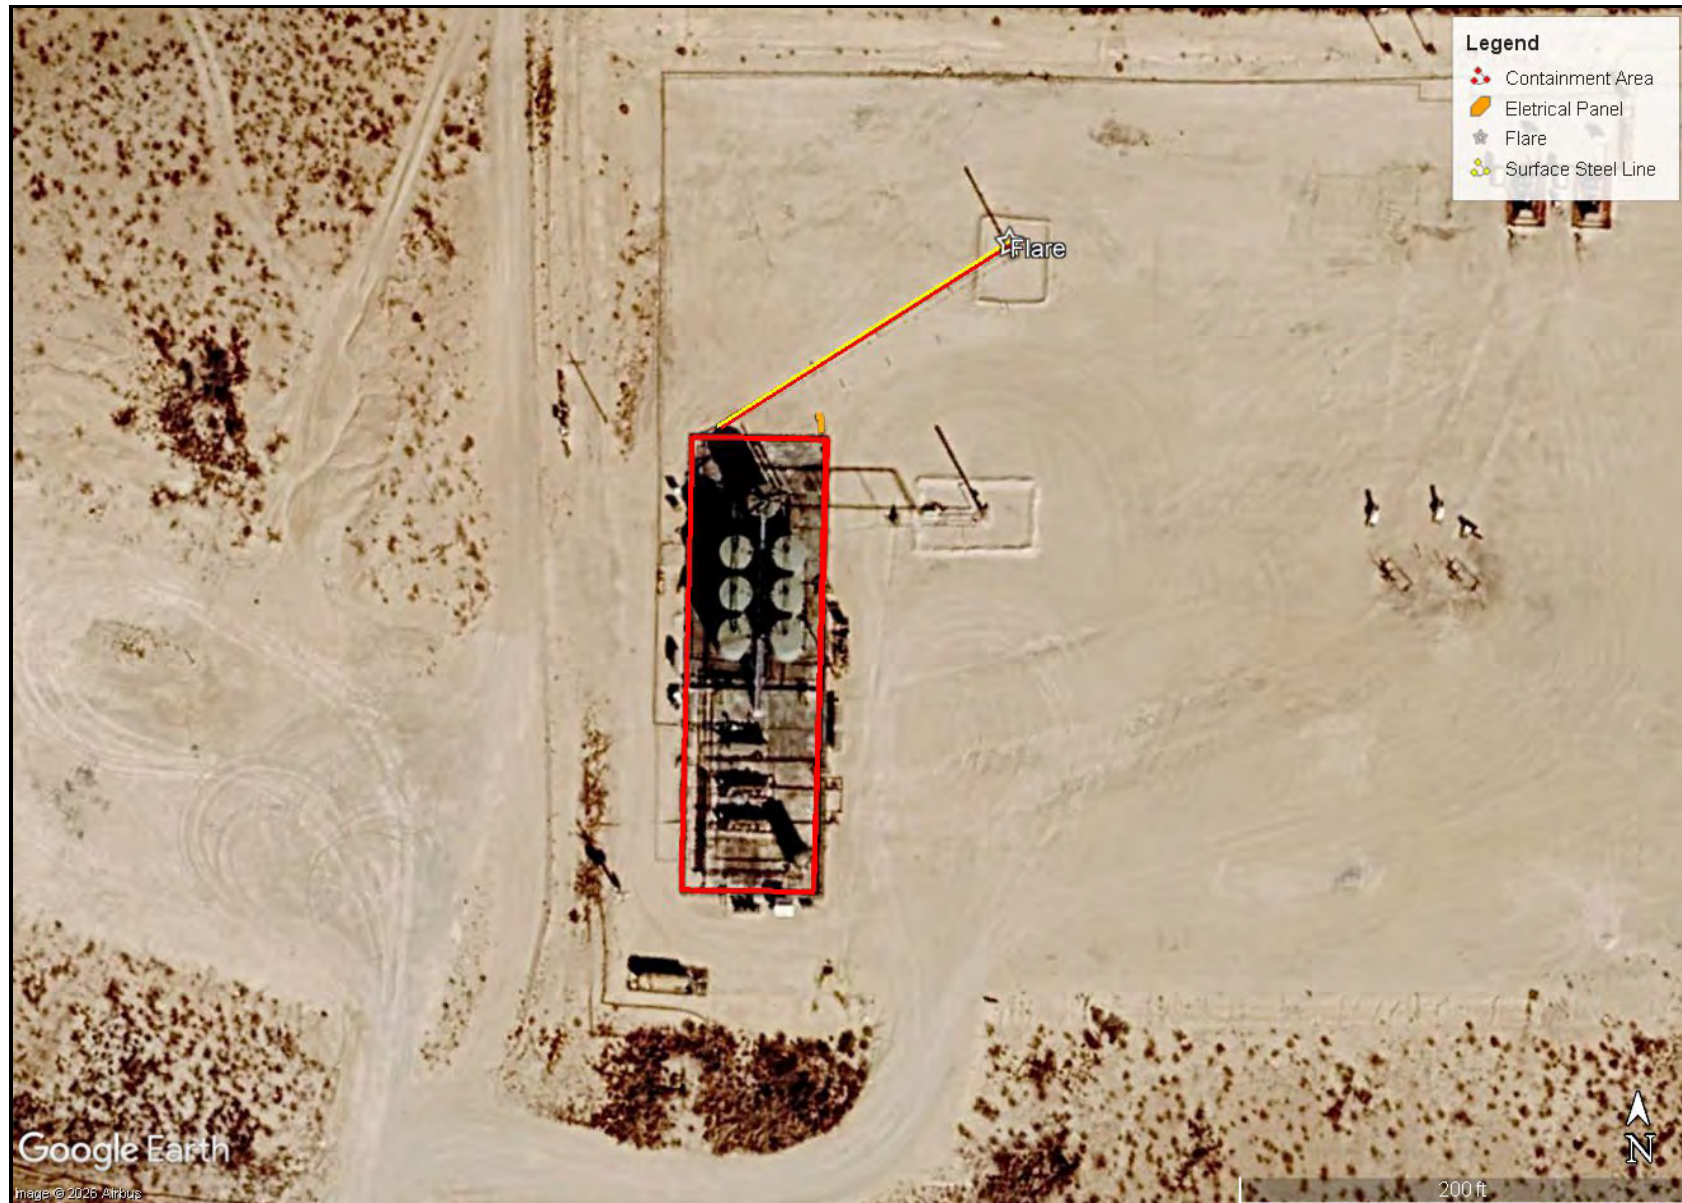
FIGURE 3A

CONTAINMENT MAP  
BTA OIL PRODUCERS, LLC  
HADES CTB (05.02.2026)  
EDDY COUNTY, NEW MEXICO  
32.340477°, -104.053425°

Prior to Carmona Resources conducting a Liner Inspection, BTA contractors removed all fluid and washed the containment. The NMOCD division office was notified via NMOCD portal on May 8, 2026 & May 14, 2026, per Subsection D of 19.15.29.12 NMAC. See Appendix B for the NMOCD correspondence prior to performing the liner inspection. On May 12, 2026 & May 19, 2026, Carmona Resources, LLC conducted liner inspection activities to assess the tank batteries lined containment integrity and determined there were no integrity issues. It was noted that there was an issue with the containment wall, which released fluid to the north of the containment. The fluid released onto the well pad was immediately removed and the affected well pad area was remediated. Refer to the Photolog in Appendix B. Appendix C also contains a Liner Integrity Certification. Figure 3 shows the containment area outline.

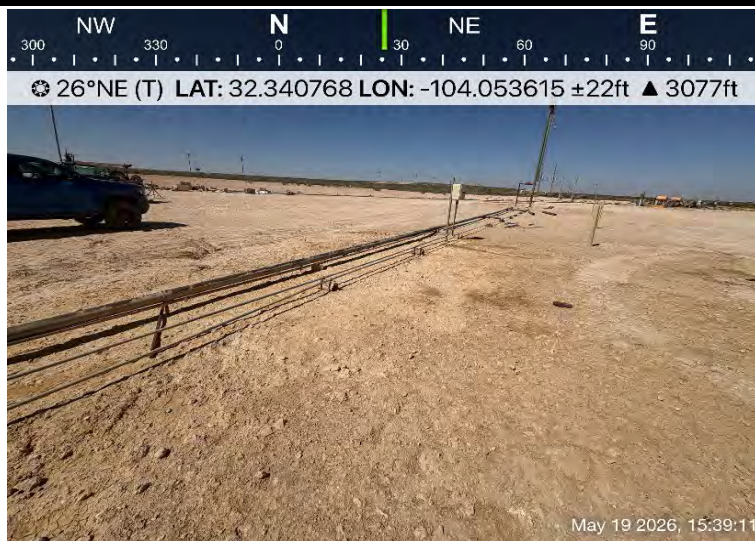
### Photograph No. 2

View Northeast of release area.

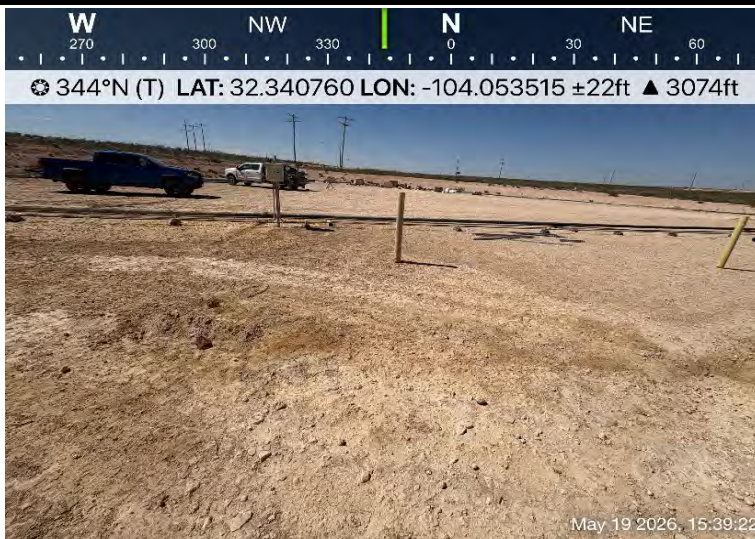
### Photograph No. 3

View North of release area.

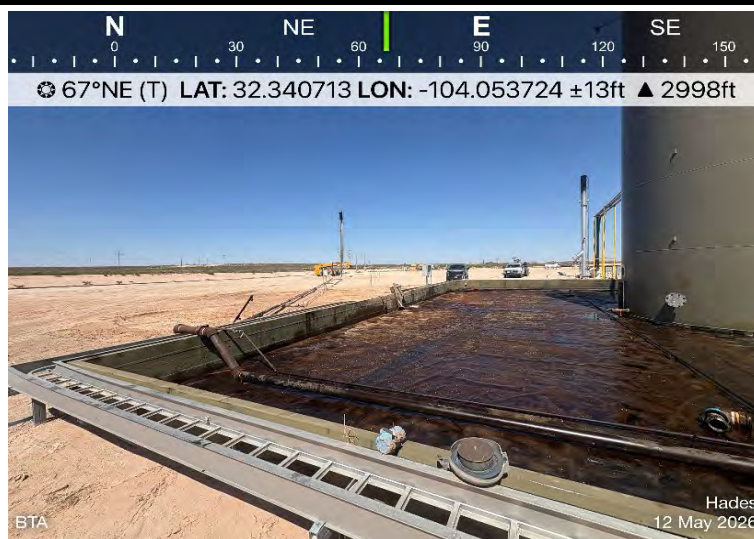
View Northeast of lined containment.

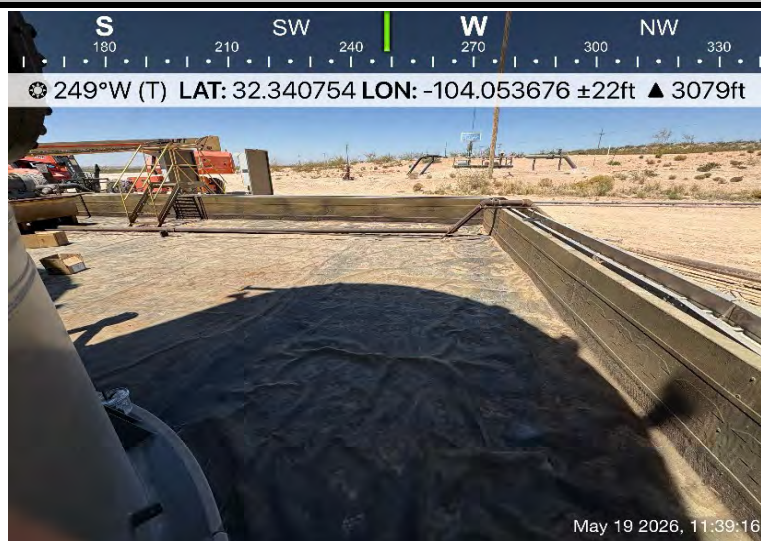
## Photograph No. 8

View West of exposed liner.

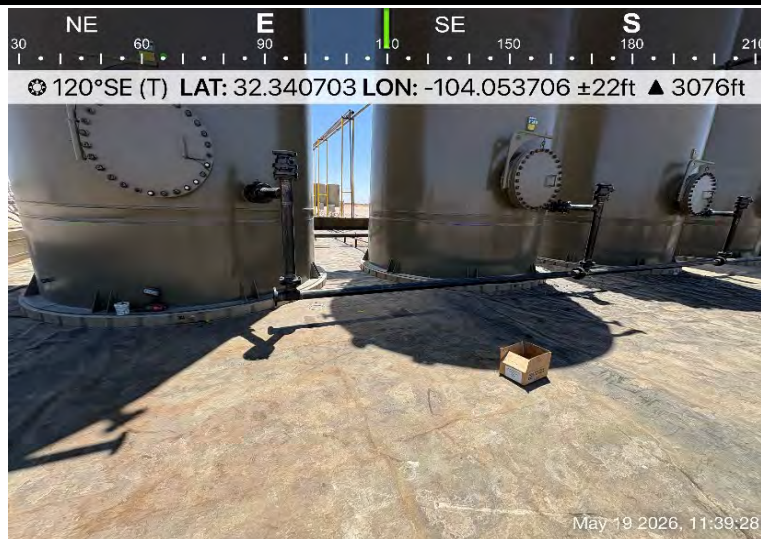
## Photograph No. 9

View Southeast of exposed liner.

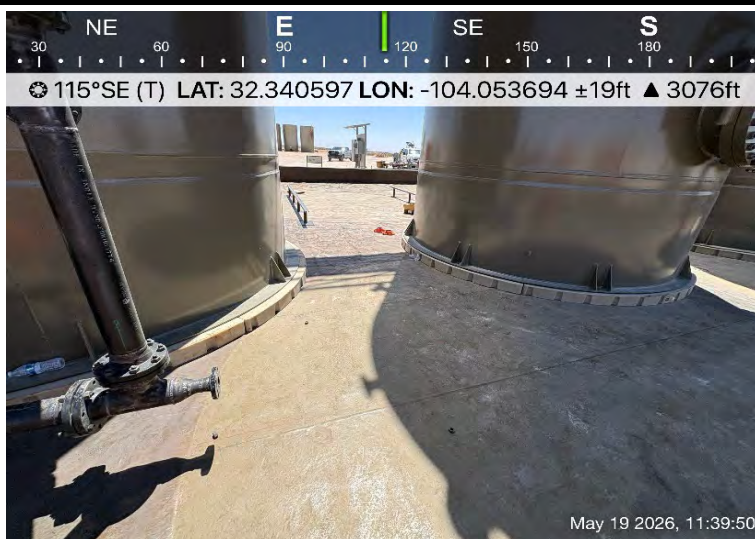
View Southeast of exposed liner.

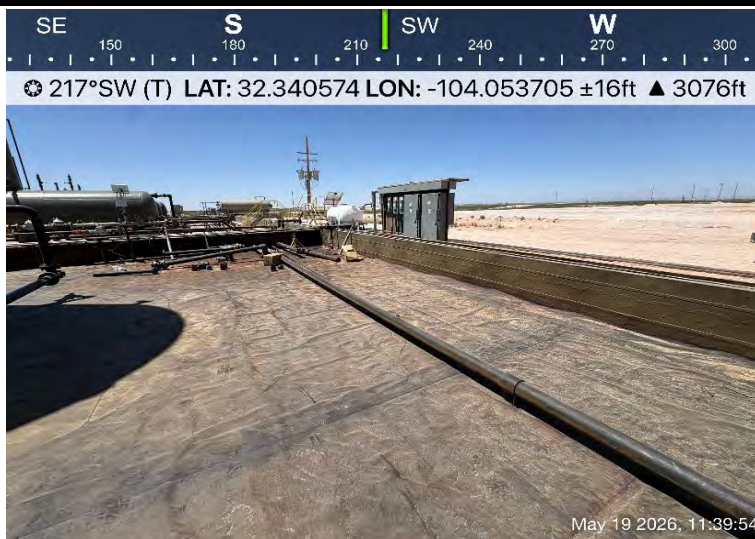
View Southwest of the exposed liner.

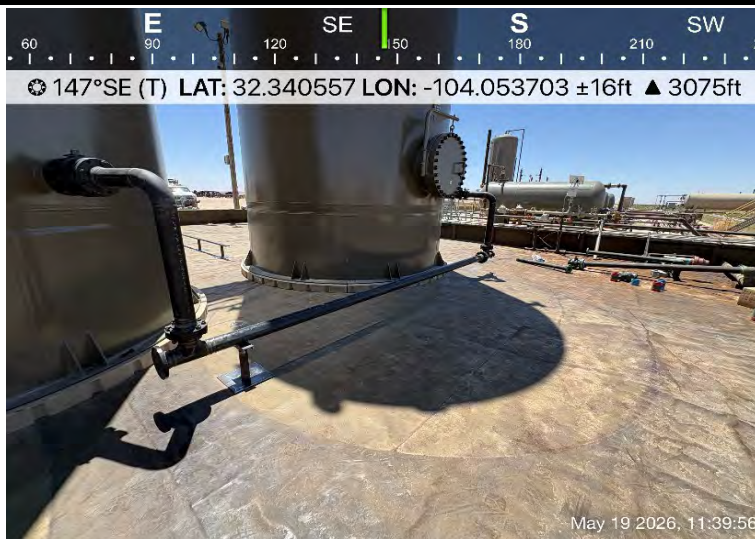
View Southeast of exposed liner.

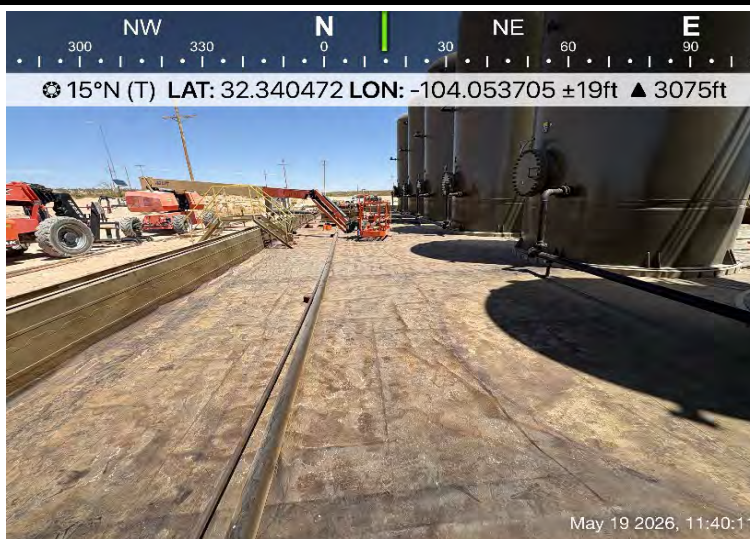
View North of the exposed liner.

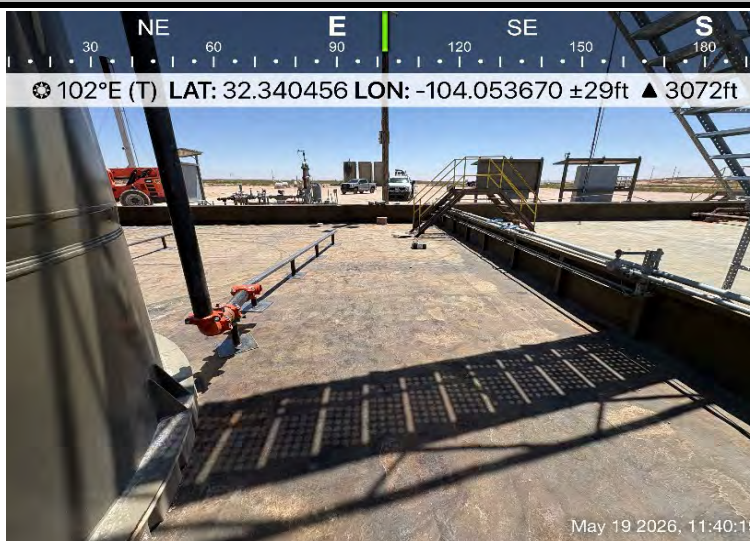
## Photograph No. 14

View East of the exposed liner.

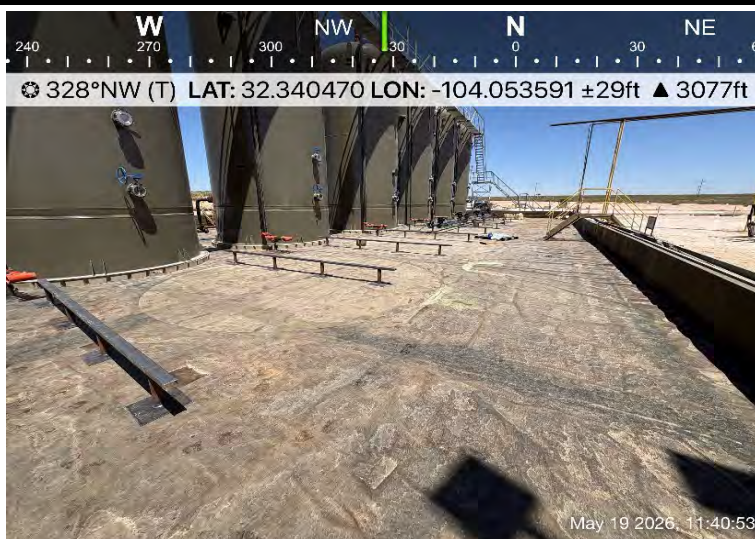
View Northwest of the exposed liner.

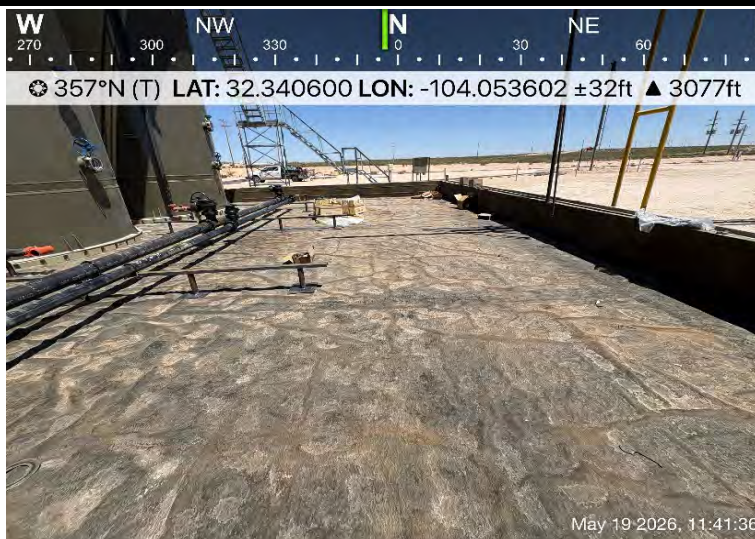
## Photograph No. 17

View North of the exposed liner.

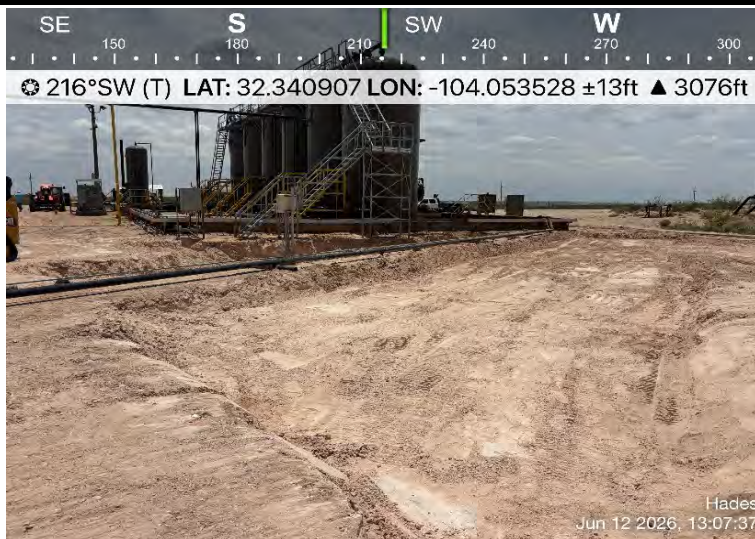
## Photograph No. 18

View Southwest of CS-1 through CS-8.

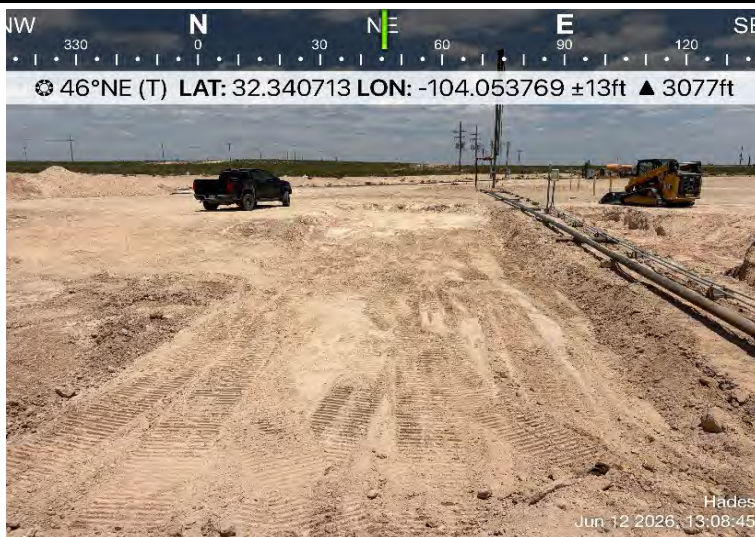
View Northeast of CS-1 through CS-8.

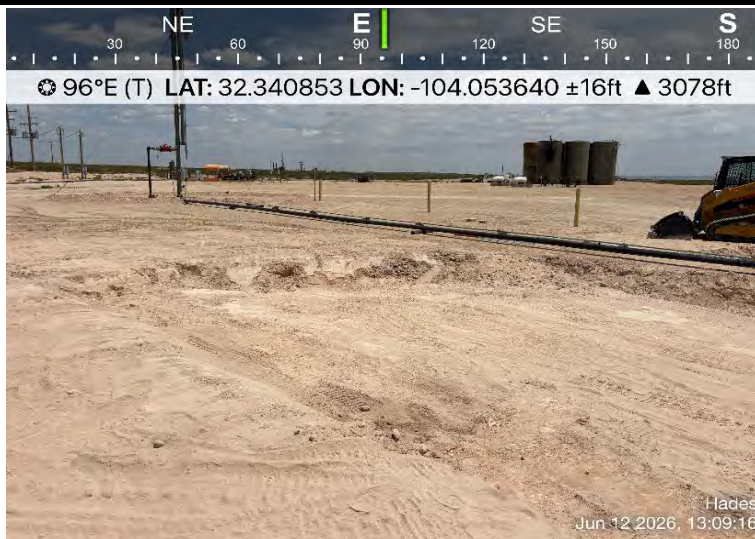
View East of CS-1 through CS-8.

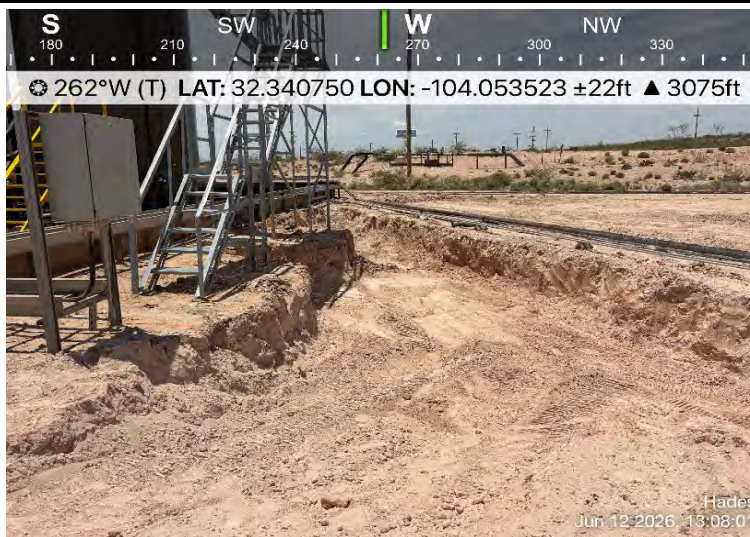
View West of CS-9 through CS-13.
