**Pit, Closed-Loop System, Below-Grade Tank, or  
Proposed Alternative Method Permit or Closure Plan Application**

1.  
Operator: SIMCOE LLC OGRID #: 329736  
Address: 1199 Main Ave., Suite 101, Durango, CO 81301  
Facility or well name: GALLEGOS CANYON UNIT #133E  
APPNumber: 30-045-25234 OCD Permit Number: \_\_\_\_\_  
U/L or Qtr/Qtr C Section 17 Township 29N Range 12W County: San Juan County  
Center of Proposed Design: Latitude 36.73185 Longitude -108.12509 NAD: ☐ 1927 ☒ 1983  
Surface Owner: ☒ Federal ☐ State ☐ Private ☐ Tribal Trust or Indian Allotment

**RE: Notice of Proposed Below-Grade Tank (BGT) Closure**

Gallegos Canyon Unit 133E  
API 30-045-25234  
(C) Section 17 – T29N – R12W  
San Juan County, New Mexico

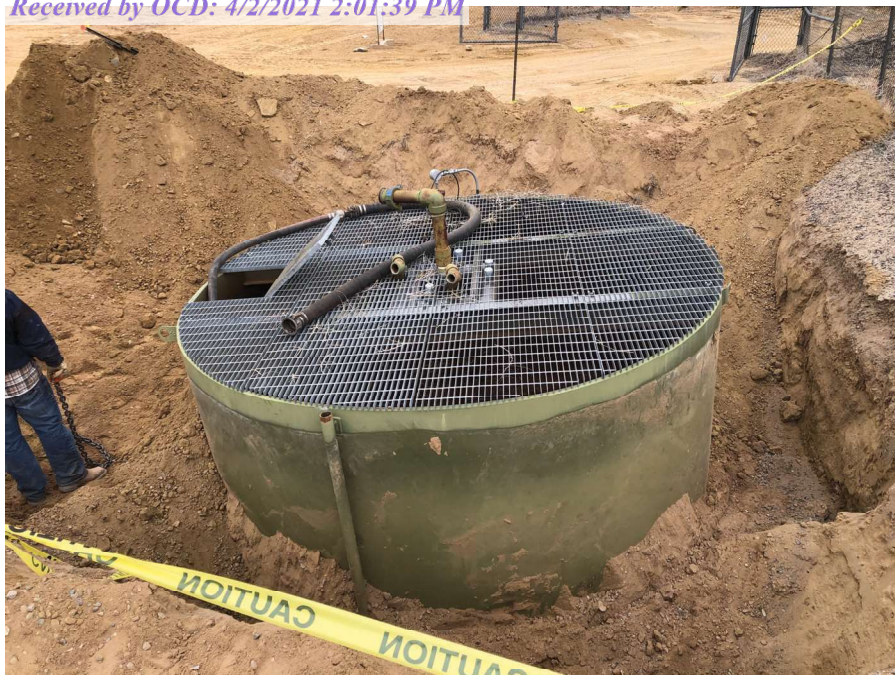
GCU 133E - BGT Tank A prior to removal

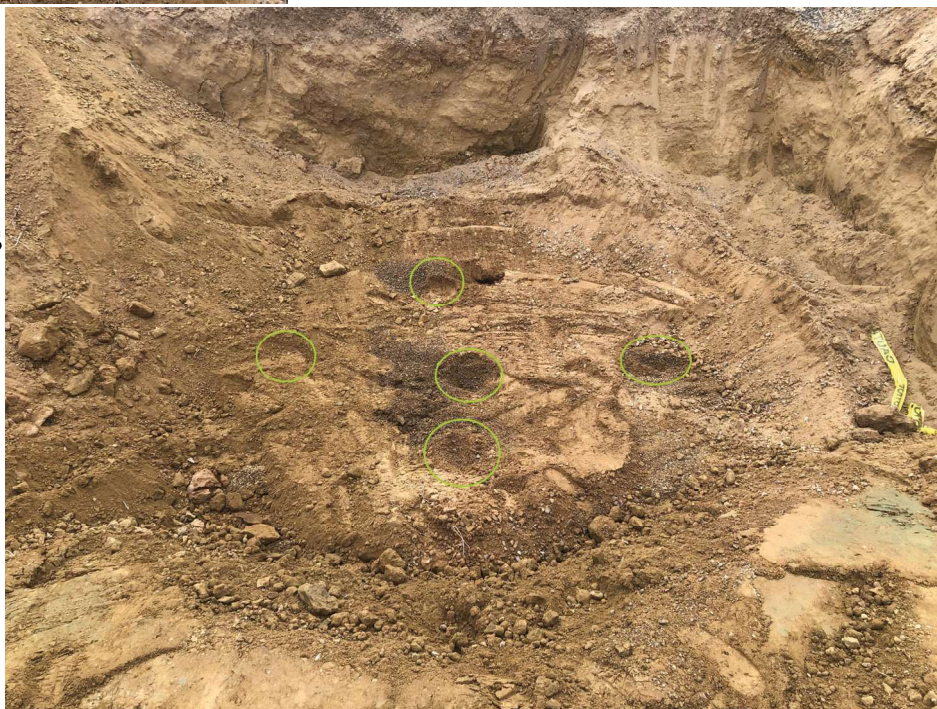
Cause of Release **TPH, BTEX, & chloride all below below-grade tank (BGT) permit closure standards. No evidence of a release had occurred.**

5 point composite sample locations

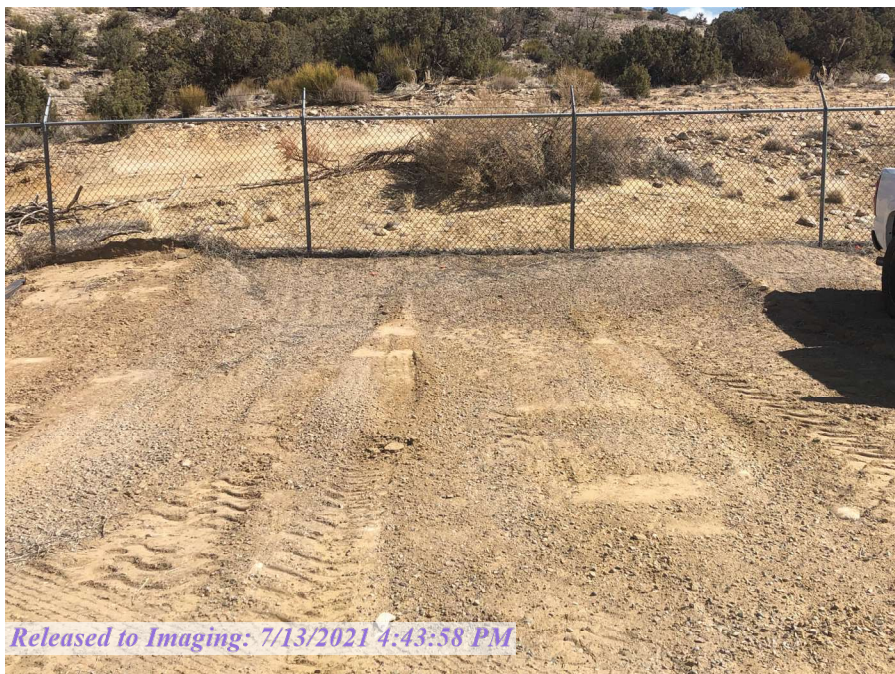
Backfilled area of former Tank A
