Pit, Below-Grade Tank, or
Proposed Alternative Method Permit or Closure Plan Application

**Hilcorp Energy Company
San Juan Basin
Below Grade Tank Closure Report**

Lease Name: LUDWICK LS 26

API No.: 30-045-20855

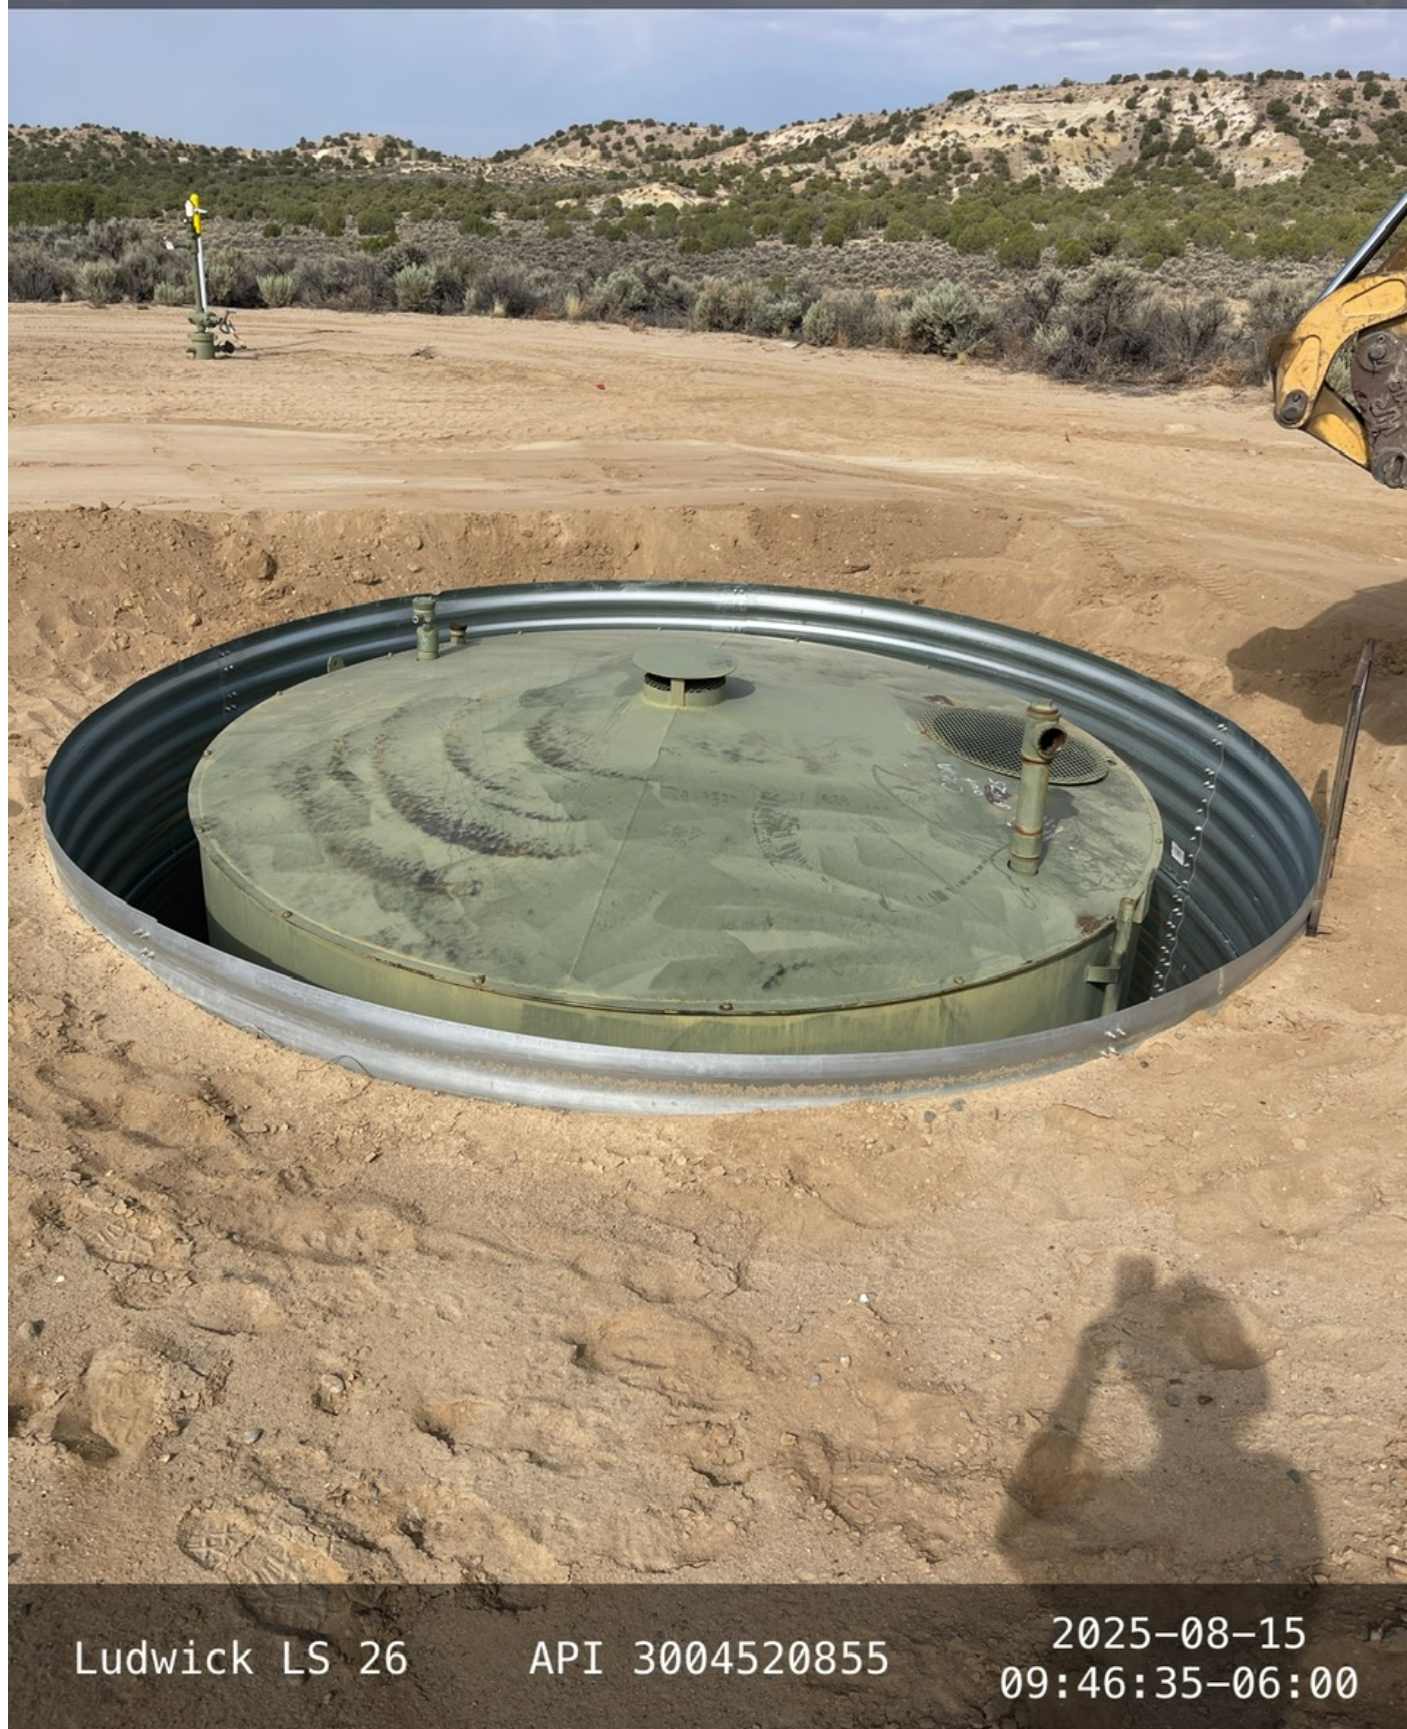
Ludwick LS 26

36.76595°N
107.92004°W

API 3004520855

2025-08-15
09:46:35-06:00

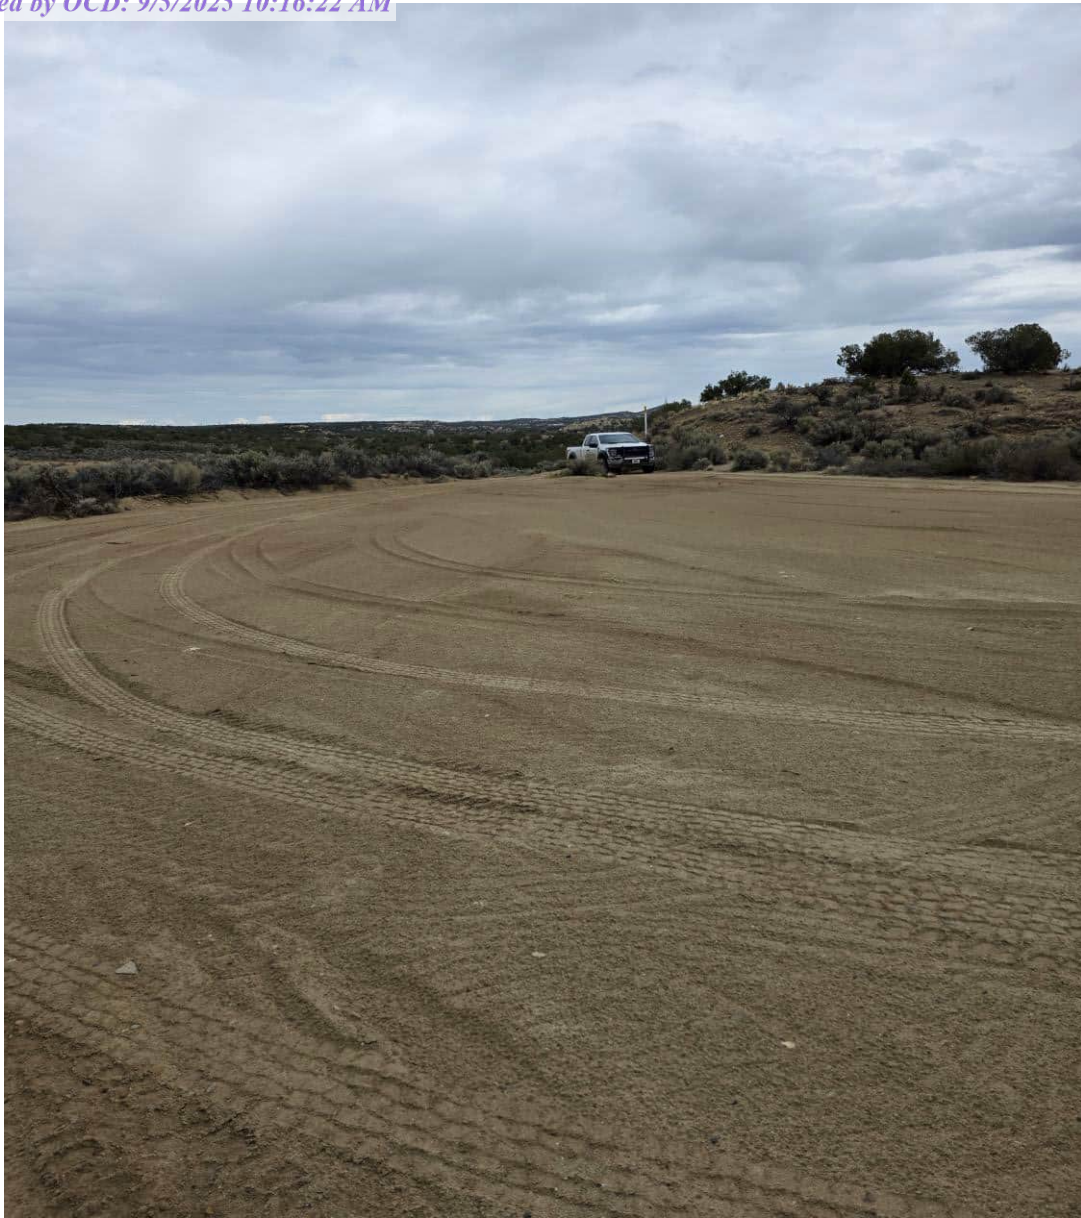
View Looking North

The below-grade tank area passed all requirements of Paragraph (4) of Subsection E of 19.15.17.13 NMAC and was backfilled with compacted, non-waste containing, earthen material.

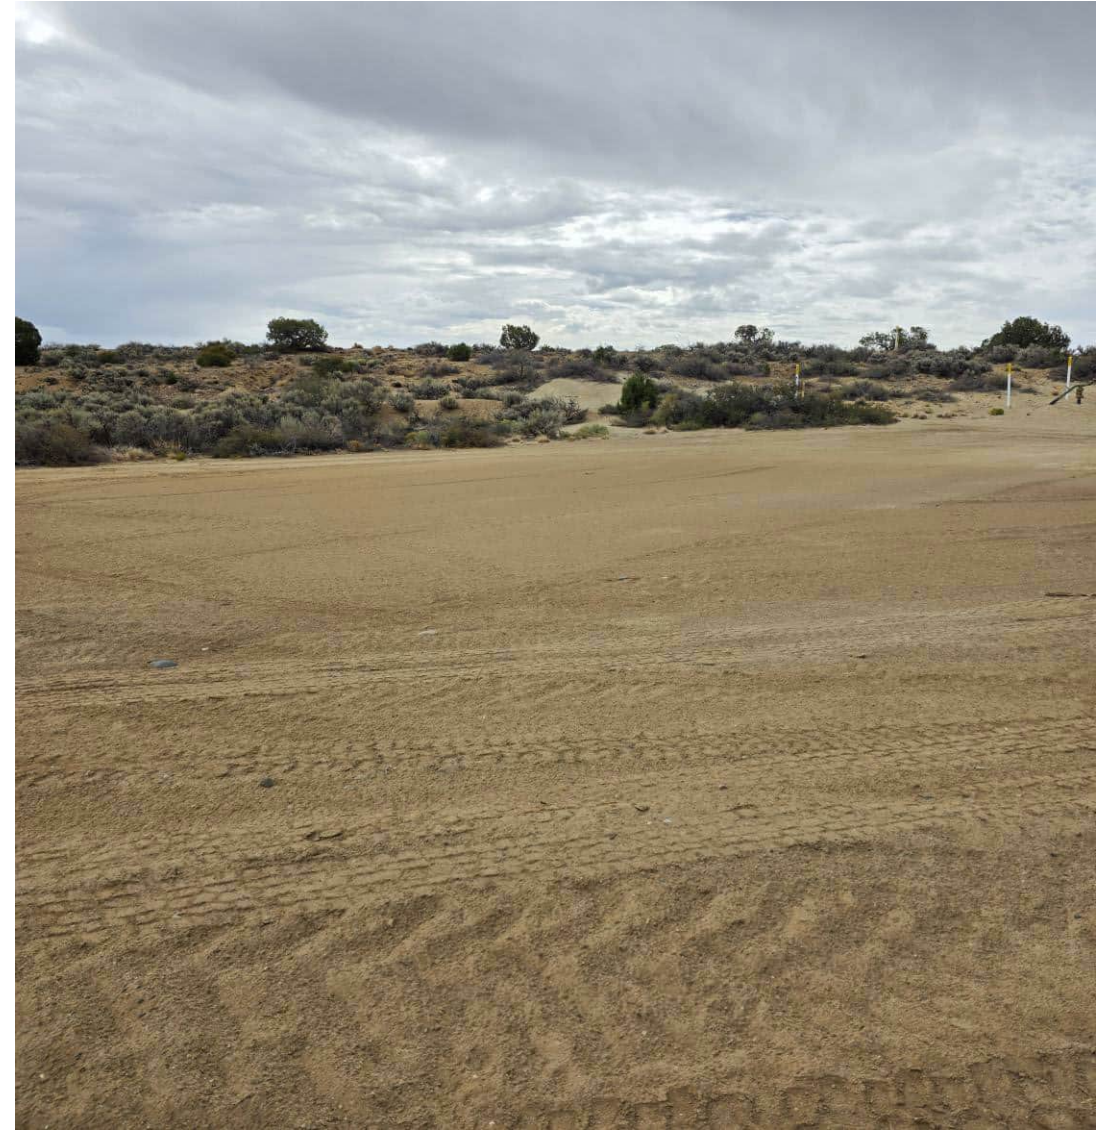
View Looking West
