Dugan Production Corp.

Buddy Com 001

BGT Closure Report

API# 30-039-23032

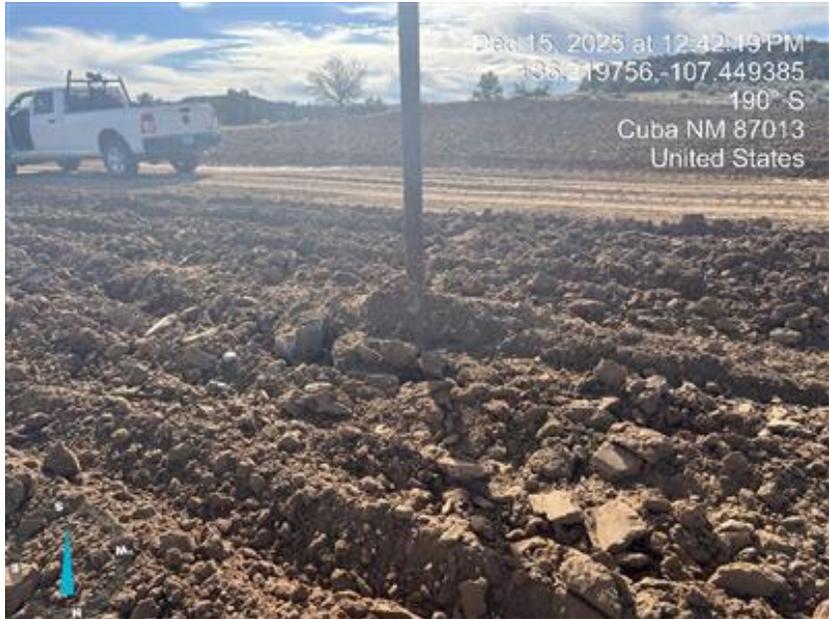
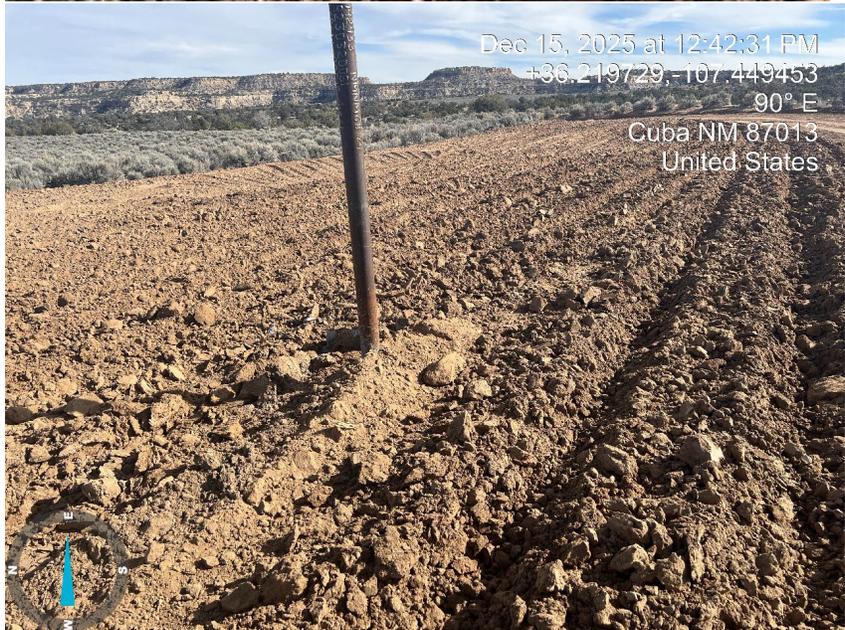
Appendix D: Site Photo

Dugan has restored the impacted surface area to the condition that existed prior to the below-grade tank installation. Restoration of the Site includes the replacement of soil to the relative positions and contoured to the topography of the area. The topsoil cover includes a top layer, which is suitable material to establish vegetation at the Site. The disturbed area was reseeded with
