RE: REQUEST FOR PERMANENT CLOSURE
BP America Production Company
Groundwater Monitoring Report
Mudge LS # 9A, Unit O, Sec. 3, T31N, R11W, NMPM
San Juan County, New Mexico

GROUNDWATER MONITORING REPORT

**MUDGE LS # 9A
(O) SEC. 3 – T31N – R11W, NMPM
SAN JUAN COUNTY, NEW MEXICO**

MUDGE LS # 9A

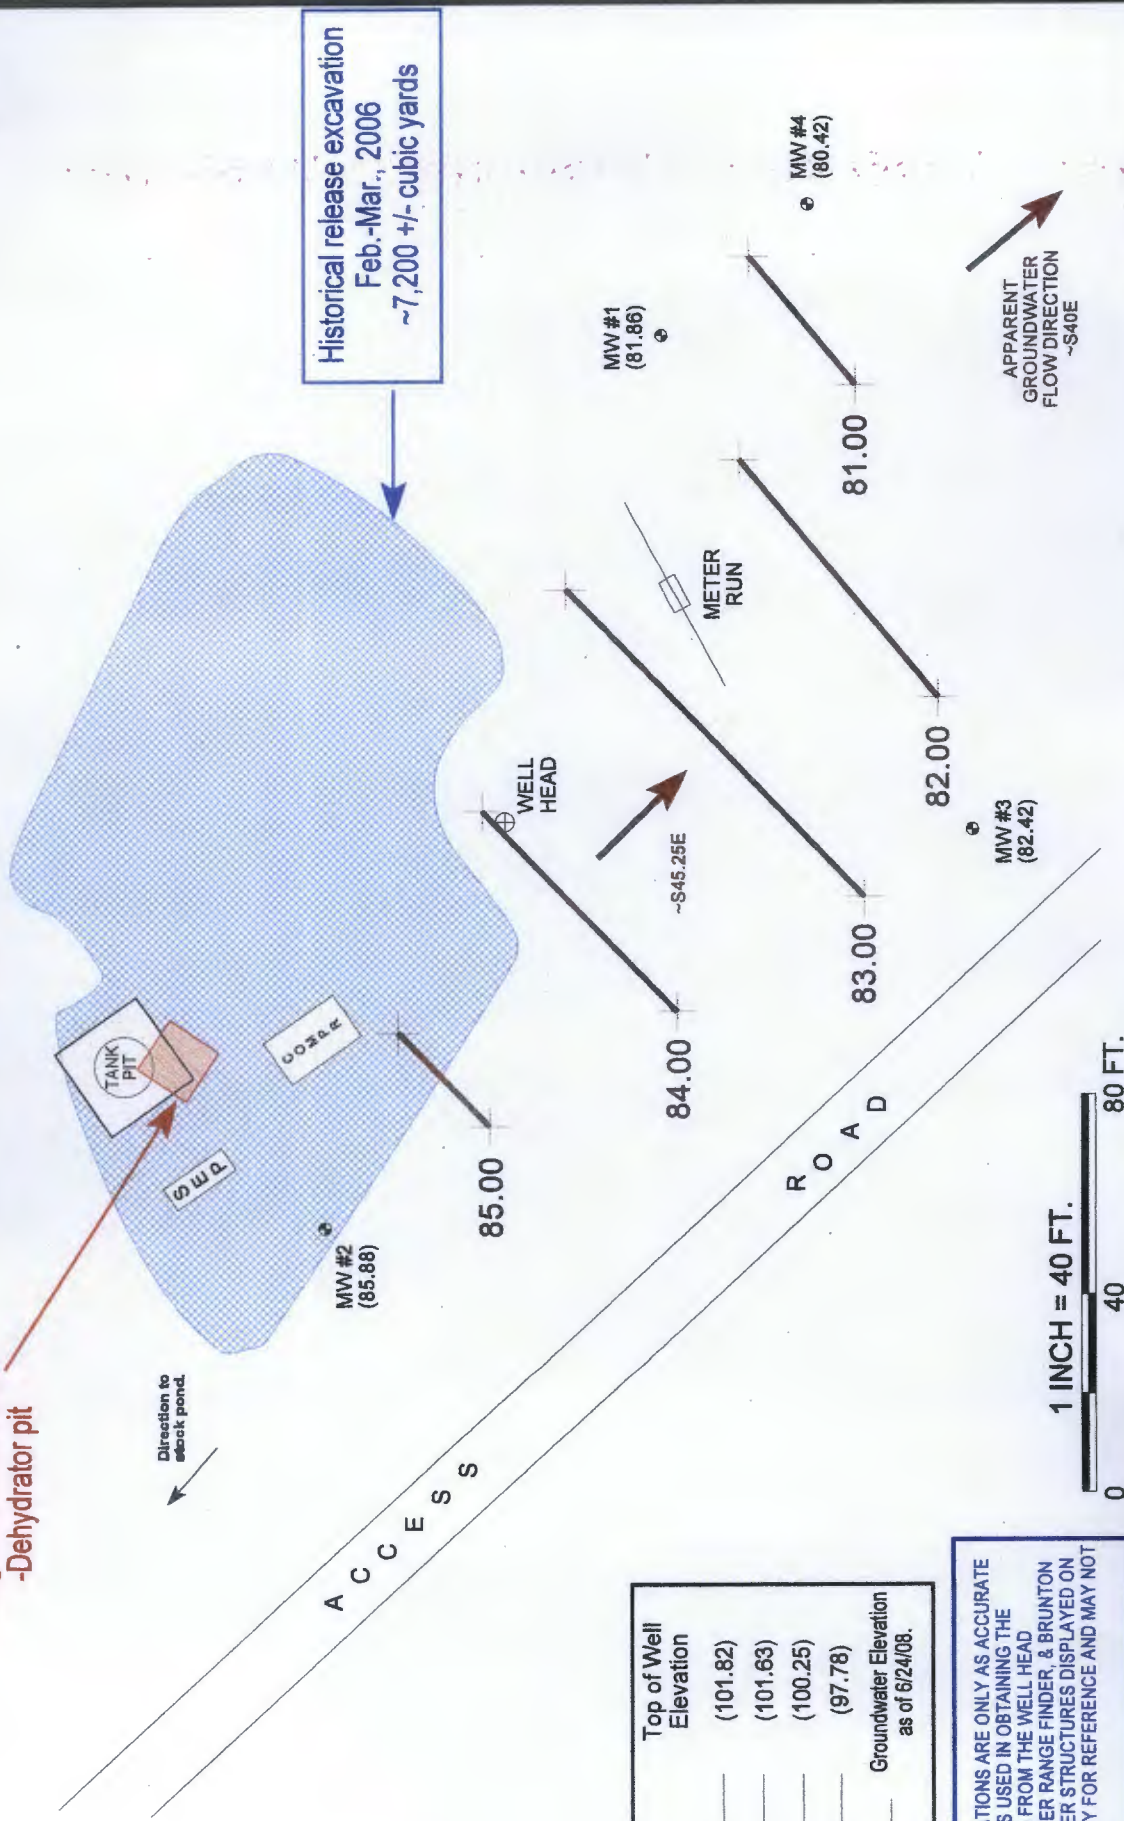
FIGURE 8 (2nd 1/4, 2008)

Top of Well Elevation	
MW #1	(101.82)
MW #2	(101.63)
MW #3	(100.25)
MW #4	(97.78)
Groundwater Elevation as of 6/24/08.

Groundwater contour maps of relative water table elevations have consistently been measure to flow toward the southeast direction (*Figure 2 through Figure 8*).
