**DECEMBER 2010 QUARTERLY GROUNDWATER
MONITORING REPORT**

CONOCOPHILLIPS COMPANY

**SAN JUAN 27-5 No. 34A
NATURAL GAS PRODUCTION SITE
RIO ARRIBA COUNTY, NEW MEXICO**

March 2011

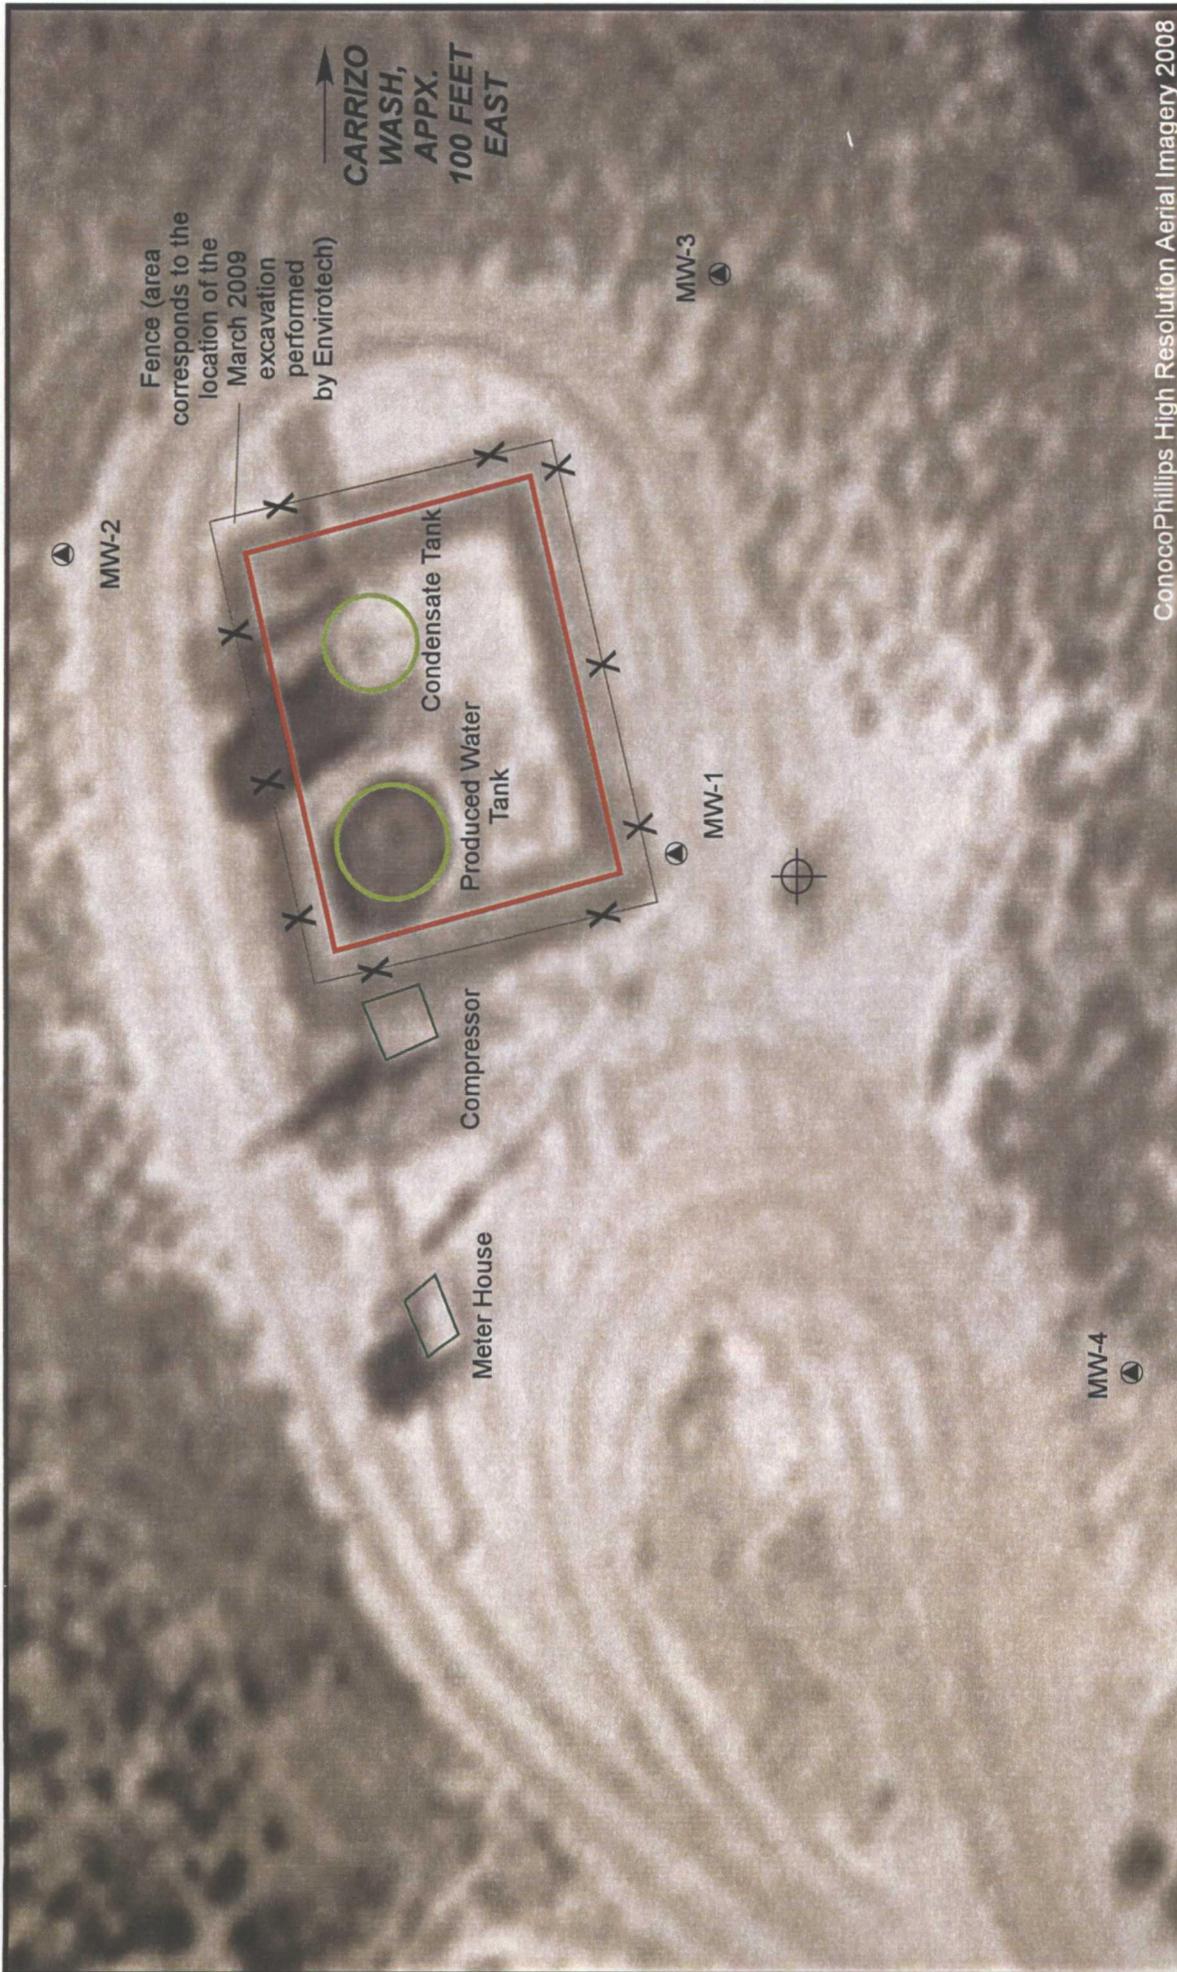
FIGURE 2:

SITE LAYOUT MAP
CONOCOPHILLIPS COMPANY
SAN JUAN 27-5 No. 34A
GAS PRODUCTION WELL
 Sec 30, T27N, R5W
 Rio Arriba County, New Mexico

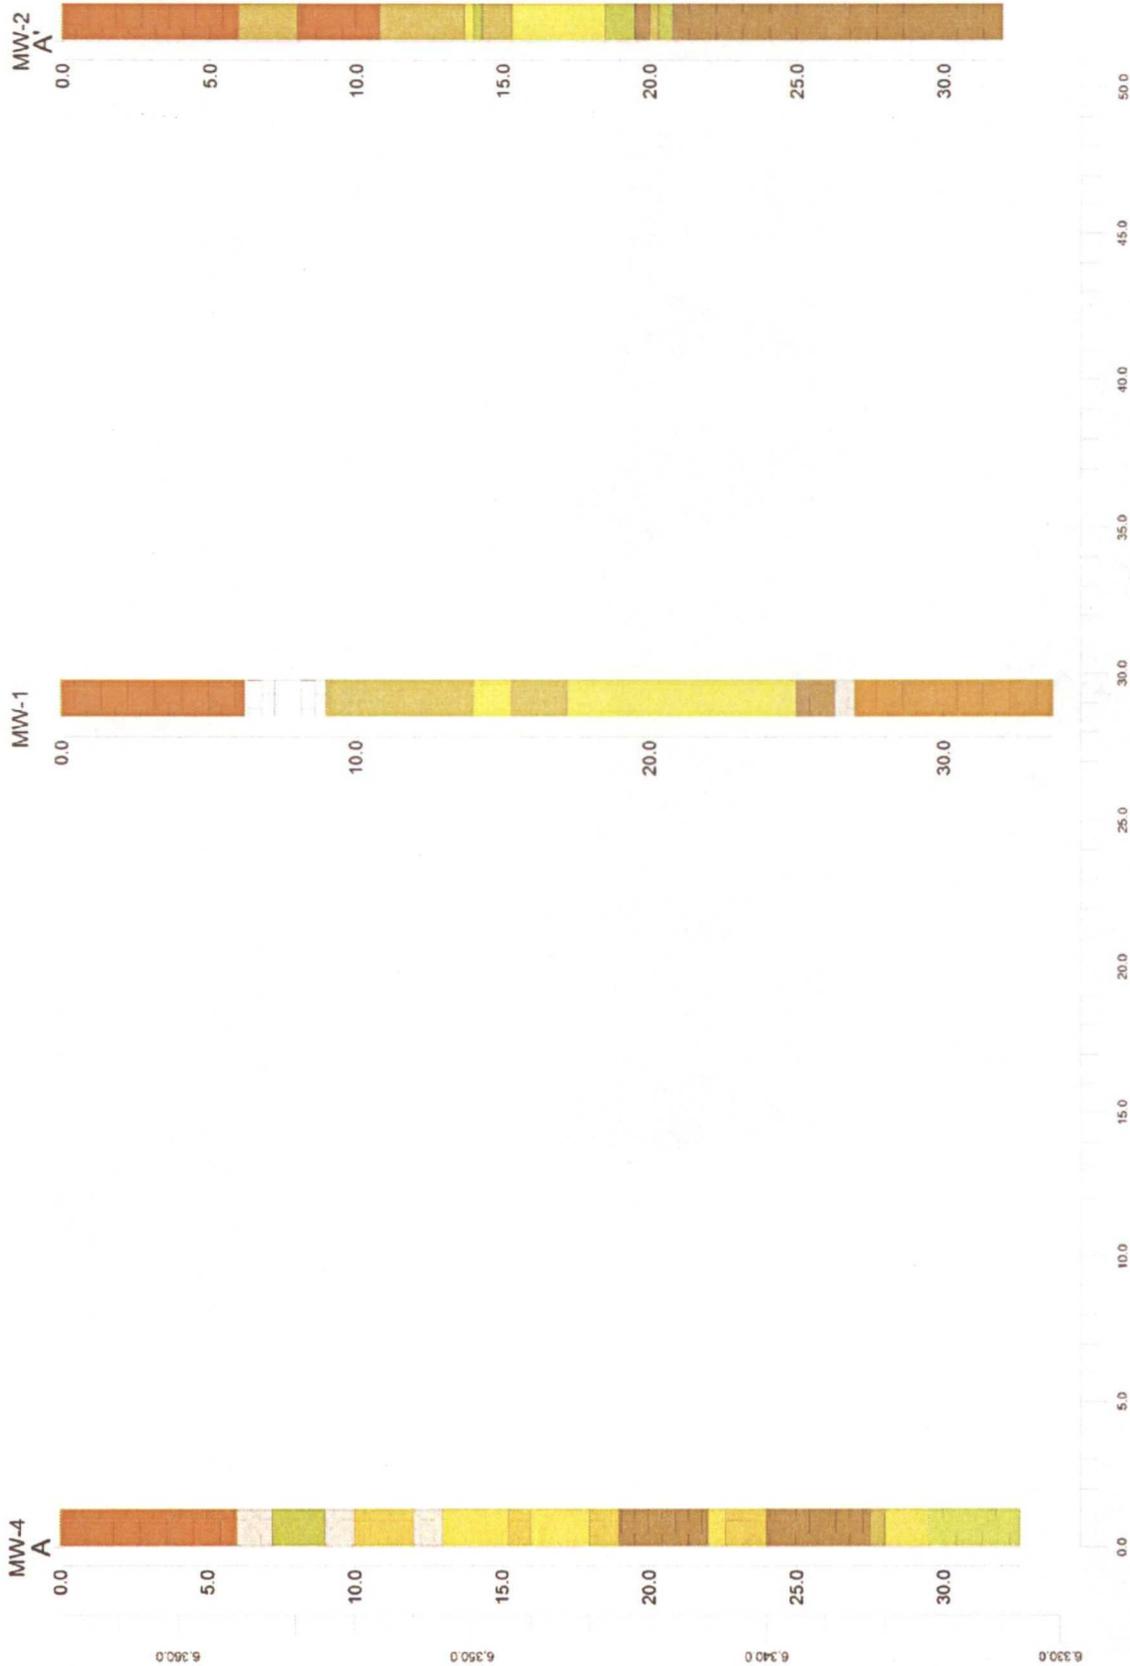
FIGURE 3:
GENERALIZED GEOLOGIC CROSS
SECTION
CONOCOPHILLIPS COMPANY
 San Juan 27-5 #34A
 Sec 30, T27N, R5W
 Rio Arriba County, New Mexico

The Site is located on BLM land outside of Blanco, NM in Section 30, Township 27N, Range 5W, of Rio Arriba County. The location and general features of the Site are presented as **Figures 1** and **2**, respectively. A generalized geologic cross section is presented as **Figure 3**.

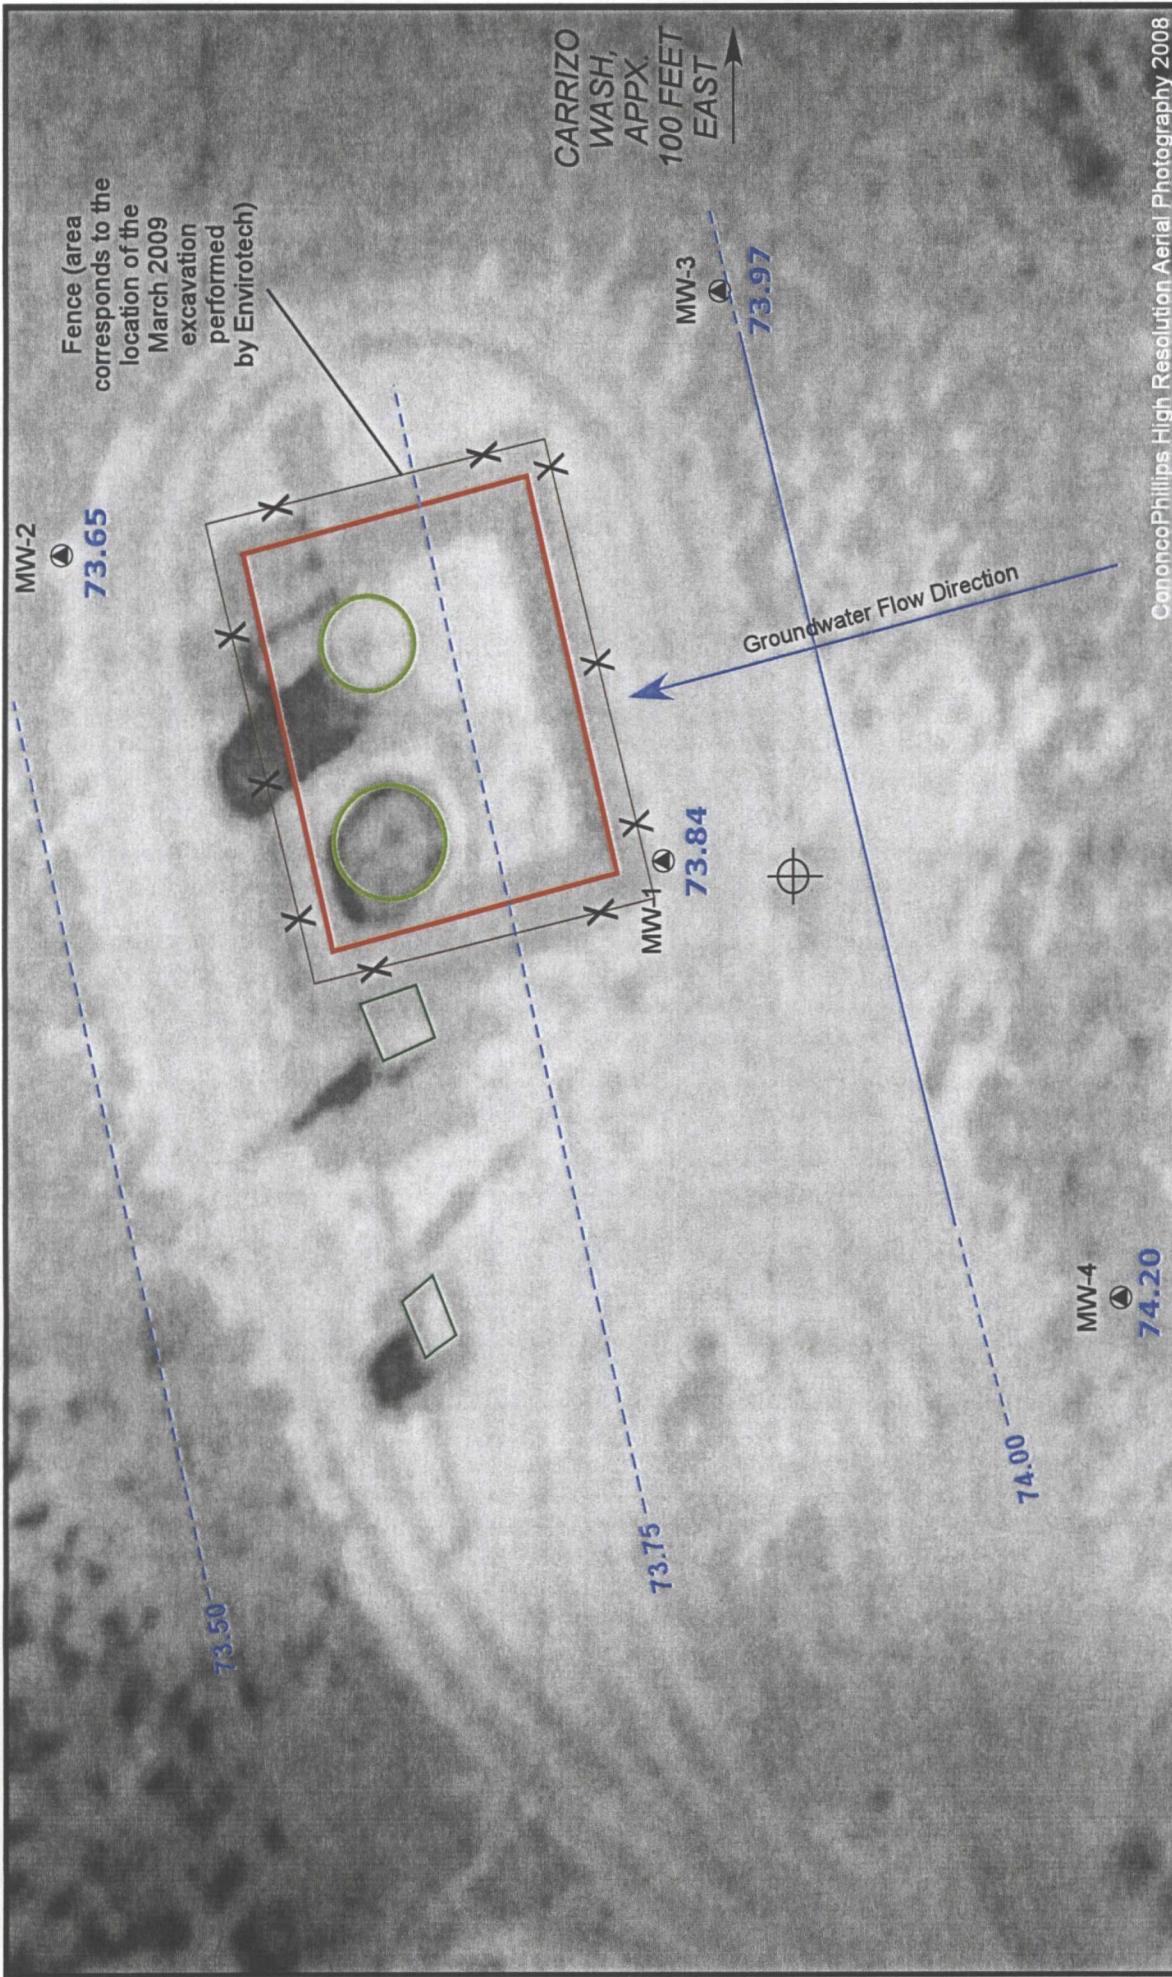
FIGURE 4:
 GROUNDWATER CONTOUR MAP
 DECEMBER 2010
 CONOCOPHILLIPS COMPANY
 SAN JUAN 27-5 No. 34A
 GAS PRODUCTION WELL
 Sec 30, T27N, R5W
 Rio Arriba County, New Mexico

On December 15, 2010, groundwater elevation measurements were recorded in Monitor Wells MW-1, MW-2, MW-3 and MW-4. **Table 2** presents the monitor well specifications and groundwater level data. A groundwater elevation contour map is presented as **Figure 4**, and illustrates that groundwater at the Site flows north-northeast. Groundwater flow direction changed slightly from previous monitoring events, possibly due to the construction of a stock pond northeast of the site during early 2010.
