**From:** Hansen, Edward J., EMNRD  
**Sent:** Monday, April 23, 2012 5:17 PM  
**To:** 'Hack Conder'  
**Cc:** Leking, Geoffrey R, EMNRD; 'Katie Jones'; 'Laura Pena'; 'Scott Curtis'  
**Subject:** Remediation Plan (1R425-22) Termination - ROC Vacuum Jct N-30 Site

RE: Termination Request  
Vacuum Jct. N-30 (1R425-22): UL/N, Sec. 30, T17S, R35E  
RICE Operating Company – Vacuum SWD System

**RICE OPERATING COMPANY  
JUNCTION BOX FINAL REPORT**

## Vacuum jct. N-30

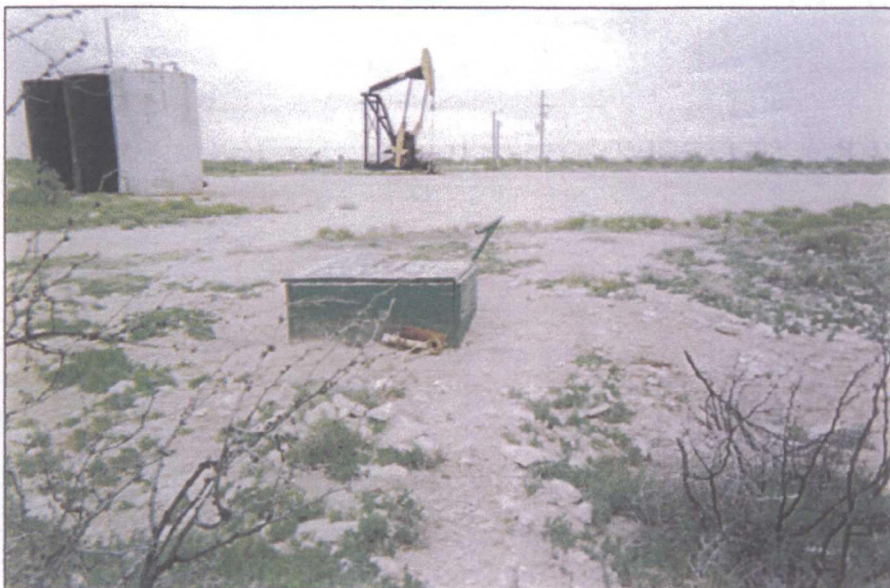
6/13/2005

undisturbed junction box

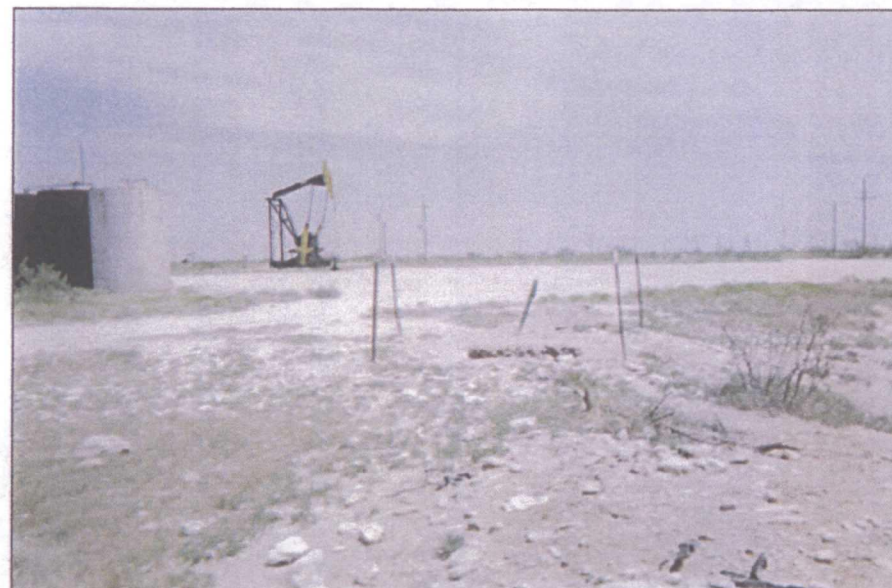
8/25/2005

box removed; before delineation

This junction box was addressed as part of the Vacuum System Abandonment. After removing the junction box, a delineation trench was made at the site using a backhoe while soil samples were collected at regular depth intervals to 13 ft BGS. Chloride field tests performed on the samples yielded concentrations that exhibited a conclusive trend of decline with depth (see graph), indicative of unsaturated historical vadose conditions. PID screenings conducted on the samples yielded very low concentrations as well, either 0.0 or 0.1 ppm. A grab sample at 13 ft BGS was collected for laboratory analysis to confirm field tests. TPH was not present within the lab's detection limits (<10.0 ppm), meeting NMOCD guidelines. The excavated soil was disposed of at a permitted facility and clean, imported soil was backfilled into the trench. The disturbed area was seeded with a blend of native vegetation and is expected to return to productive capacity at a normal rate. Since the Vacuum SWD System is no longer in service, a new box is not required.

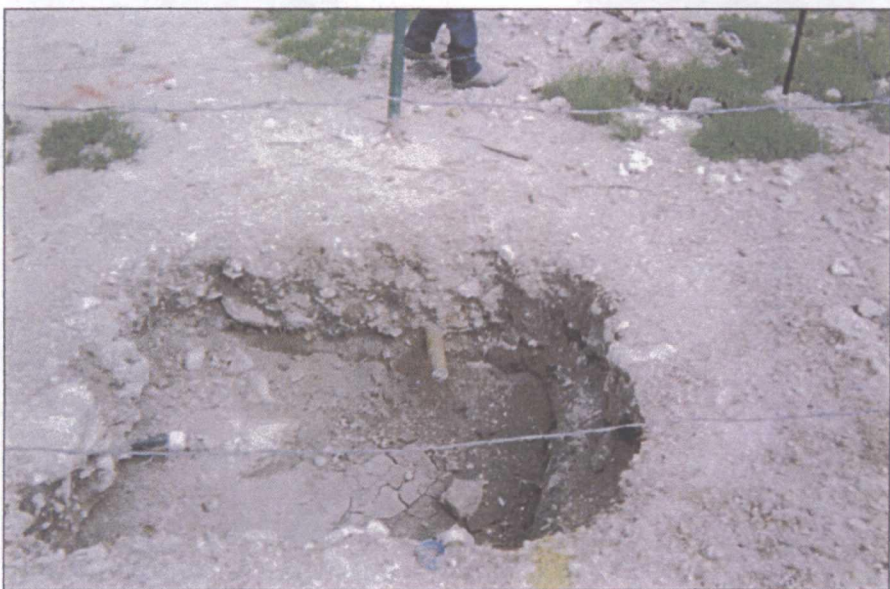
7/12/2005

box removed; before delineation

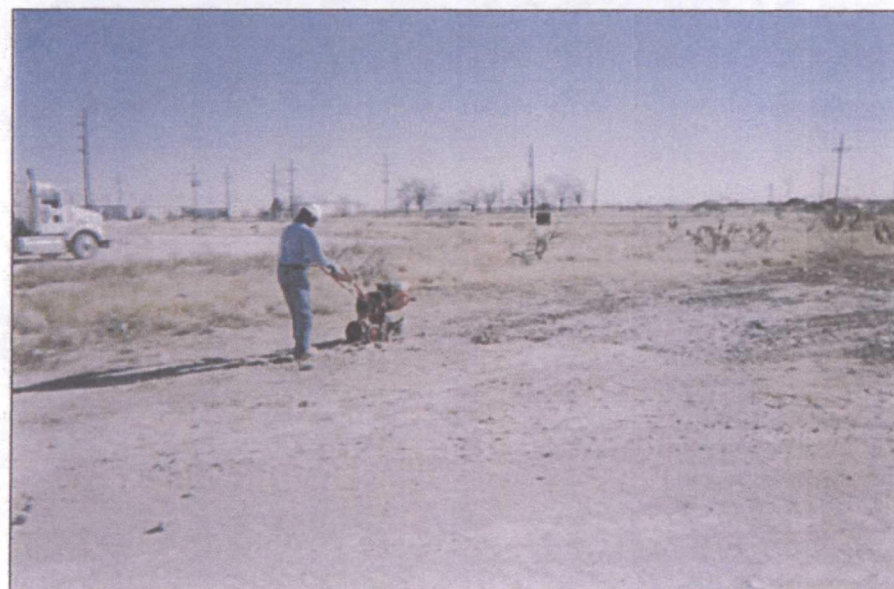
1/5/2006

seeding disturbed surface
